Donald C. Cook Nuclear Plant Unit 2  
Proposed Alternative to the  
American Society of Mechanical Engineers Code, Section XI  
Repair Requirements

### **10 CFR 50.55a Relief Request Number ISIR-4-06**

#### **Proposed Alternative in Accordance with 10 CFR 50.55a(a)(3)(ii) Hardship or Unusual Difficulty without Compensating Increase in Level of Quality or Safety**

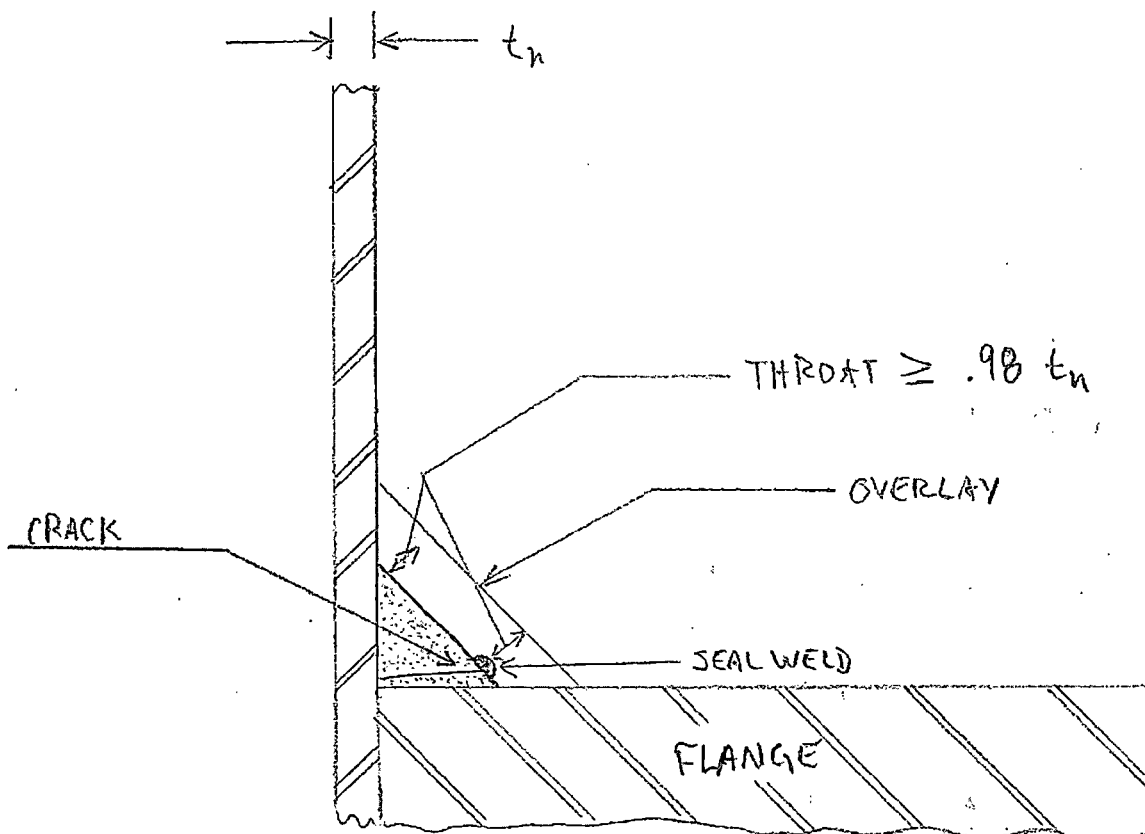
Proposed Overlay

- The through wall defect is on the toe flange side of the weld which most likely propagated from the root of the weld.
- A sketch of the pipe, flange, existing weld and overlay, and an isometric drawing marked to show the flange with the leak are provided in Section 7 of this attachment.
- The flange and pipe material are listed in the following table.

The proposed alternative is application of a weld overlay in accordance with ASME Code Case N-666, "Weld Overlay of Class 1, 2, and 3 Socket Welded Connections, Section XI, Division 1." This Code Case is referenced in Regulatory Guide 1.147, Revision 17 under Table 1, Acceptable Section XI Code Cases. Use of this code case will seal the leakage and defect as well as restore the structural integrity of the socket weld identified in Section 1 above. The only exception that will be taken is that the failure mechanism is not currently believed to be vibration induced. All other criteria of the Code Case will be met including the following requirements.

The leak will first be seal welded with 309L filler material. The seal weld will be examined visually (VT-1) and dye penetrant tested prior to performing the weld overlay.

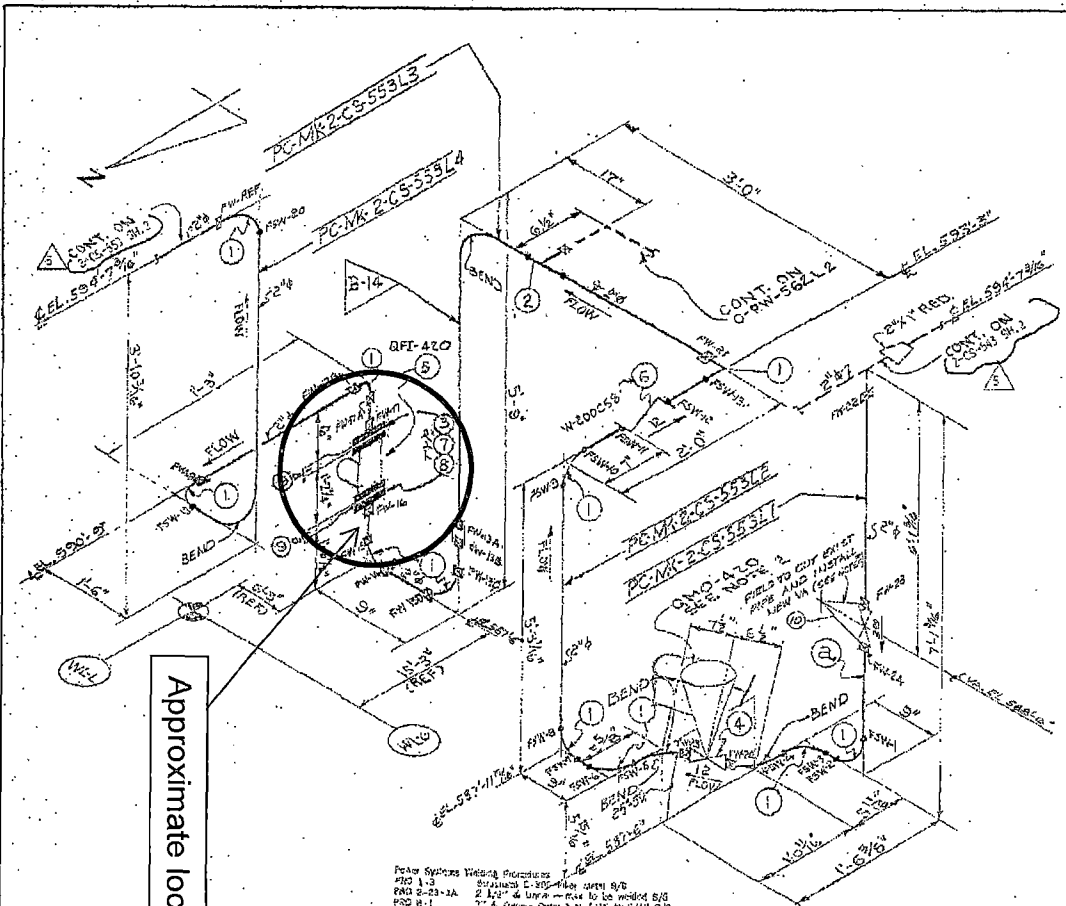
The affected component is socket weld FW-17 attaching a flange fitting to Chemical and Volume Control System Boric Acid Makeup System American Society of Mechanical Engineers (ASME) Code Class III two-inch piping downstream of a flow indication instrument 2-QFI-420 in Donald C. Cook Nuclear Plant Unit 2.

During normal plant operation, with Unit 2 at 100 percent power during cycle U2C22, leakage from a through wall defect was discovered at the toe of the flange weld identified in Section 1 above. A relief request is being requested since performing a repair in accordance with the applicable code requirement would result in hardship and unusual difficulty. Additionally, it would not provide a compensating increase in quality and safety compared to the repair as specified in Code Case N-666, with deviation, which is being requested. This defect is located in a section of piping that can only be isolated from the charging system suction header by a single check valve, which is common to both charging pumps. Therefore, normal repair would require re-welding this flange under a non-positive isolation boundary. In addition, after the repair is performed and the system is refilled; there is no means available to vent the piping to remove air from the system. It is unacceptable to introduce air into the charging system suction lines due to concerns for air binding of the high head injection pumps. If a high point vent was to be installed, it would require extensive work to remove surrounding interferences and would potentially increase the risk of foreign material introduction in the charging system, and possibly, the reactor coolant system. Based on the remaining

Approximate location of leak
