SUBJECT: Forwards response to NRC requests for info re non-nuclear instrumentation/integrated control sys failures. Corrective actions should preclude recurrence of event similar to Crystal River. No OL mods necessary.

Subject: Oconee Nuclear Station
Docket Nos. 50-269, -270, -287

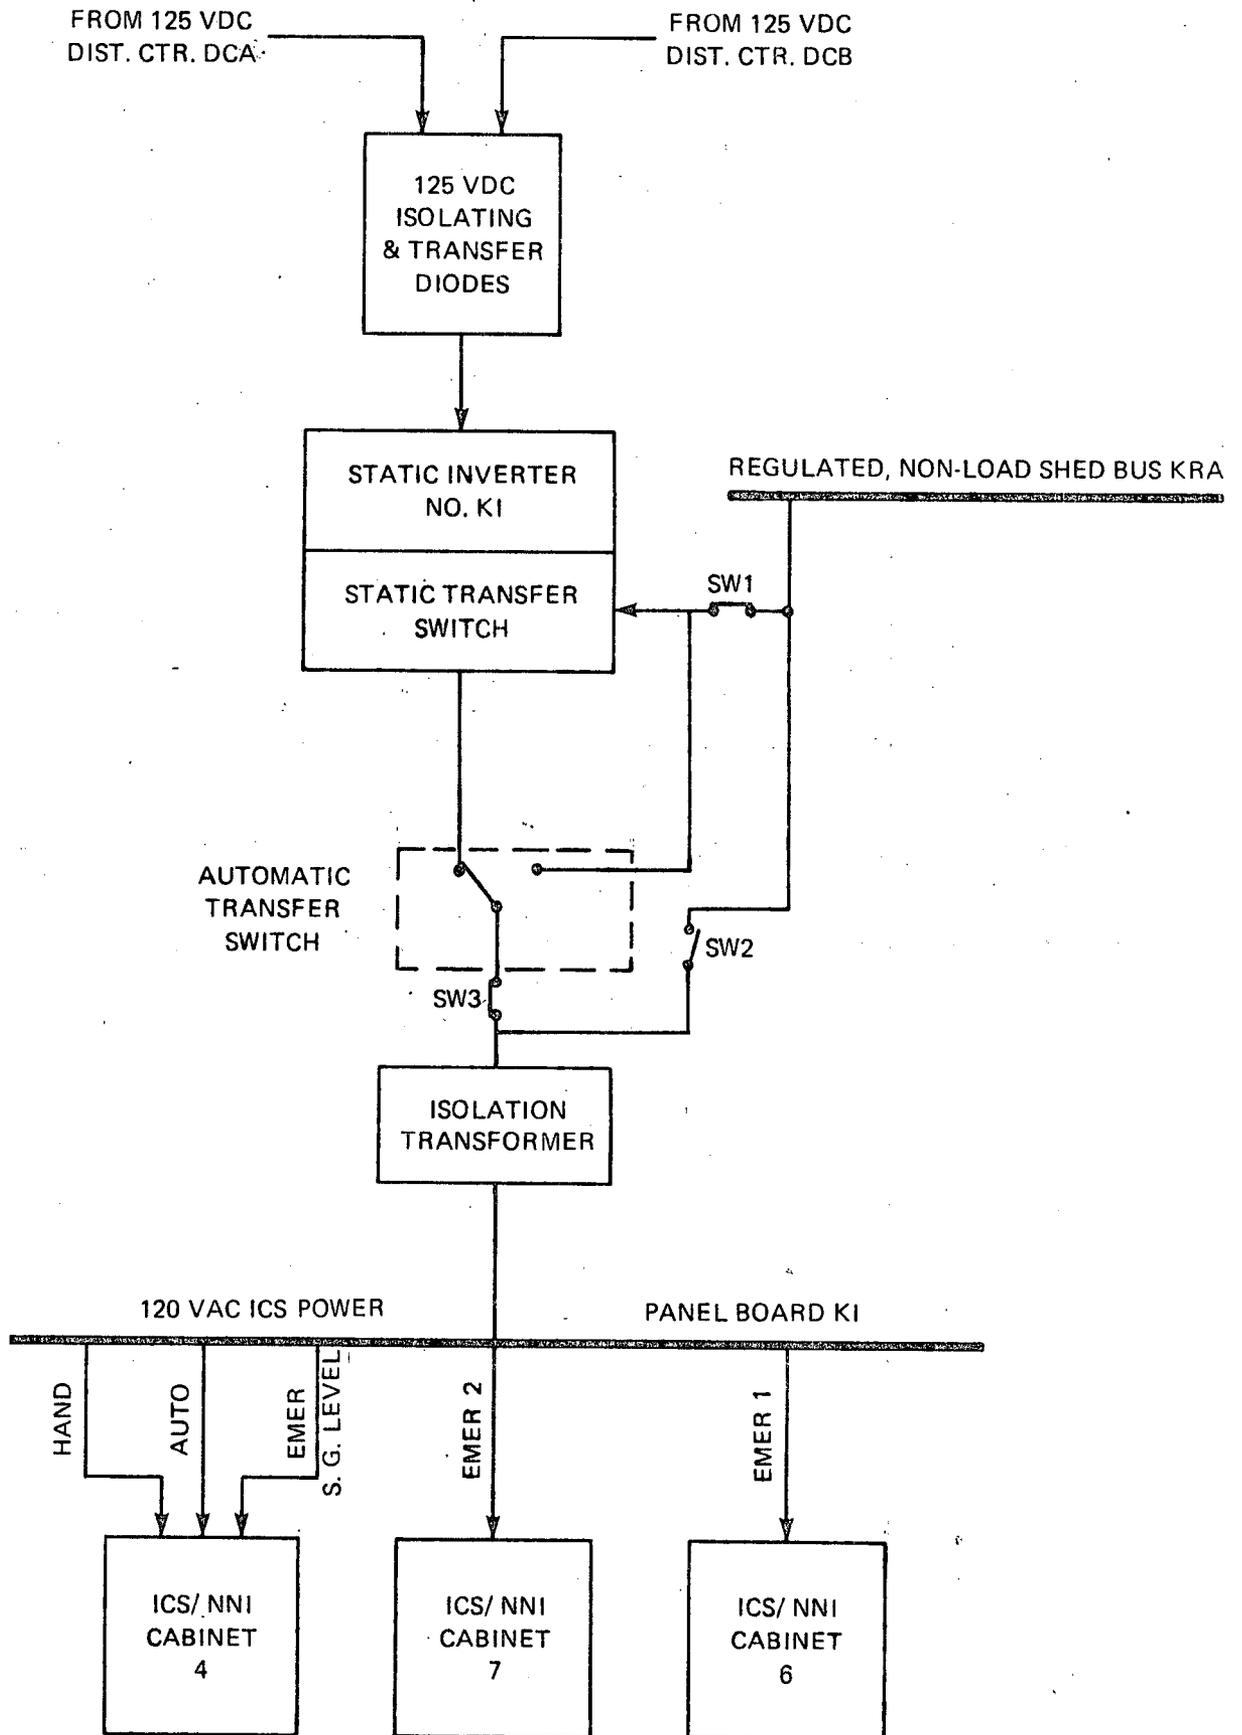
FIGURE 1
OCONEE NUCLEAR STATION
TYPICAL ICS/NNI AC SUPPLY

The ICS/NNI system at Oconee is powered from a dedicated static inverter system which receives a DC input from the vital instrumentation and control batteries and a backup AC input from a regulated non-load shed bus. (Refer to the attached Figure 1.) On November 10, the static switch on the output of the inverter system failed preventing either the inverter source or the backup source from feeding the integrated control system. In this particular instance, power was restored by manually switching the backup source to panel 3KI. This was accomplished by the operator such that the ICS system was without power for approximately 2 1/2 minutes. To eliminate the need for a manual transfer and to improve the integrity of this AC supply, an automatic transfer switch has been added such that on an inverter or static switch failure, the inverter static switch system will be bypassed and regulated non-load shed power supplied to panel board 3KI through the automatic power transfer switch. This automatic transfer takes place in less than 1.2 seconds and eliminates the need for manual transfer.
