REGULATORY INFORMATION DISTRIBUTION SYSTEM (RIDS)

SUBJECT: LER 89-006-00: on 890804, improper relay setting due to design deficiency could trip 2B reactor bldg spray pump.
W/8 ltr.

Subject: Oconee Nuclear Station
Docket Nos. 50-269, -270, -287
LER 270/89-06

Topic: Trip Proper Relay Setting, Due to Design Deficiency, Could Trip 2B Reactor Building Spray Pump During LOCA/LOOP Event

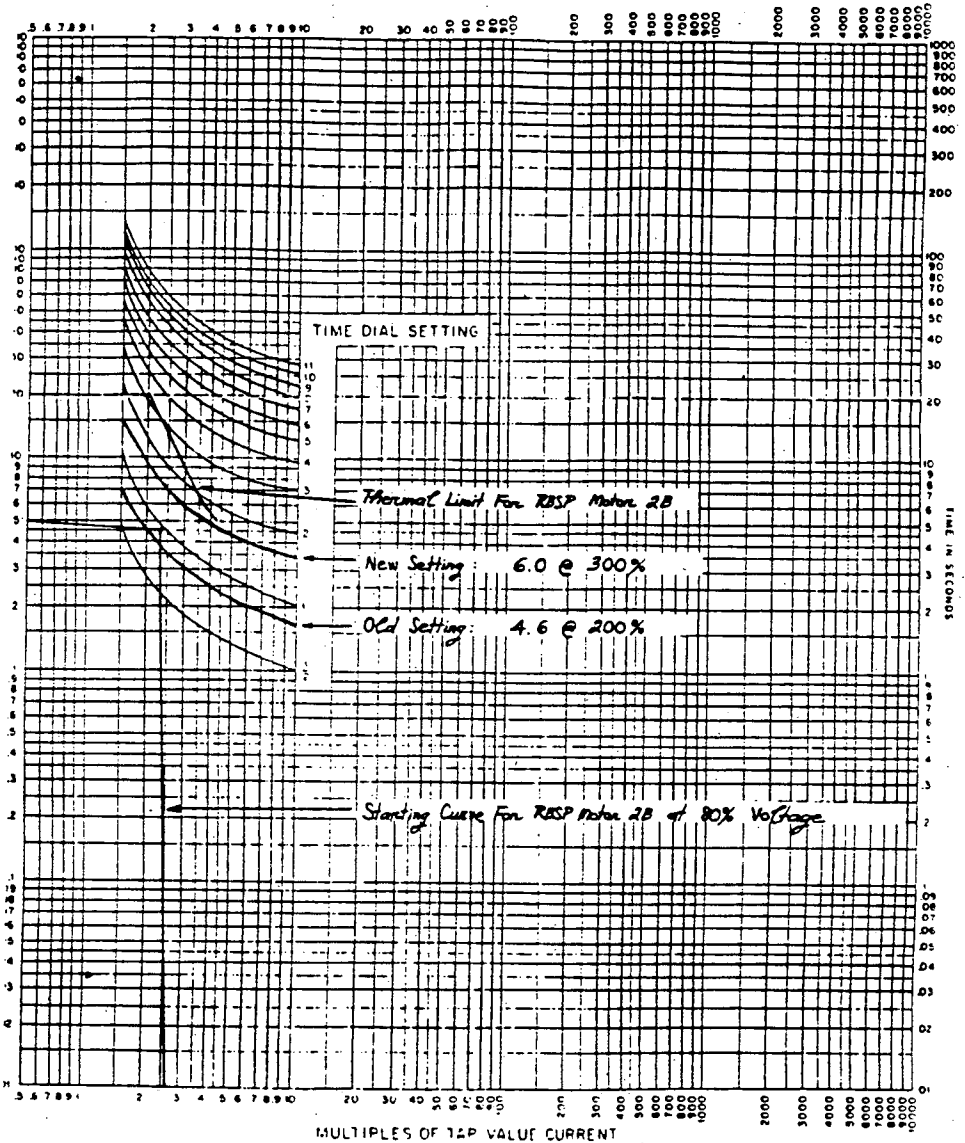
WESTINGHOUSE ELECTRIC CORPORATION, NEWARK, N.J., U.S.A. CURVE # 471045

The potential for the 2B Reactor Building Spray Pump Motor to trip with an overcurrent relay setting of 4.6 seconds @ 200% was only present during a Loss Of Coolant Accident (LOCA)/Loss Of Offsite Power (LOOP) scenario. The motor manufacturer guarantees the motor to start at a minimum of 80% rated voltage. During the initial phases of a LOCA/LOOP, the voltage at the RBS Pump Motor terminal dips to 81%, while during a LOCA, the startup voltage dips to approximately 87%. The difference in these startup voltages is due to the fact that a LOCA-only unit is immediately powered from the switchyard while a LOCA/LOOP unit would be powered from a Keowee Hydro unit [EIIS:EK] through transformer CT-4 [EIIS:XFMR] and the standby buses. The previous overcurrent relay setpoint of 4.6 seconds @ 200% was not sufficient to allow the motor to fully start during the reduced starting voltage of the LOCA/LOOP, but was sufficient to allow the motor to fully start during the LOCA startup voltage.

The raising of the relay setpoint to 6.0 seconds @ 300% allows the motor to successfully start at starting voltages of less than 80%. In addition, the new setpoint does not exceed the thermal damage limit for the motor which ensures that the motor will not be damaged due to the additional starting time.

TYPE CO-5 LONG TIME OVERCURRENT RELAY
TYPICAL 50/60 CYCLE CURRENT TIME CURVES

As shown above the voltage at the RSP pump motor terminal dips to 81% under a LOCA/LOOP scenario. This should be adequate for the motor to start since it is guaranteed by the motor manufacturer to start at 80% voltage.

- A new overcurrent protective relay setting was determined.
- Design Engineering calculation OSC-2563 was revised to demonstrate capability of the 2B RBS Pump Motor to start under LOCA/LOOP conditions with the new relay setting. (See Technical Data and Current Time Curves on page 11 of this report).
- The overcurrent protective relay was adjusted to the new setting of 6.0 seconds @ 300% plus or minus 5% in accordance with Exempt Change OE-2714. This action was taken on August 5, 1989 and cleared the LCO on Unit 2.
