SUBJECT: Special rept: on 900827, high pressure injection train rendered automatically inoperable.

Subject: Oconee Nuclear Station, Unit 2
Docket No. 50-270
Special Report Concerning High Pressure
Injection Train Rendered Automatically
Inoperable Due To Inappropriate Operator Actions

TITLE (4) **High Pressure Injection Train Rendered Automatically Inoperable Due to Inappropriate Operator Actions**

PIR# 2-090-0081

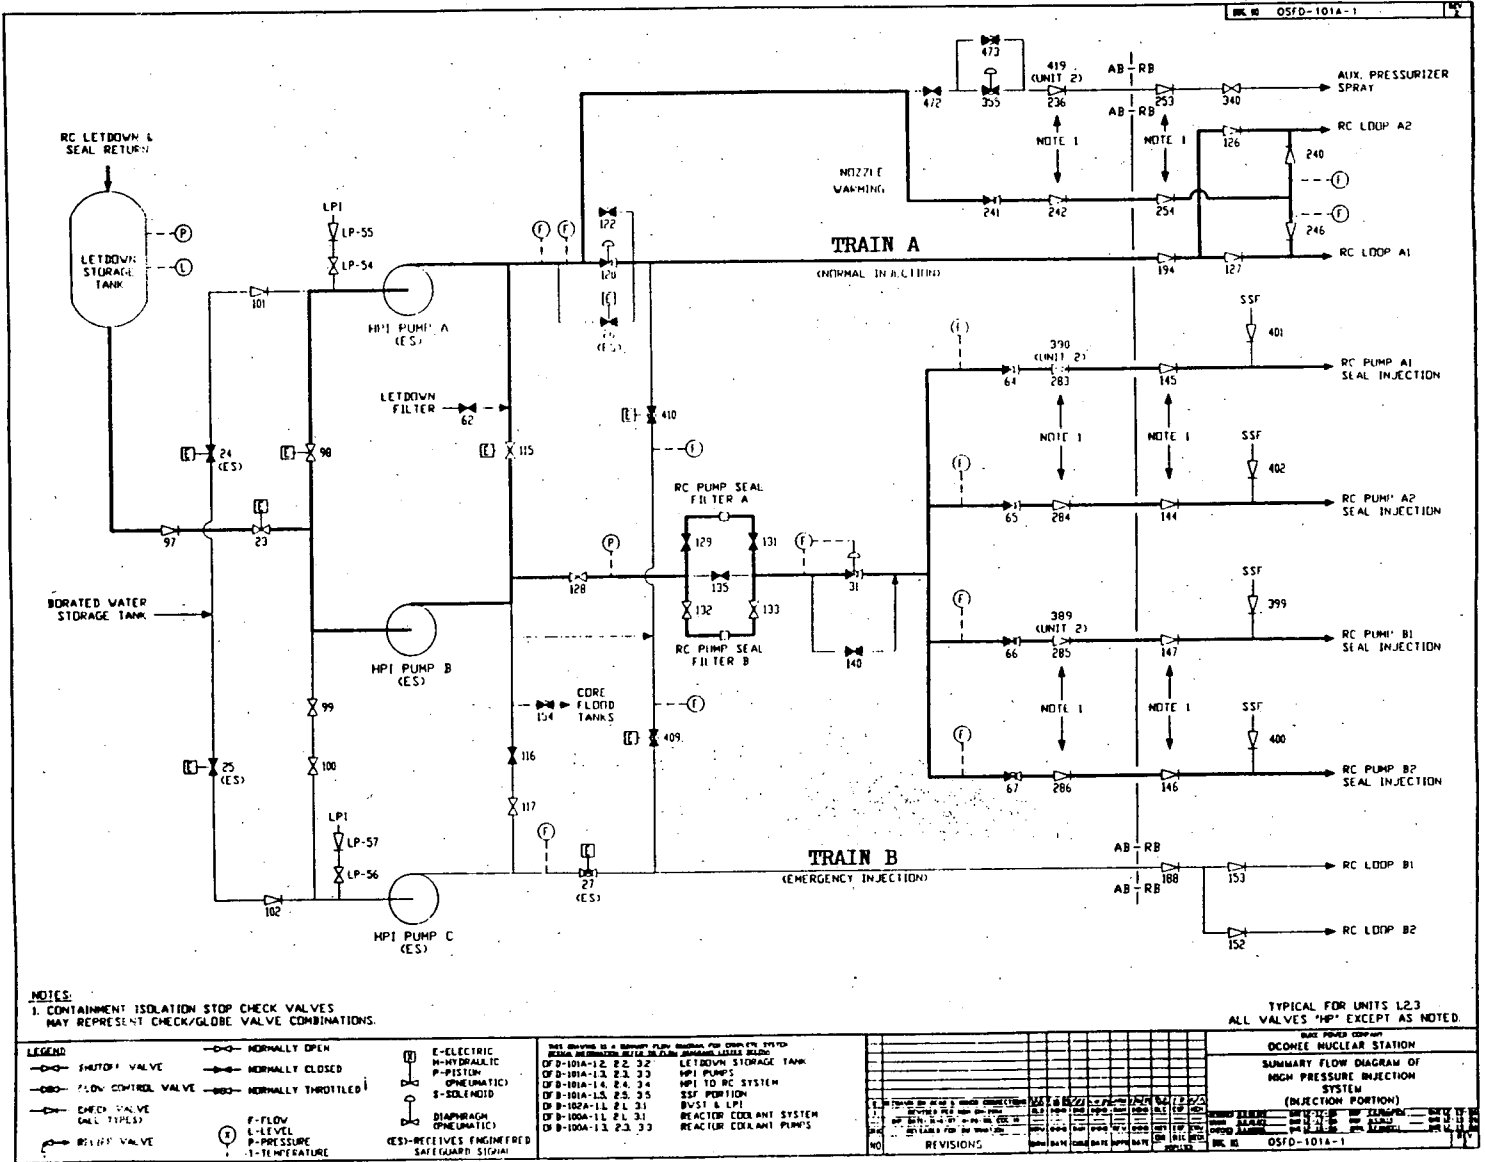
ATTACHMENT 1

Oconee Unit 2 has three HPI pumps [EIIS:P] (pumps A, B, and C). The three pumps are installed in parallel with a cross connecting header on the discharge of the pumps capable of furnishing either or both HPI Trains A and B (see attachment 1 drawing). During normal operation, one pump is required to supply normal makeup and reactor coolant pump seal injection. A second pump functions automatically as a backup. The third pump is used only for emergency injection. The HPI pumps are powered from the 4160V switchgear. All three pumps receive an automatic Engineered Safeguard [EIIS:JE] actuation signal on low Reactor Coolant System [EIIS:AB] pressure and/or high reactor building [EIIS:NH] pressure.
