DUKE POWER COMPANY  
OCONEE NUCLEAR STATION

UNIT 2  
REACTOR BUILDING  
POST-TENSIONING SYSTEM  
SIXTH SURVEILLANCE

February 14, 1995

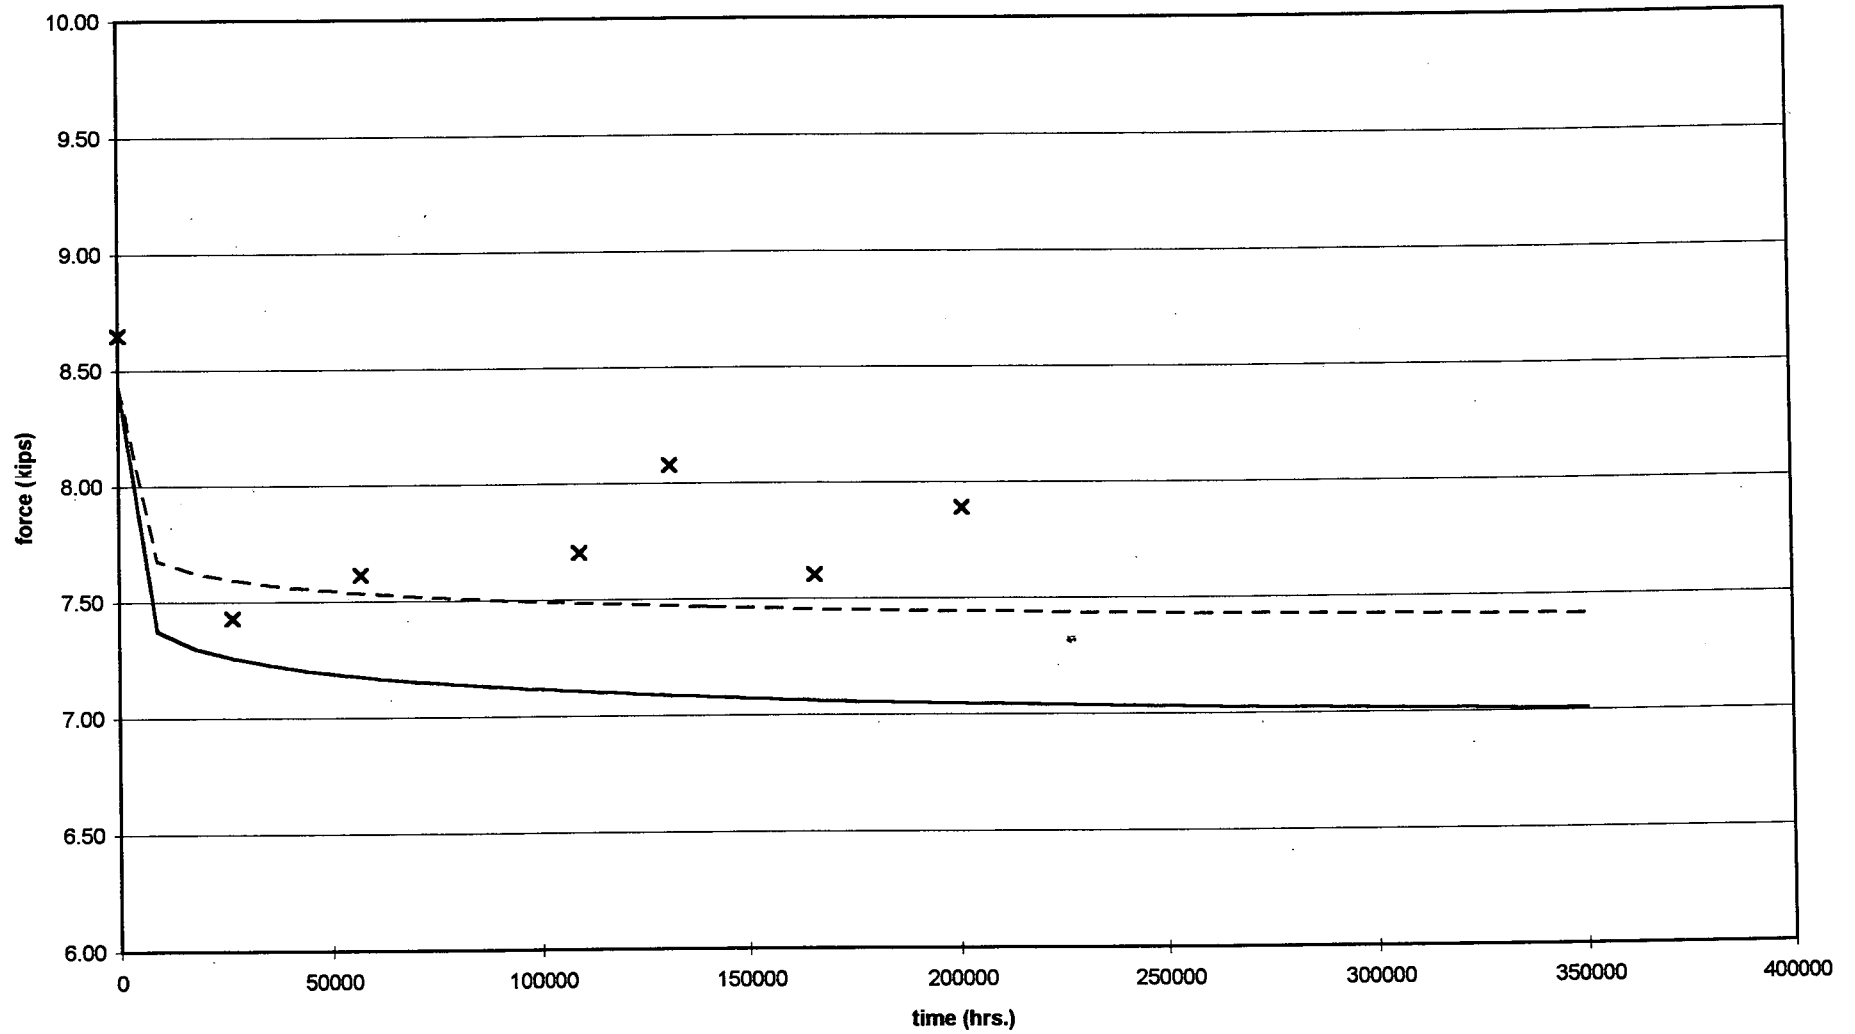
**Figure 1**

Lift-off forces were obtained for each inspected tendon - see Table 3. From these readings an average force per wire was determined. Long-term trends of these wire forces, considering effects of elastic shortening, steel relaxation, and concrete creep and shrinkage, are shown graphically in Figures 1, 2, and 3. Lift-off forces exceeded required values. Average lift-off force of three randomly selected vertical tendons - 61V14, 61V22, and 61V28 - coincided precisely with predicted value for current surveillance period.

**Dome Tendon Group Force-Time Plot**

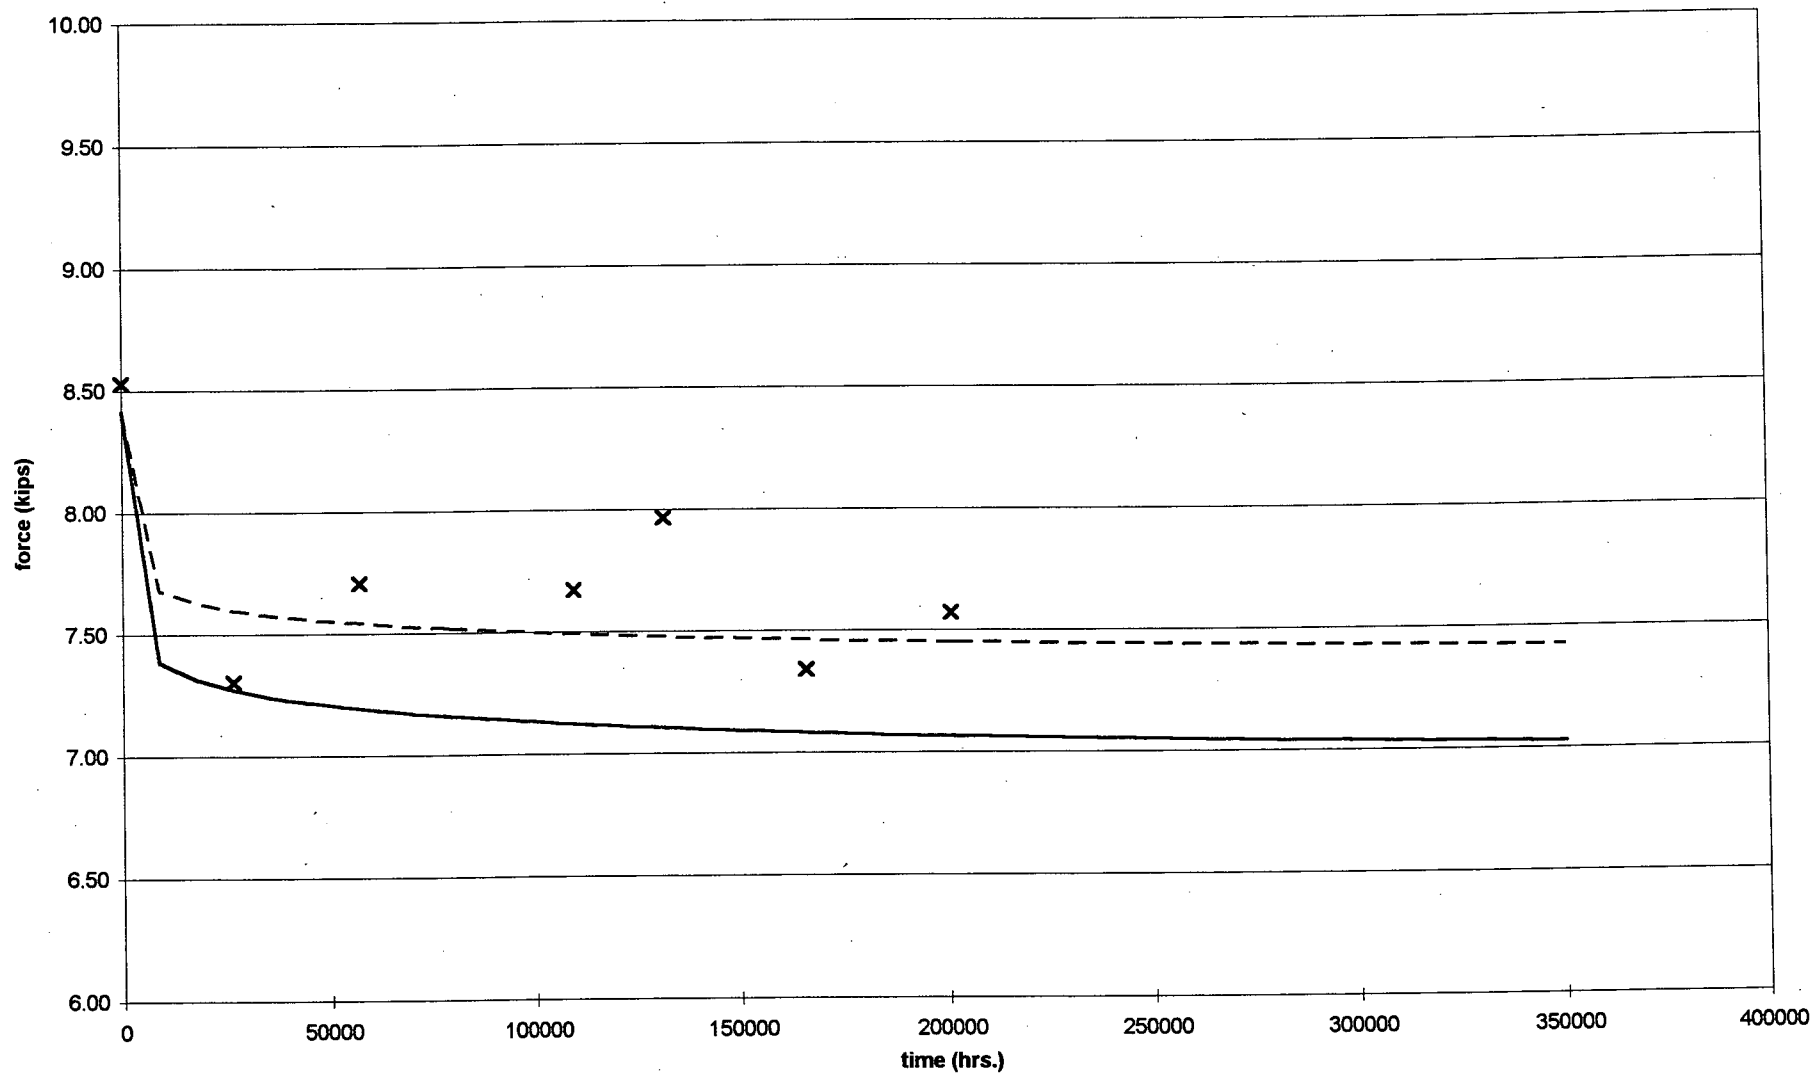
**Figure 2**

**Hoop Tendon Group Force-Time Plot**

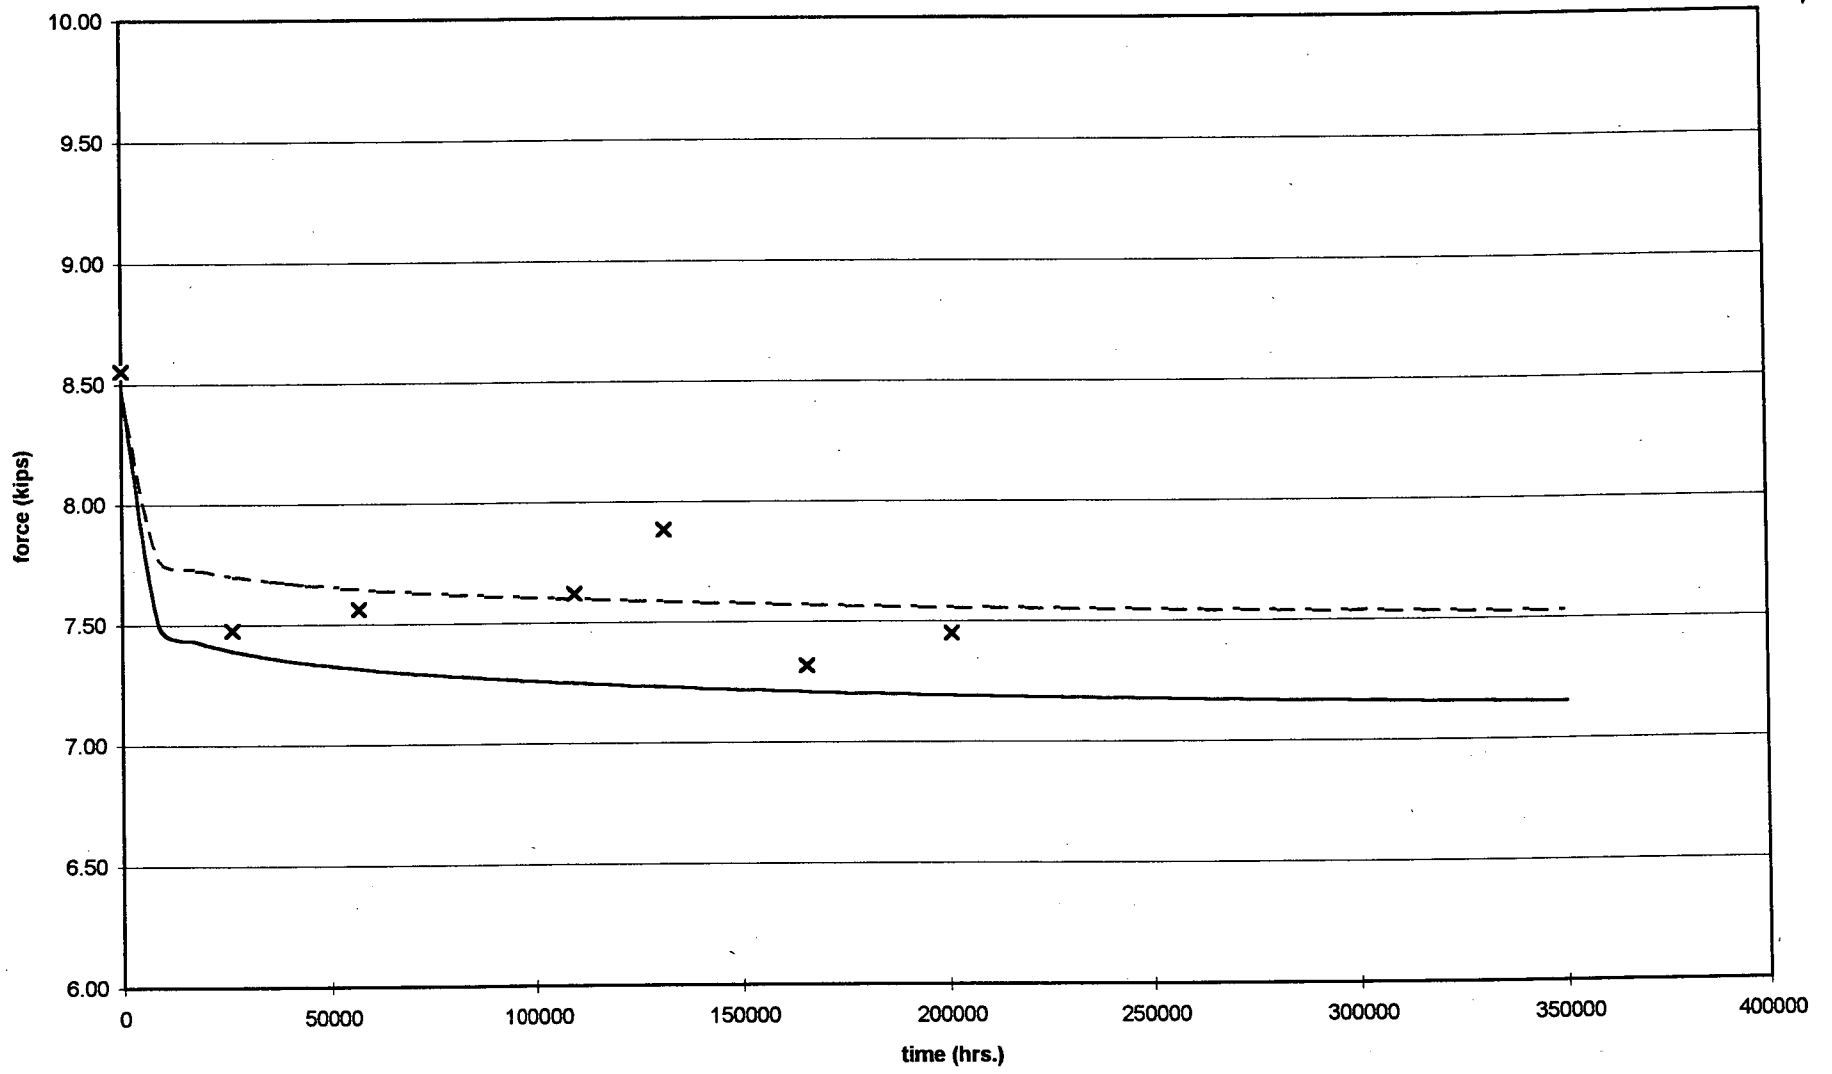
**Figure 3**

**Vertical Tendon Group Force-Time Plot**
