SUBJECT: LER 96-004-01: on 960924, secondary drain line rupture resulted in manual reactor trip. Caused by lack of understanding of water hammer, inadequate procedures & human error. Mod installed & procedures revised. W/961209 ltr.

Subject: Oconee Nuclear Station
Docket Nos. 50-269, -270, -287
Licensee Event Report 270/96-04, Revision 1
Problem Investigation Process No.: 2-096-1828

LICENSEE EVENT REPORT (LER)

TITLE (4)
Secondary Drain Line Rupture Results In A Manual Reactor Trip

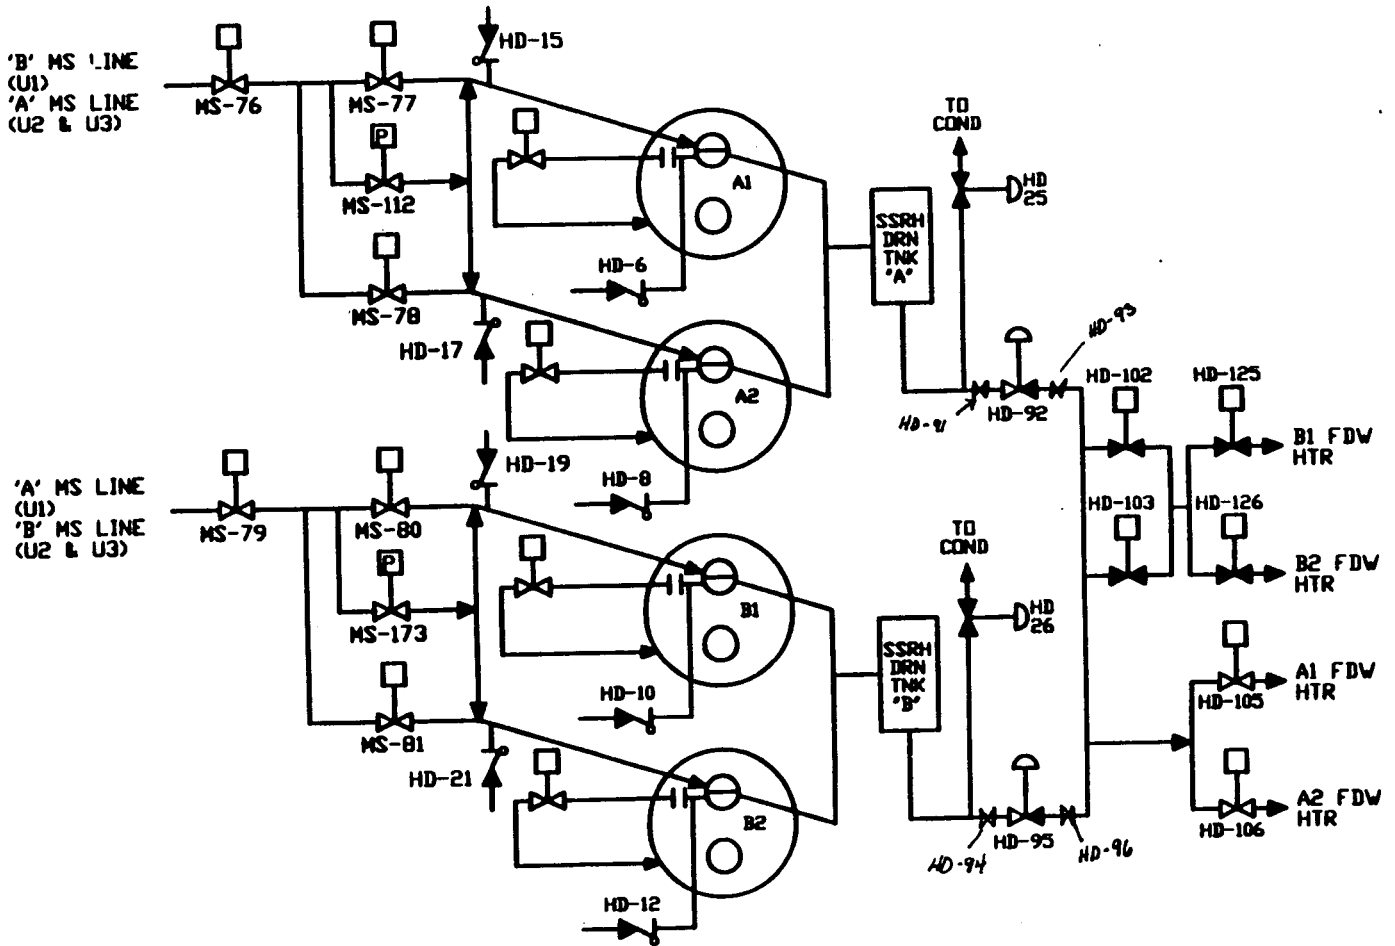
Attachment 1

On September 24, 1996, the Unit 2 Operations Coordinator verbally reminded the Unit 2 Shift Supervisor to open 2HD-91 and 2HD-94 at approximately 600 Mwe. (See Attachment 1)

At approximately 1642 hours, with Unit 2 at approximately 60% full power, a rupture of a SSRH line, downstream of 2HD-94, occurred. The release of steam resulted in burn injuries to seven employees (five NLOs and two I&C technicians). There were no radioactive releases, radioactive exposures to employees, or contamination of employees.

The Failure Investigation Team's preliminary conclusion was that a severe water hammer was the immediate cause of the pipe rupture. This team also concluded that erosion/corrosion was not a factor in the piping failure.
