ACCESSION NBR: 9101290122 DOC. DATE: 91/01/21 NOTARIZED: NO DOCKET #
 FACIL: 50-270 Oconee Nuclear Station, Unit 2, Duke Power Co. 05000270
 AUTH. NAME AUTHOR AFFILIATION
 LOWERY, H.R. Duke Power Co.
 BARRON, H.B. Duke Power Co.
 RECIP. NAME RECIPIENT AFFILIATION
 Document Control Branch (Document Control Desk)

Subject: Oconee Nuclear Station
Docket No. 270
Special Report Concerning Reactor Coolant
System Pressure Boundary Leak on Incore
Instrumentation Closure Housing

TITLE (4) **Reactor Coolant System Pressure Boundary Leak on Incore Instrumentation Closure Housing Due to Equipment Failure**

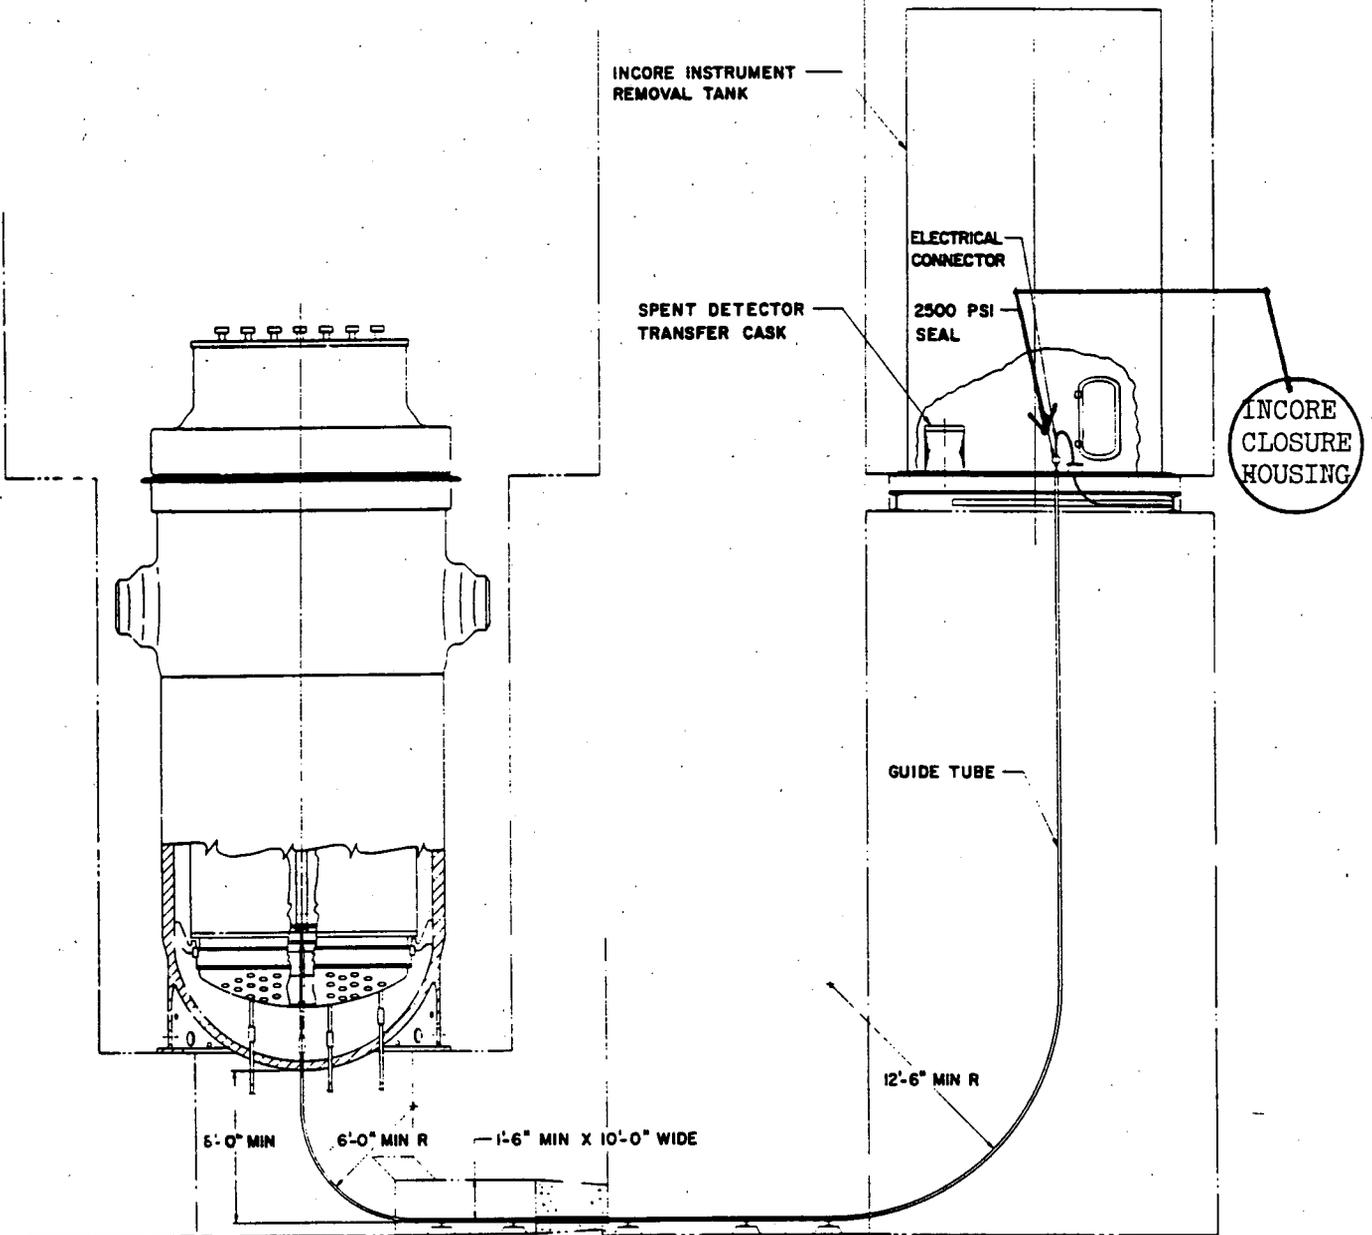
Figure 7.6-11

The INC is inserted into the core through incore piping closure assemblies in the Incore Instrument Tank (see Attachment 1). The Incore Instrument Tank is the location of the pressure and electrical connections to the Incore Piping. From the Incore Instrument Tank, the Incore Piping completes two 90 degree turns and enters the bottom of the RV through the Incore Instrument Nozzles. These are the only penetrations into the RV below core level. From the bottom of the RV, the Incore piping extends up within the Lower Grid Assembly [EIIS:AC] and aligns the INC to the instrumentation tubes of 52 selected fuel assemblies.

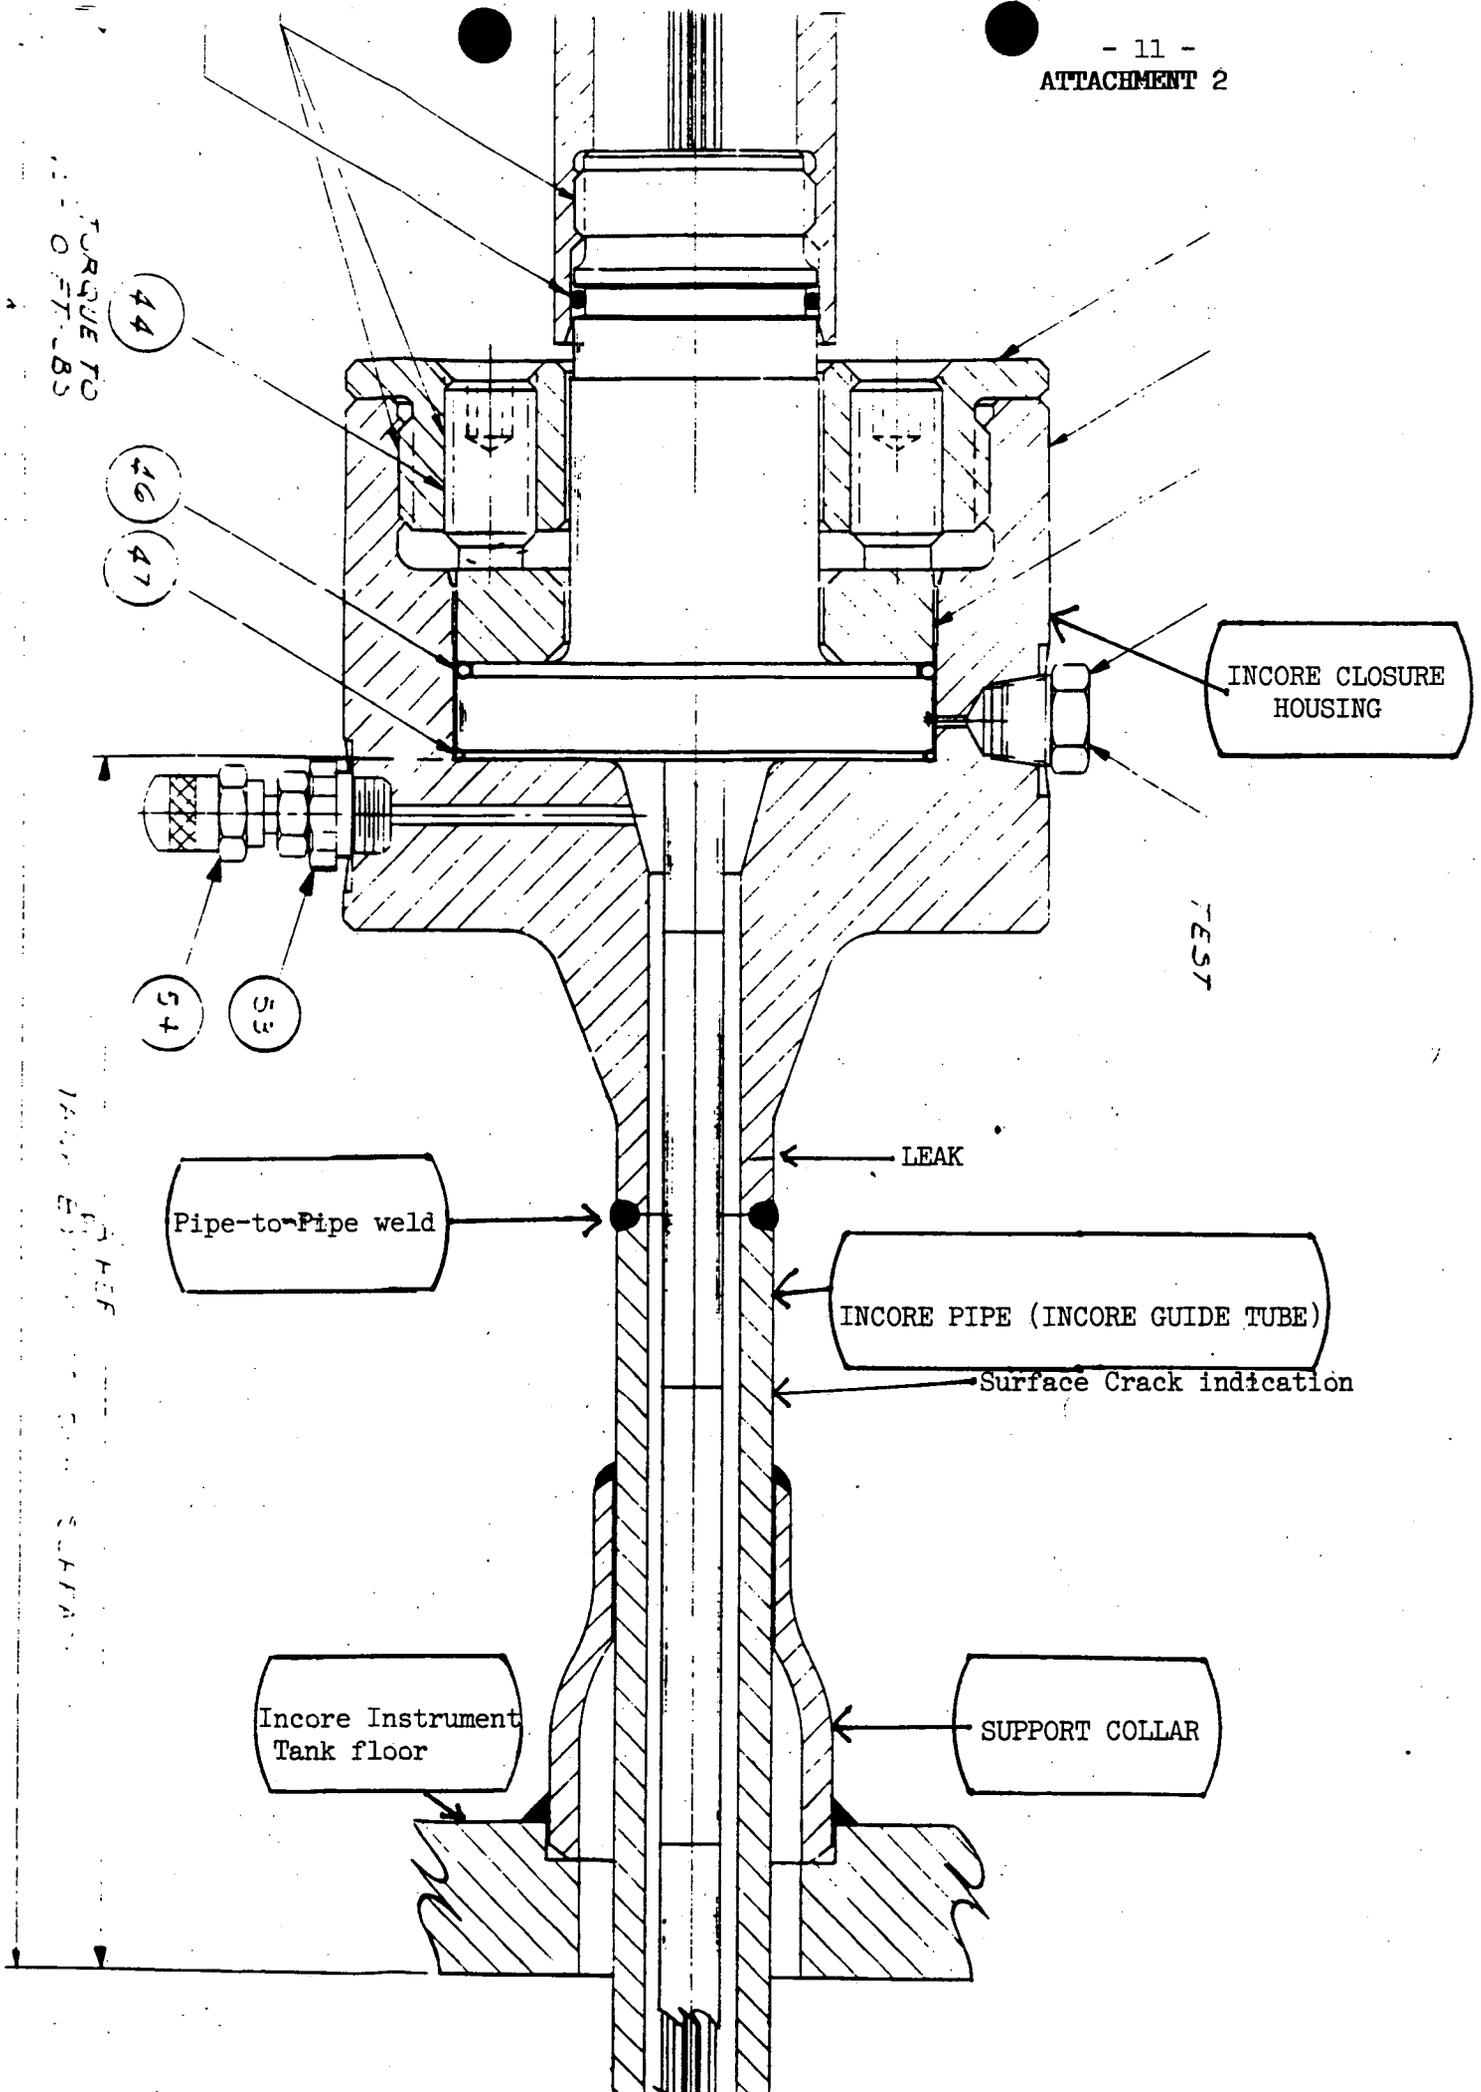
Upon I&E's attempt to repair L2, they discovered that the Incore Closure Housing had a crack just below the housing and above the weld (Attachment 2). I&E contacted Mechanical Maintenance (MM) upon the discovery of the crack. On 11/12/90, Quality Assurance performed a Dye Penetrant Test (PT) on the observed crack to determine the extent of the discrepancy. The PT revealed a second indication on the Incore Closure Housing. At the

Both the Incore Closure Housing L2 and the removed portion of the Incore Piping were sent to the B&W Lynchburg Research Center for destructive testing. Dye Penetrant Tests performed at the Research Center on the Incore Closure Housing indicated one through-wall crack with several other cracks approximately 180 degrees away.

- 1) Incore Closure Housing L2 and Incore Pipe failed primarily due to mechanical fatigue.
- 2) Fatigue striation spacings indicated high-cycle, low-amplitude loading.
- 3) The source of the loading is not known, but could have been caused by multi-mode vibrations.
- 4) The Incore Closure Housing material exhibited a relatively high non-metallic inclusion content, which may have reduced the fatigue life of the component.
- 5) Bulk chemistry for both the Incore Closure Housing and the Incore Pipe was within the limits for Type 304L stainless steel as stated in ASME Specification SA-182.

- 1) Cut the support collar to the incore pipe weld.
- 2) Pull incore pipe up far enough to PT the affected section of incore pipe.
- 3) Weld support collar to incore piping.
- 4) Cut incore piping a minimum of 1/2" below lowest indication without cutting incore wire.
- 5) Cut and restrain incore wire.
- 6) Weld cap onto incore pipe.
