# ACCELERATED DISTRIBUTION DEMONSTRATION SYSTEM

Subject: Oconee Nuclear Station  
Docket Nos. 50-269, -270, -287  
LER 270/91-02

TITLE (4) **Flow Orifice Installed Backwards Due to Unknown Cause Results in Degraded Emergency Core Cooling System During Certain Small Break Loss of Coolant Accident Scenarios**

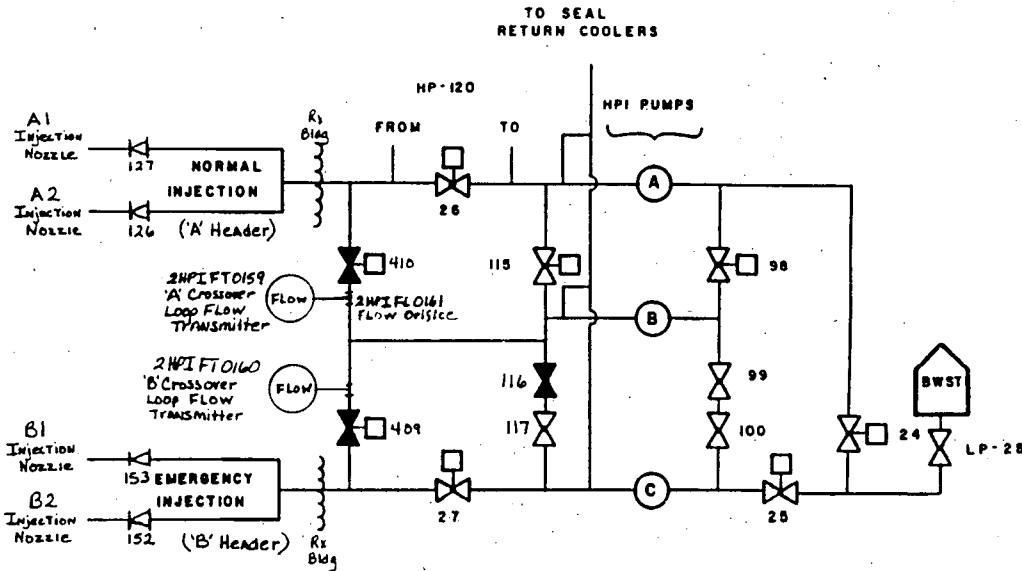
**ATTACHMENT 1**

The HPI System is also a part of the Emergency Core Cooling System (ECCS) which mitigates the consequences of loss of coolant accidents (LOCA). The HPI System prevents uncovering of the core for smaller break sizes, where high RCS pressure is maintained, and delays the uncovering of the core for intermediate break sizes. The HPI System, during emergency operation, supplies borated water to the RCS from the Borated Water Storage Tank (BWST). The HPI System has three parallel HPI pumps that have the capability to take suction from the BWST. The HPI pumps have the capability to discharge through two redundant flow paths into the RCS, utilizing four injection nozzles (two per flowpath). The injection nozzles are located on each of the reactor inlet pipes downstream of the Reactor Coolant Pumps. Each HPI flowpath is connected by piping and associated valves at each HPI pump discharge header, making up the 'A' and 'B' Crossover Flow loops. This cross-connect provides for remote manual alignment to ensure flow to the core through both HPI trains should a single failure of an HPI pump or HPI injection valve prevent automatic injection through one train. (See Attachment 1)

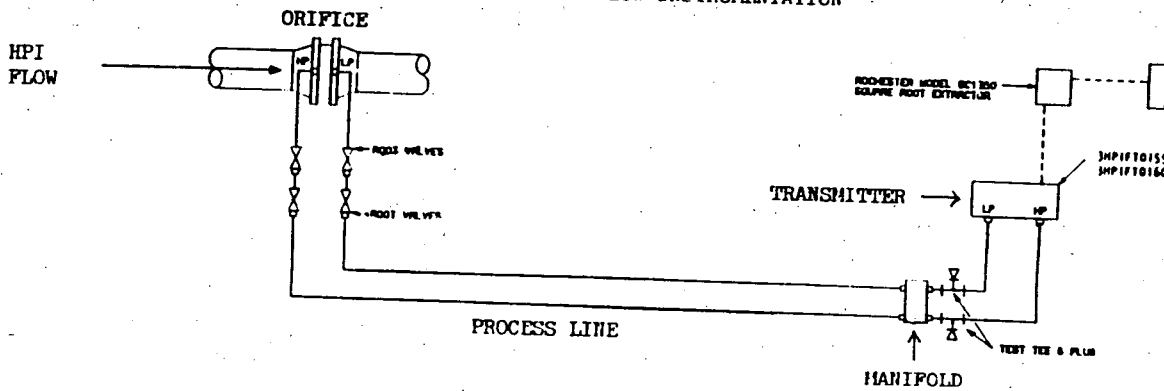
**ATTACHMENT 2**

As a corrective action for the event of the crossed impulse lines on Unit 3, Work Requests were issued for the other two Oconee Units to verify that the transmitters were connected to the process line correctly and to verify that the flow orifice plates were installed correctly. On April 8, 1991, at 1700 hours, Unit 2 HPI Crossover Flow orifice 2HPIFE0161, the primary flow element feeding 2HPIFT0159 flow transmitter, was discovered to be installed backwards.

The orifice plate that was found installed backwards was confirmed, by the identification number imprinted on the orifice, to be the same one that was installed in 1980. The orifice plate has the imprinted mark of "Inlet" stamped on the exposed portion of the plate and is facing the outlet direction of the flange in relation to the direction of flow within the piping. No other documentation was found that indicated that the orifice plate had ever been removed since the initial installation. However, this is not conclusive evidence that the orifice plate was never removed since 1980, although an extensive search of work history records was performed.

**HIGH PRESSURE INJECTION PUMP  
CROSSOVER FLOW INSTRUMENTATION**

1. The reversed flow orifice will be reinstalled in the correct position during the next outage of sufficient duration.
2. All other flow orifices that are installed in safety related systems on all three units will be inspected to ensure correct installation.
3. Mechanical personnel having responsibility for installation of orifices, will be trained on the importance of proper installation and given training concerning the installation of basic types of orifices emphasizing the guidelines set forth in NRC Information Notice 90-69.
4. The Nuclear Station Modification Program will ensure that procedures to install orifice plates include instructions that define the direction of flow within the piping.
