ACCESSION NBR:9105300311 DOC.DATE: 91/05/16 NOTARIZED: NO DOCKET #
 FACIL:50-270 Oconee Nuclear Station, Unit 2, Duke Power Co. 05000270
 AUTH.NAME AUTHOR AFFILIATION
 LOWERY,H.R. Duke Power Co.
 BARRON,H.B. Duke Power Co.
 RECIP.NAME RECIPIENT AFFILIATION

SUBJECT: LER 91-003-00:on 910416,both trains of HPI sys, (ECCS) declared inoperable due to excessive LDST pressure.Cause unknown.Excessive hydrogen vented into GWD sys to reduce LDST pressure.W/910516 ltr.

TITLE (4)
Excessive Letdown Storage Tank Pressure for Unknown Reason Makes High Pressure Injection System Inoperable

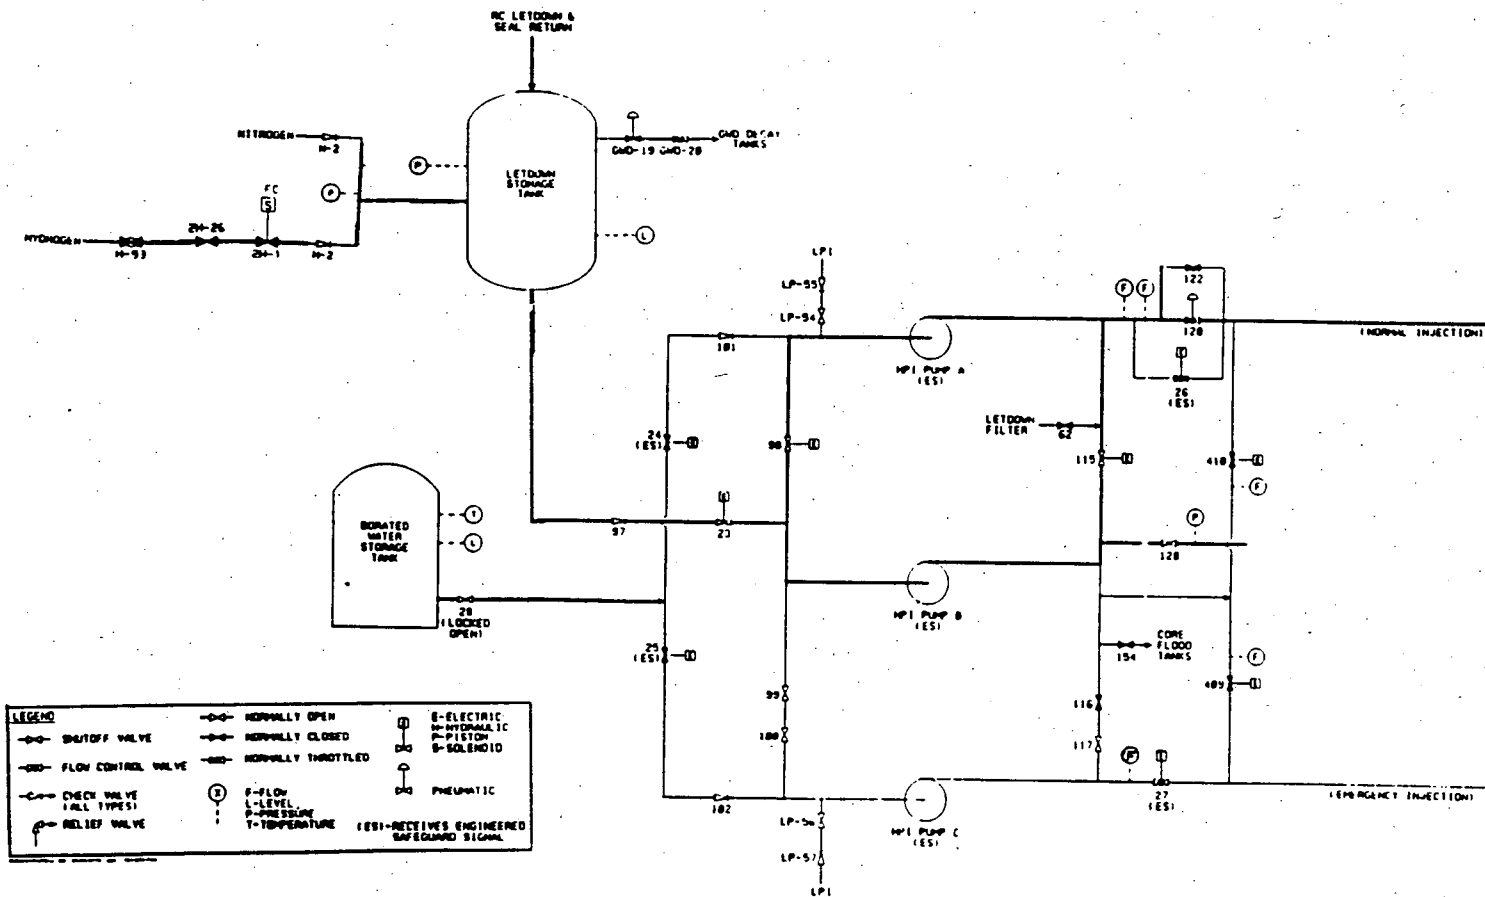
ATTACHMENT B

The HPI System is also a part of the Emergency Core Cooling System (ECCS) which mitigates the consequences of loss of coolant accidents (LOCA). The HPI System prevents uncovering of the core for smaller break sizes, where high RCS pressure is maintained, and delays the uncovering of the core for intermediate break sizes. The HPI System, during emergency operation, supplies borated water to the RCS from the Borated Water Storage Tank (BWST). The HPI System has three parallel HPI pumps that have the capability to take suction from the BWST and to discharge through two redundant flow paths into the RCS, utilizing four injection nozzles (two per flow path). The injection nozzles are located on each of the reactor inlet pipes downstream of the Reactor Coolant Pumps. (See Attachment B)
