SUBJECT: LER 92-002-00: on 920210, TS violation occurred due to
 pressurizer safety relief valve actuation. Caused by setpoint
 error. Test procedures changed. W/920325 ltr.

FACILITY NAME (1) Oconee Nuclear Station, Unit 2						DOCKET NUMBER (2) 0 5 0 0 0 2 7 0			PAGE (3) 1 OF 0 8		
--	--	--	--	--	--	---	--	--	-----------------------------	--	--

TITLE (4) **Pressurizer Safety Relief Valve Actuation Setpoint Error Due To Defective Procedure Results In A Technical Specification Violation**

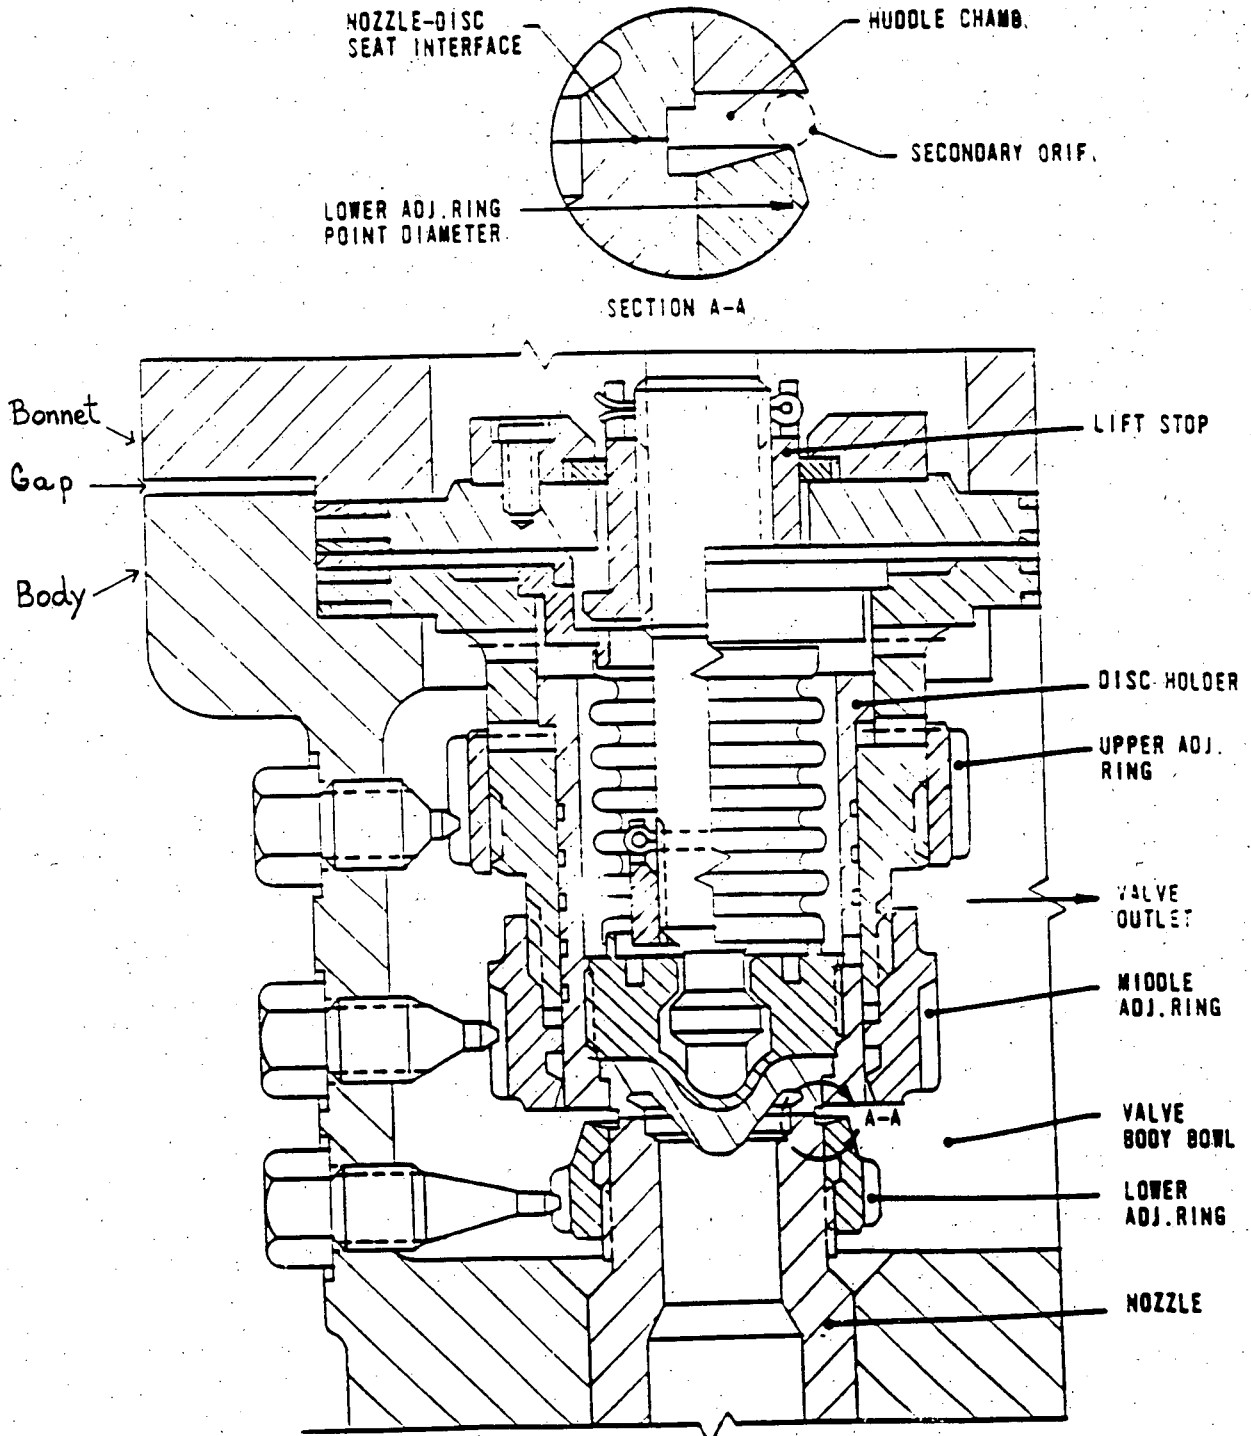
**FIGURE 1
VALVE OPENING**

If valves are leaking during the steam setpoint verification test, the valves' huddle chamber (see Figure 1) could become pressurized, effectively increasing the valve seat area. With this larger area, a lower pressure could then produce sufficient force to lift the disc. If the leak was later repaired as was done with the jack and lap process, this would result in a higher actual setpoint if retesting on steam is not performed.

To improve the jack and lap process, the procedure was changed to require reestablishment of the bonnet-to-body gap (see Figure 1) as well as a subsequent steam setpoint verification test.
