SUBJECT: LER 92-003-00: on 920226, discovered that mgt deficiency & inappropriate action resulted in loss of TS required temp overpressure protection. Caused by mgt deficiency. Valve 2HP-26 & 2HP-27 breakers were opened. W/920327 ltr.

Subject: Oconee Nuclear Station
Docket Nos. 50-269, -270, -287
LER 270/92-03

TITLE (4) **Management Deficiency And Inappropriate Action Result In The Loss Of Technical Specification Required Low Temperature Overpressure Protection**

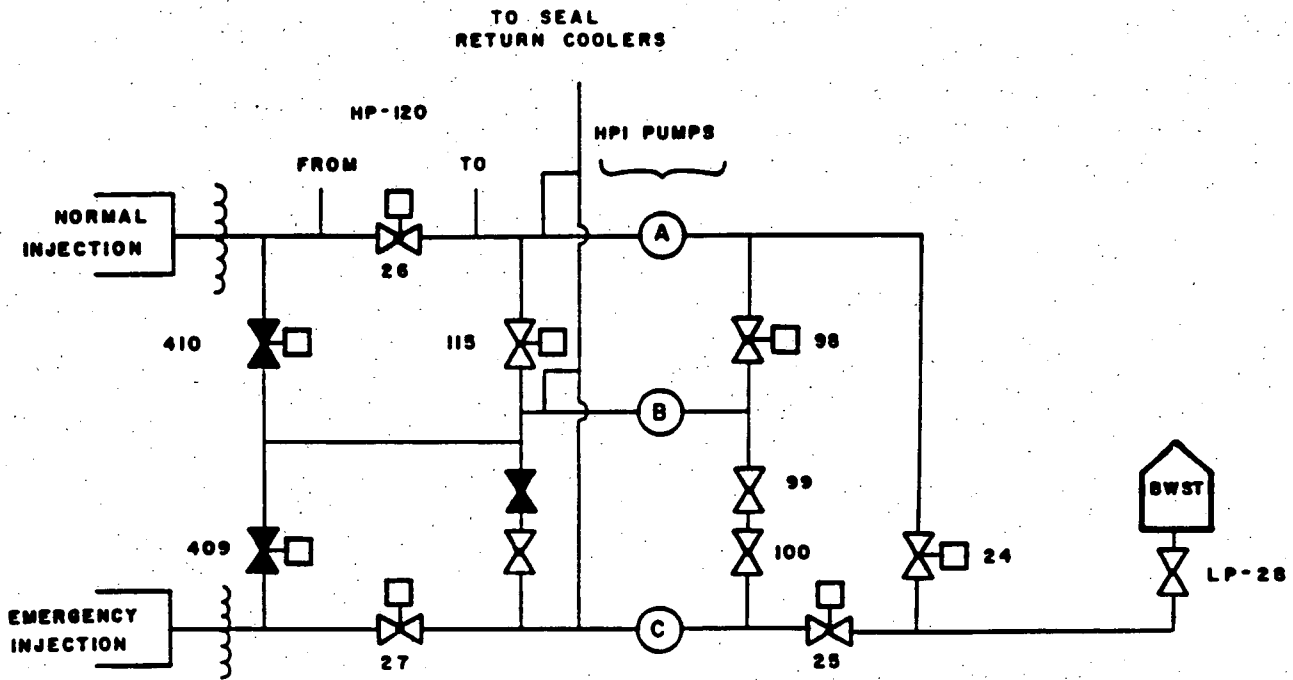
**ATTACHMENT A
HIGH PRESSURE INJECTION SYSTEM**

Attachment A shows a summary flow diagram of the HPI system.
