SUBJECT: Special rept: on 930630, valve packaging event occurred due to equipment failure. Leakage cleaned up, area decontaminated, studs on valve 2HP-64 replaced & valve vendor contacted for assessment of problem relative to 10CFR21 considerations.

Subject: Oconee Nuclear Station  
Docket Nos. 50-269, -270, -287  
Special Report Concerning Manual  
Start of Engineered Safeguards Pump

This report is provided for information regarding a June 30, 1993 valve packing leak event. The NRC was notified of the event at 1253 hours because it was initially decided that starting the 2A HPI pump could conservatively be considered reportable under 10CFR50.72 (b)(2)(ii) as an event or condition that results in manual or automatic actuation of any Engineered Safety feature. However, upon further review, it was decided for reasons described in this report, that this event is not reportable.

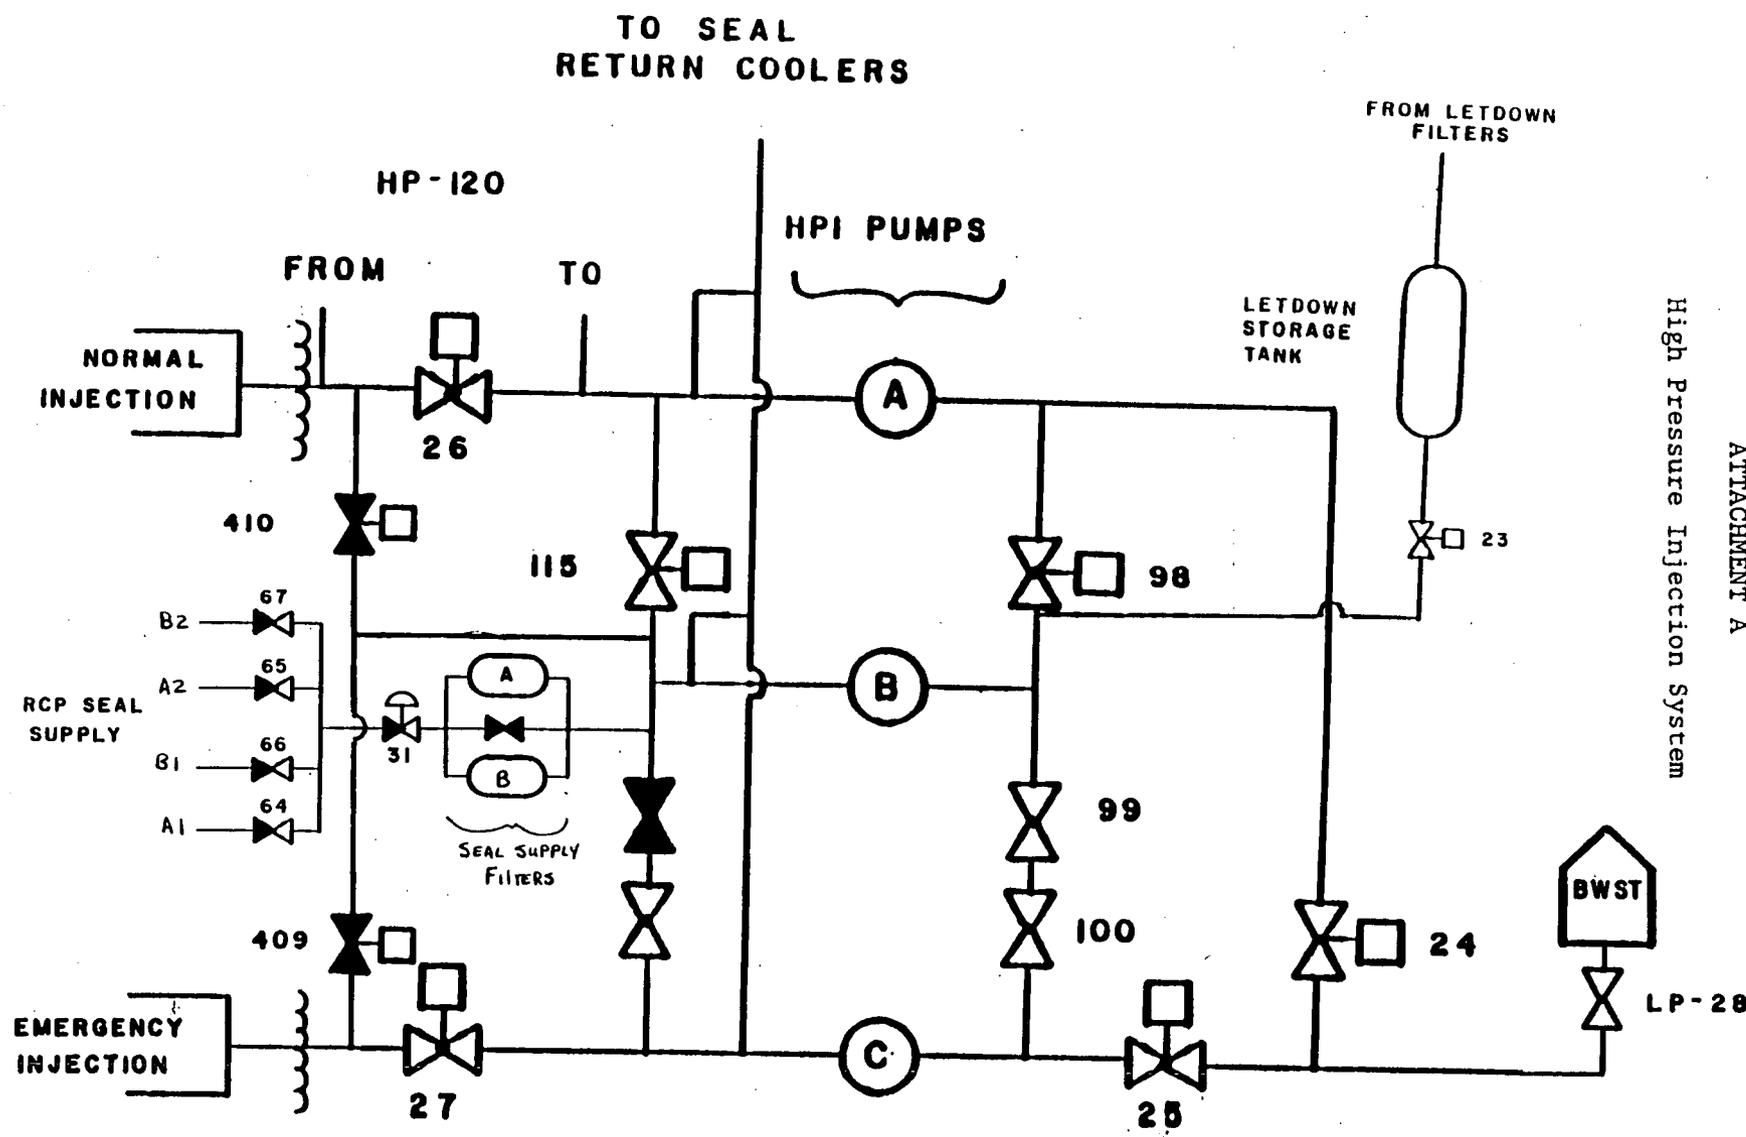
ATTACHMENT A

The High Pressure Injection (HPI) System [EII:BQ] is a part of the Emergency Core Cooling System which mitigates the consequences of loss of coolant accidents. The HPI System prevents uncovering of the core for smaller break sizes, where high Reactor Coolant System (RCS) [EII:AB] pressure is maintained, and delays the uncovering of the core for intermediate break sizes. The HPI System, during emergency operation, supplies borated water to the RCS from the Borated Water Storage Tank (BWST). The HPI System has three parallel HPI pumps that have the capability to take suction from the BWST and to discharge through two redundant injection flow paths into the RCS. (See Attachment A)

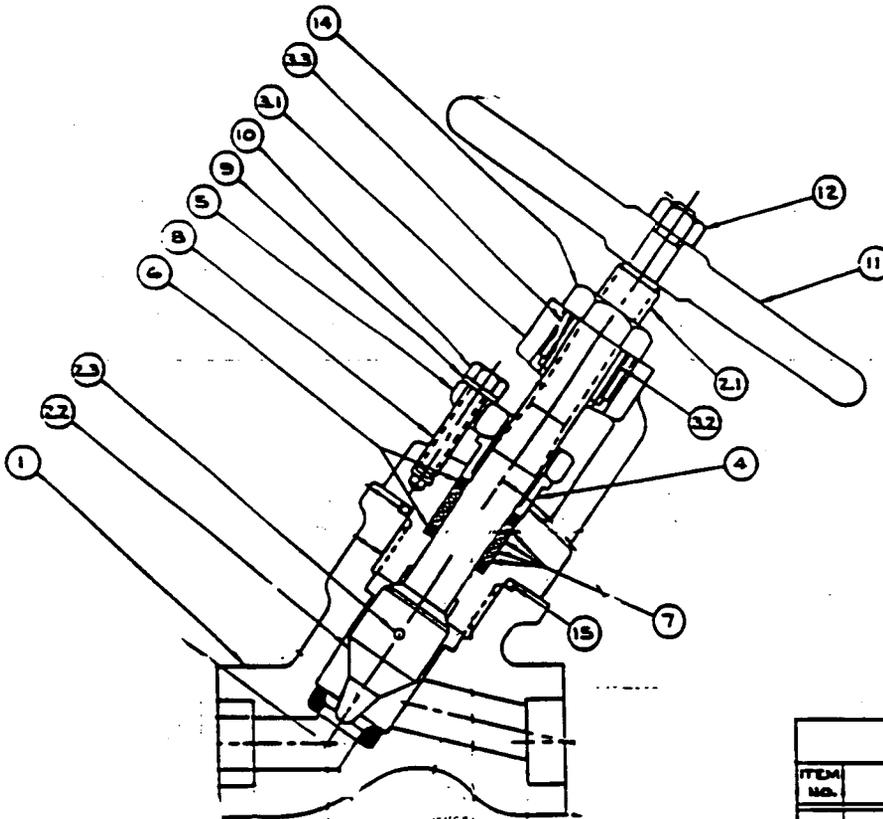
ATTACHMENT B

Valve 2HP-64 (see Attachment B) is a manual throttle valve used to regulate the seal supply flow to RCP 2A1. It is a 1/2 inch, stainless steel, packed y-globe throttle valve, manufactured by Kerotest and has been in service since March, 1988. The gland studs are 1/4 inch in diameter and are made of cadmium plated ASTM A193, Grade B7 material.

According to MT-A, he tightened the gland nuts in 1/2 turn increments, alternating between the two nuts. At approximately 1015 hours, after approximately 1 and 1/2 turns, one of the studs broke. (Subsequent examination showed that it sheared at the surface of the valve bonnet.) The gland and gland follower were pushed up the stem by system pressure until the gland was cocked at an angle, held by the single remaining stud and nut. The packing leak increased from minor seepage to a more noticeable level.

MT-A dressed out in paper anti-contamination clothing. He also went to the hot tool storage area to get additional tools and a 4 inch C-clamp. Upon his return to the valve, MT-A attempted to install the C-clamp on the valve stem. However, at approximately 1030 hours, while he was doing this, the second gland stud also broke, allowing the gland and gland follower to back out completely. System pressure ejected the packing, and High Pressure Injection (HPI) system water began spraying out of the valve.

The broken studs were sent to the Duke Power Applied Science Center laboratory for analysis. The laboratory examination confirmed that the studs composition and structure was consistent with ASTM A193, Grade B7 material with cadmium plating. The stud which broke first had a rust deposit indicating that failure had occurred in at least two steps. The laboratory examination found evidence of ductile failure at both the initiation and final fracture points, with propagation by mixed intergranular and ductile fracture. The second stud showed mixed microvoid and intergranular fracture. The laboratory report concluded that hydrogen had been absorbed into the metal, possibly during the cadmium plating process, causing hydrogen embrittlement.

The initiating cause of this event is equipment failure. Both gland studs broke during the attempt to tighten the valve packing. The Root Cause of the event is Design/Manufacturing Deficiency, (Material Deficiency, apparently resulting from the manufacturing process). Laboratory tests indicate that hydrogen, presumed to be introduced during the cadmium plating process, induced embrittlement which weakened the gland studs.

1. The studs on 2HP-64 were replaced, the valve repacked, and the system was returned to service.
2. Component Engineering inspected the packing gland studs on the other seal supply throttle valves for all three Oconee Units.

1. During the next appropriate outage of sufficient duration on each unit, the valve packing gland studs (or the entire valves) on all seal supply throttle valves will be replaced.
2. Site Engineering will contact the valve vendor for assessment of the defective stud problem relative to 10CFR21 considerations.
