SUBJECT: LER 93-special-01: on 930630, defective studs causes reactor coolant leak & manual start of Engineered Safeguard pump. Caused by design manufacturing deficiency. Studs replaced & sys returned to normal.

Subject: Oconee Nuclear Station
Docket Nos. 50-269, -270, -287
Supplement to Special Report Concerning
Manual Start Of Engineered Safeguards Pump

TITLE (4) **Defective Studs Cause Reactor Coolant Leak And Manual Start Of Engineered Safeguards Pump**

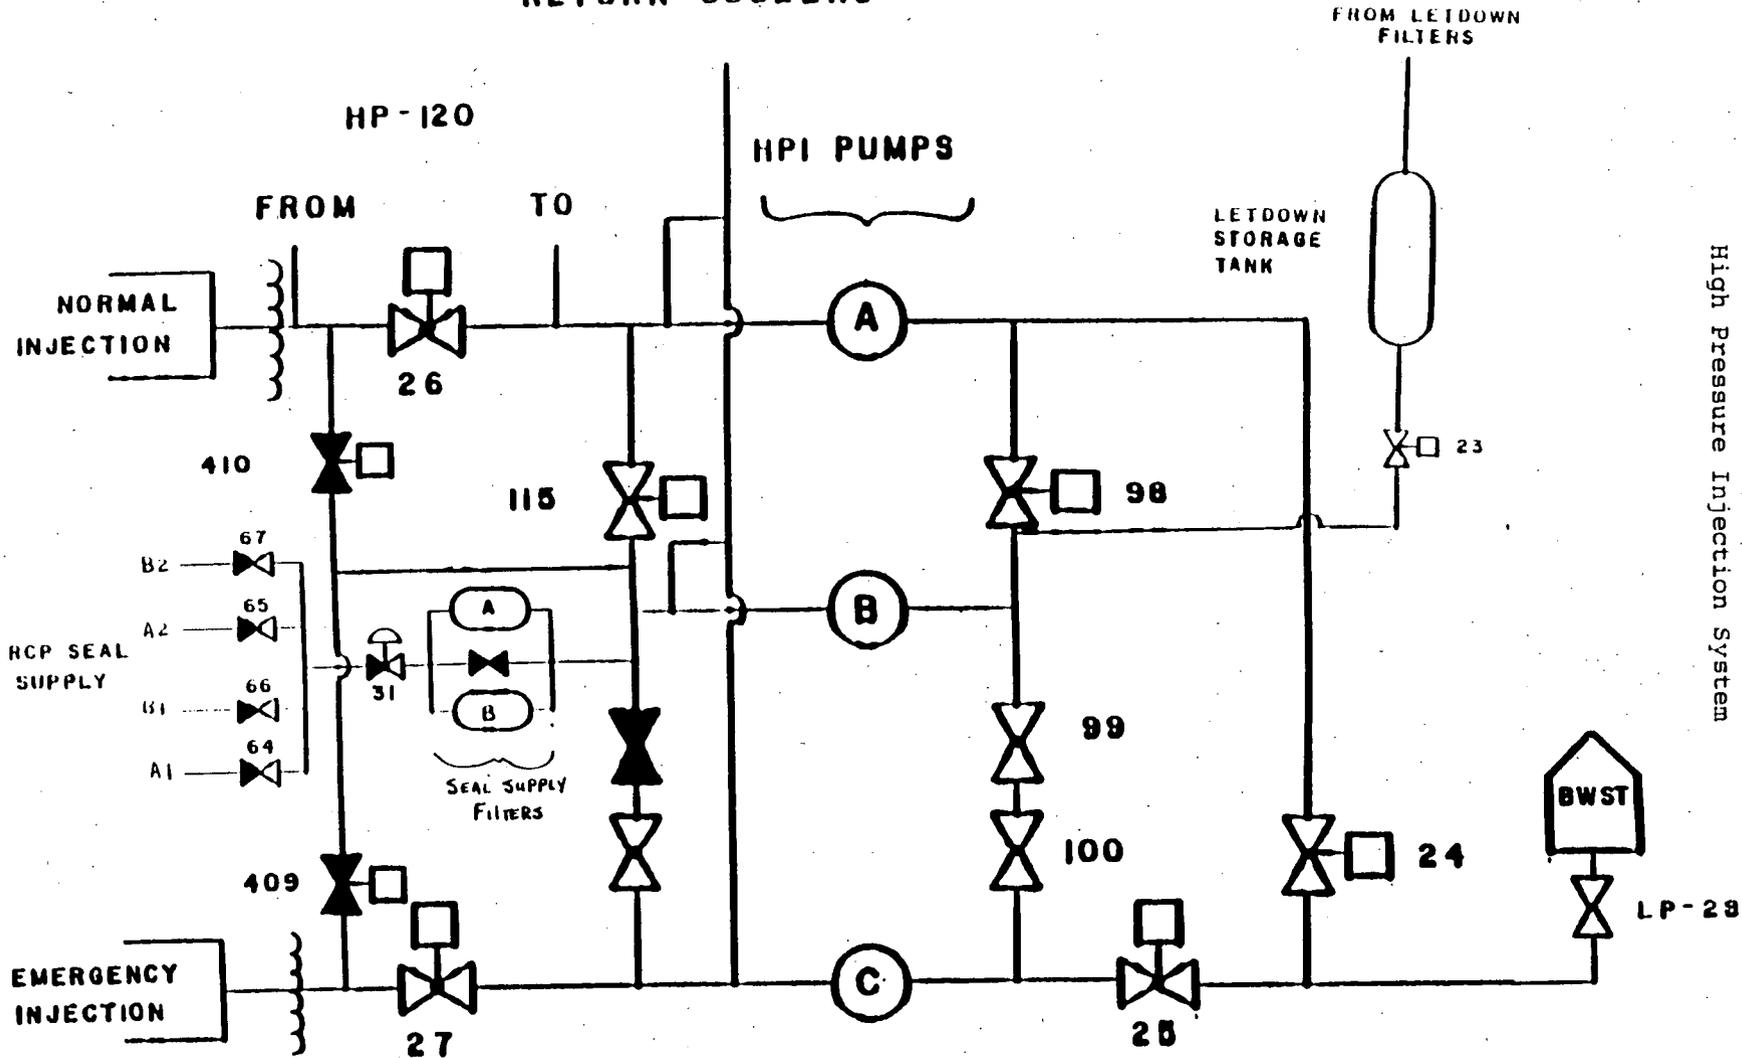
ATTACHMENT A
High Pressure Injection System

The High Pressure Injection (HPI) System [EIIS:BQ] is a part of the Emergency Core Cooling System which mitigates the consequences of loss of coolant accidents. The HPI System prevents uncovering of the core for smaller break sizes, where high Reactor Coolant System (RCS) [EIIS:AB] pressure is maintained, and delays the uncovering of the core for intermediate break sizes. The HPI System, during emergency operation, supplies borated water to the RCS from the Borated Water Storage Tank (BWST). The HPI System has three parallel HPI pumps that have the capability to take suction from the BWST and to discharge through two redundant injection flow paths into the RCS. (See Attachment A)

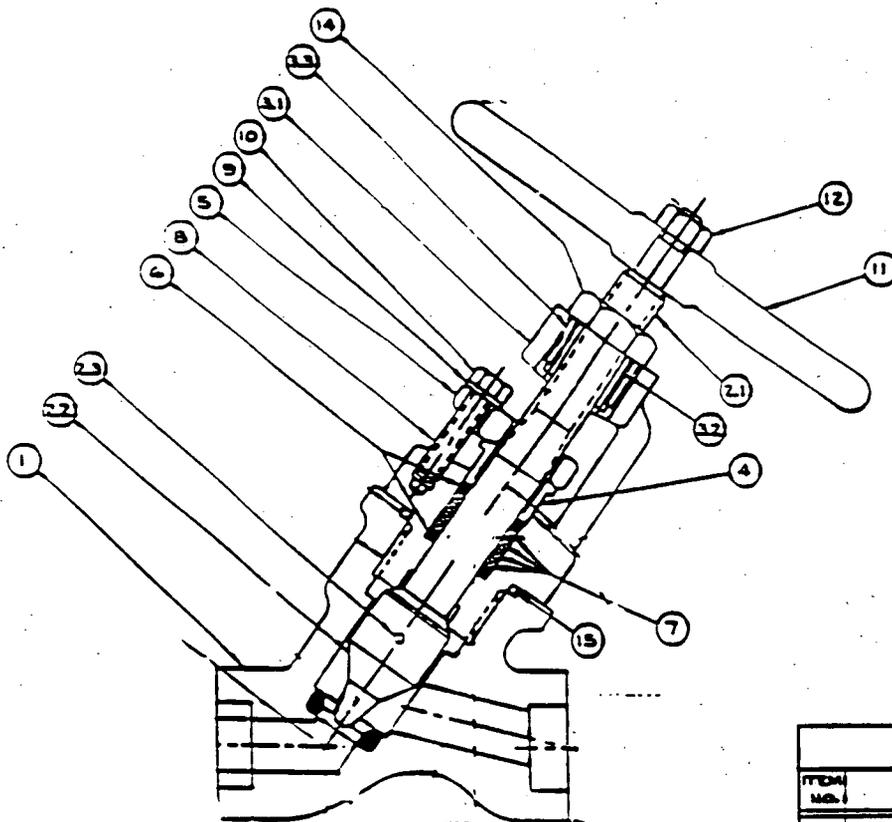
ATTACHMENT B

Valve 2HP-64 (see Attachment B) is a manual throttle valve used to regulate the seal supply flow to RCP 2A1. It is a 1/2 inch, stainless steel, packed y-globe throttle valve, manufactured by Kerotest and has been in service since March, 1988. The gland studs are 1/4 inch in diameter and are made of cadmium plated ASTM A193, Grade B7 material.

According to MT-A, he tightened the gland nuts in 1/2 turn increments, alternating between the two nuts. At approximately 1015 hours, after approximately 1 and 1/2 turns, one of the studs broke. (Subsequent examination showed that it sheared at the surface of the valve bonnet.) The gland and gland follower were pushed up the stem by system pressure until the gland was cocked at an angle, held by the single remaining stud and nut. The packing leak increased from minor seepage to a more noticeable level.

MT-A dressed out in paper anti-contamination clothing. He also went to the hot tool storage area to get additional tools and a 4 inch C-clamp. Upon his return to the valve, MT-A attempted to install the C-clamp on the valve stem. However, at approximately 1030 hours, while he was doing this, the second gland stud also broke, allowing the gland and gland follower to back out completely. System pressure ejected the packing, and High Pressure Injection (HPI) system water began spraying out of the valve.

The broken studs were sent to the Duke Power Applied Science Center laboratory for analysis. The laboratory examination confirmed that the studs composition and structure was consistent with ASTM A193, Grade B7 material with cadmium plating. The stud which broke first had a rust deposit indicating that failure had occurred in at least two steps. The laboratory examination found evidence of ductile failure at both the initiation and final fracture points, with propagation by mixed intergranular and ductile fracture. The second stud showed mixed microvoid and intergranular fracture. The laboratory report concluded that hydrogen had been absorbed into the metal, possibly during the cadmium plating process, causing hydrogen embrittlement.

The initiating cause of this event is equipment failure. Both gland studs broke during the attempt to tighten the valve packing. One root cause of the event is Design/Manufacturing Deficiency, (Material Deficiency, apparently resulting from the manufacturing process). Laboratory tests indicate that hydrogen, presumed to be introduced during the cadmium plating process, induced embrittlement which weakened the gland studs.

1. The studs on 2HP-64 were replaced, the valve repacked, and the system was returned to service.
2. Component Engineering inspected the packing gland studs on the other seal supply throttle valves for all three Oconee Units.

1. During the next appropriate outage of sufficient duration on each unit, the valve packing gland studs (or the entire valves) on all seal supply throttle valves will be replaced.
2. Site Engineering will contact the valve vendor for assessment of the defective stud problem relative to 10CFR21 considerations.
3. Engineering and Maintenance will review the ONS packing program. This review will evaluate valve and packing manufacturer recommendations, as well as the packing program at the other Duke Power Company nuclear sites. Following the review, any appropriate programmatic and procedural changes will be implemented and training given.
