LICENSEE EVENT REPORT (LER)

Oconee Nuclear Station, Unit 2

TITLE (4) Operation With Steam Generator Tube Indications In Excess Of Limits Due To Manufacturing Error

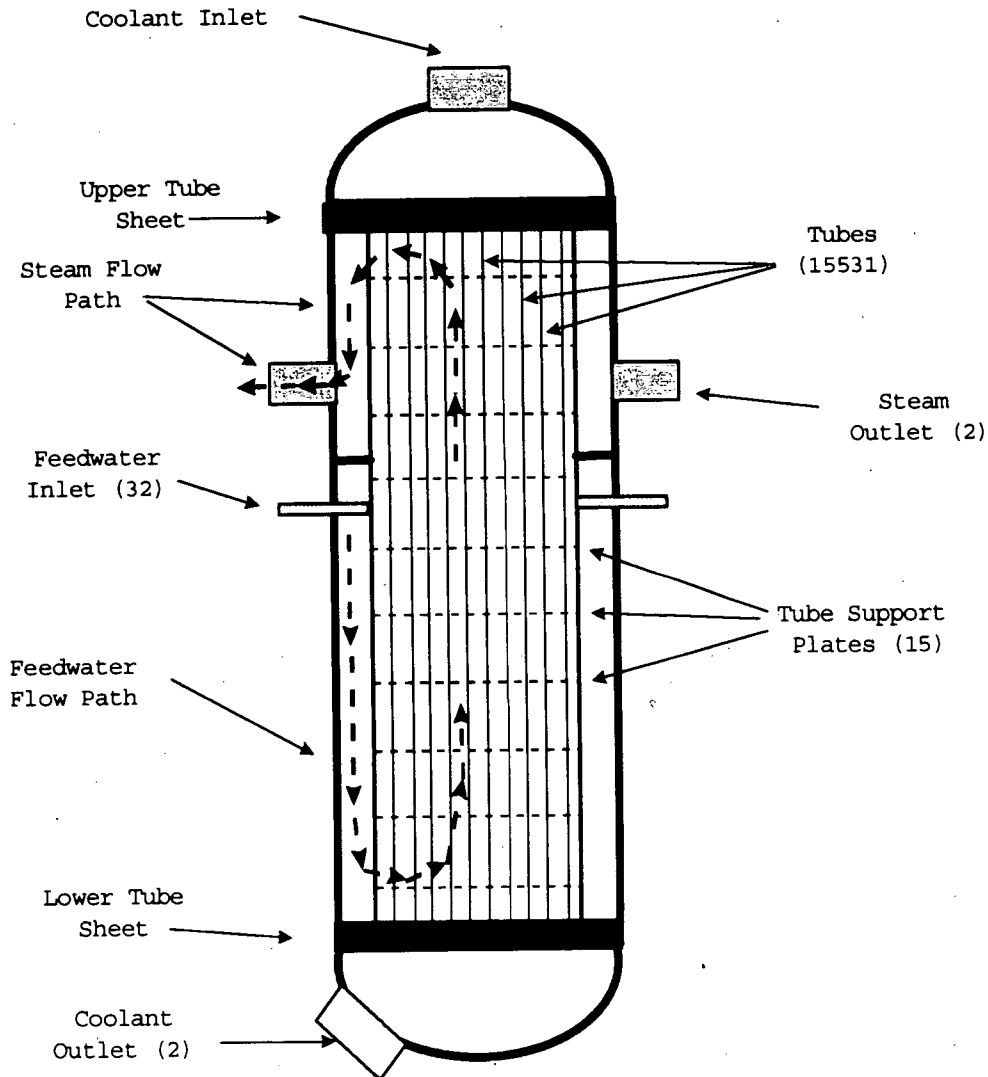
Attachment A

Oconee Nuclear Station uses the Babcock and Wilcox (B&W) Nuclear Steam Supply System [EIIS:AC], which includes two Once Through Steam Generators (OTSGs) [EIIS:SG], for primary to secondary heat transfer. The B&W OTSG is a vertical, straight tube heat exchanger. The OTSGs are 73 feet tall, and approximately 13 feet in diameter. Inside the OTSG shell, there is an upper tube sheet, 15 tube support plates, a lower tube sheet, and 15531 tubes per steam generator. See Attachment A.

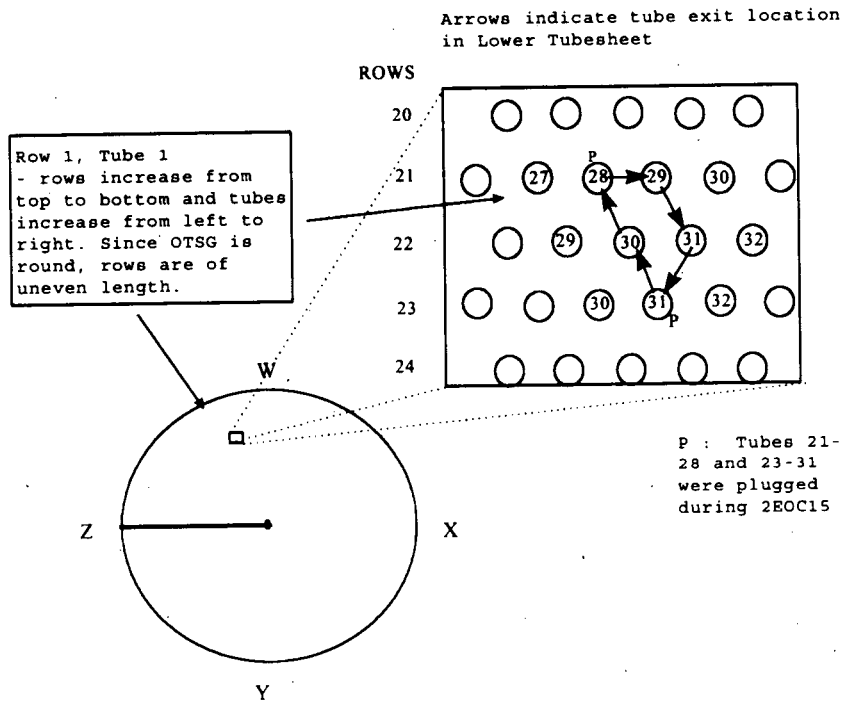
Attachment B

For identification purposes, tubes are designated by row and tube co-ordinates. The row numbers start on one edge of the tube sheet and tube numbers start at the beginning of each row and count up. See Attachment B. By design, the tubes go "straight" through the OTSG, such that a tube should penetrate the upper and lower tube sheets at the same co-ordinates. All tube inspections and repairs are accomplished using the assumption that these tube locations are as designed. Tube examinations are often executed by running different test probes from the upper and lower tube-sheets. Tube repair, by plugging, requires locating the tube end location from each tube-sheet and removing the tube from service by installing a plug at each end. For each activity, the positive identification of the tube by its co-ordinates on the respective tube-sheet is essential. There is not a requirement that the tube be verified to be in the same tube "hole" in each tube-sheet.

The five affected tubes in the 2A OTSG are at UTS locations 21-28, 21-29, 22-30, 22-31, and 23-31. The relationship is that the tube in location 21-29 in the UTS comes out in location 22-31 in the LTS. Location 22-31 in the UTS is 23-31 in the LTS, 23-31 in the UTS is 22-30 in the LTS, 22-30 in the UTS is 21-28 in the LTS, and 21-28 in the UTS is 21-29 in the LTS.
