SUBJECT: Follows up 800530 ltr which provided preliminary info re large vol of water discovered in tendon gallery on 800529. Caused by inleakage permitted by inoperable tendon gallery sump pumps. Diagram encl.

Re: Oconee Unit 2
Docket No. 50-270

DUKE POWER COMPANY
OCONEE UNIT 2

CONTAMINATED WATER FLOW PATH TO TENDON GALLERY

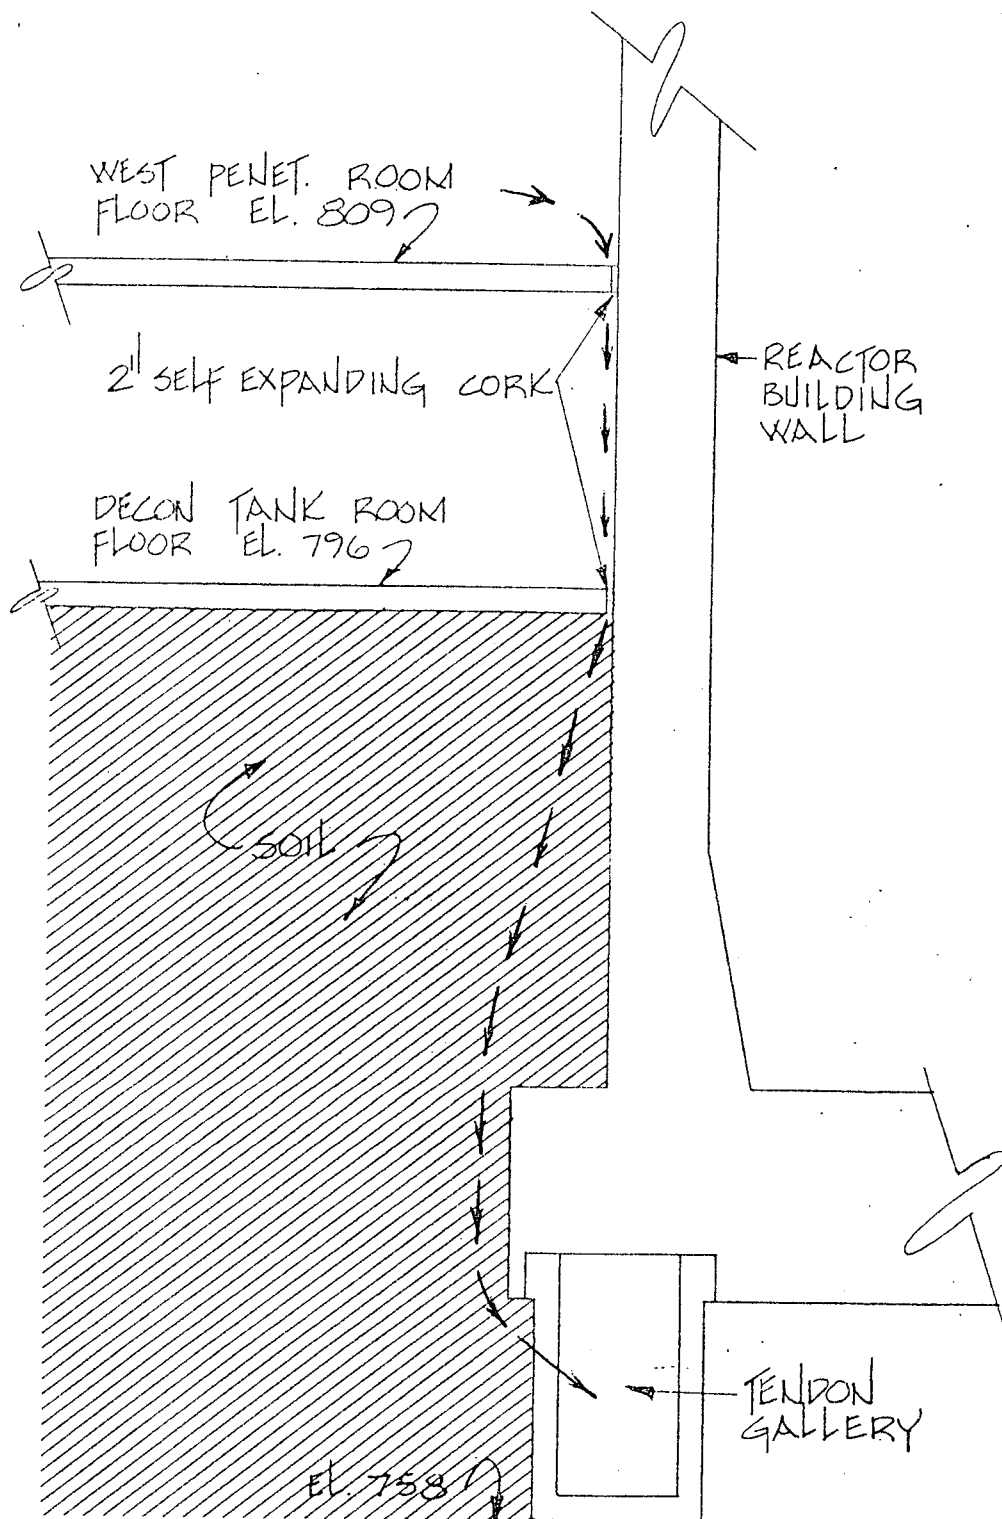
FIGURE 1

from the West Penetration Room floor. This exact arrangement is also used to separate the Decon Tank Room floor from the Reactor Building wall. Thus, it is considered that the water from the leaking valves, after entering the Decon Tank Room seeped through the cork interface between the Decon Tank Room floor and the Reactor Building wall and into the soil below. Since the Decon Tank Room is the lowest room on the west side of the Auxiliary Building that is adjacent to the Reactor Building, it is further considered that the seepage of this water could continue through the soil and into the top of the tendon gallery by means of a joint in the concrete. Figure 1 illustrates this flow path.

The observations made on Unit 1, however, demonstrate that water can violate the expanding cork interface used to separate the Auxiliary Building floors from the Reactor Building wall. Therefore, it is considered that a leak occurred at some time in the past in Unit 2's West Penetration Room and that water from this leak entered the Unit 2 tendon gallery following the flow path illustrated in Figure 1. Although the leak was evidently repaired, some of the water that seeped into the Decon Tank Room was trapped in the pipe trench, thereby providing a link in the identification of the source of contamination.

In order to eliminate the potential flow path of contaminated water from the Auxiliary Building, Duke Power Company will review the adequacy of the current design of the interface between the Auxiliary Building floors and the Reactor Building wall. Other designs will be evaluated and appropriate design modifications will be implemented to establish an effective seal in this interface.
