## AEOD TECHNICAL REVIEW REPORT

TR REPORT NO.: AEOD/T92-01  
DATE: January, 1992  
CONTACT: Mary S. Wegner

**SUBJECT: ENHANCED SETPOINT TESTING PROCEDURES FOR PRESSURIZER SAFETY VALVES AT OCONEE AND CATAWBA**

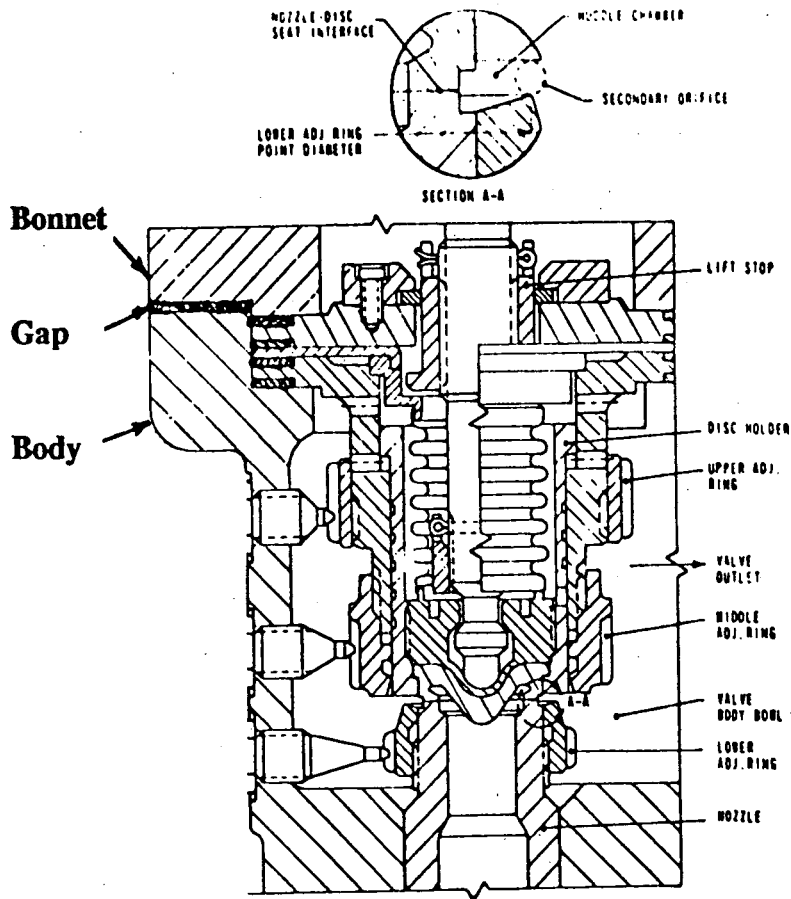
**Figure 1: PSV Internals**

If valves are leaking during the steam setpoint verification test, the valves' huddle chamber (See Figure 1) could become pressurized, effectively increasing the valve seat area. [With this larger area, a lower pressure could then produce sufficient force to lift the disc.] This would cause a lower apparent setpoint and the compression screw would be adjusted to further compress the spring. This would give an artificially high setpoint on the valve if the leak was later repaired as was done with the jack and lap process. If testing on steam is not performed [after the valve is repaired to correct leakage] then the repaired valve will have a higher setpoint than desired.

To improve the jack and lap process, the procedure was changed to require reestablishment of the body-to-bonnet gap (see Figure 1) as well as a subsequent steam setpoint verification test. To control setpoint trending, the test procedure was changed to require three consecutive setpoint verification pops be within 10 psi if trending occurs with no turn around. Ring adjustments after setpoint tests were prohibited; that is, if ring adjustments were made, steam setpoint verification tests would be conducted subsequent to ring adjustments.

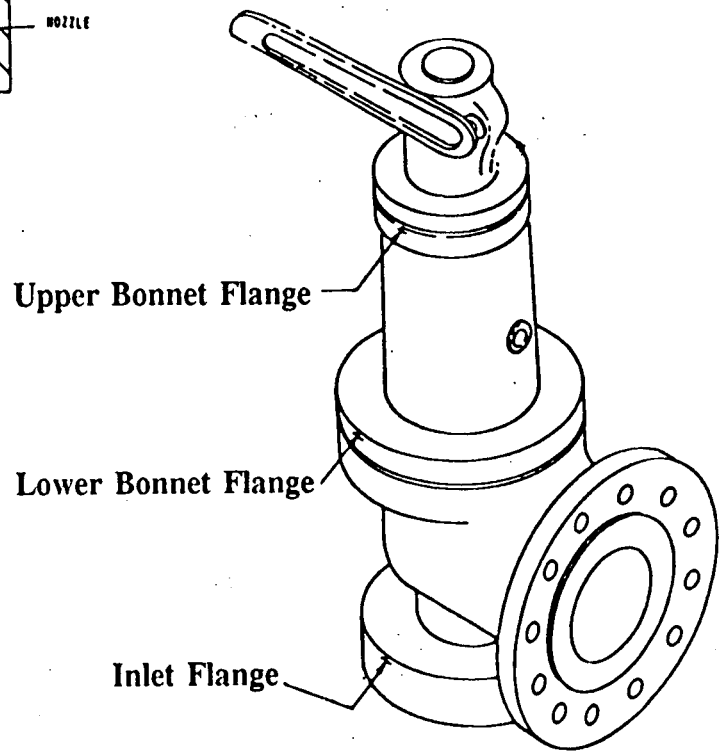
**Figure 2: Location of Thermocouples**

Although the remaining possible root causes were thought to be less credible, some corrective actions were instituted to address them. Temperature measurements of three body and bonnet locations were to be done by using two thermocouples on the upper bonnet flange, two thermocouples on the lower bonnet flange, and two thermocouples on the inlet flange. One thermocouple of each pair would be located 120° from the other. Test process affects were addressed by two procedure changes which instituted a torquing guideline to ensure even loading and alignment when the valve was installed for the test and a standardized pressurization rate to eliminate the possible effects of the pressure ramp on the setpoint determination.

Since the subject valve had previously been properly setpoint tested and successfully leak tested, it was mounted on the steam header for a setpoint verification test. After mounting the valve and attaching the required instruments per procedure (see Figure 2), saturated steam at 90 percent of the nameplate rating was applied to the valve inlet until the temperatures were stabilized prior to starting the testing.
