Duke Energy Carolinas, LLC (Duke Energy)
McGuire Nuclear Station (MNS), Units 1 and 2
Docket Numbers 50-369 and 50-370
Renewed License Numbers NPF-9 and NPF-17

SUBJECT: 10 CFR 71.95 Report on the 8-120B Cask for the McGuire Nuclear Station, Units 1 and 2

**Failure to Observe Certificate of Compliance Conditions
for the 8-120B Vent Port Pre-Shipment Leak Test**

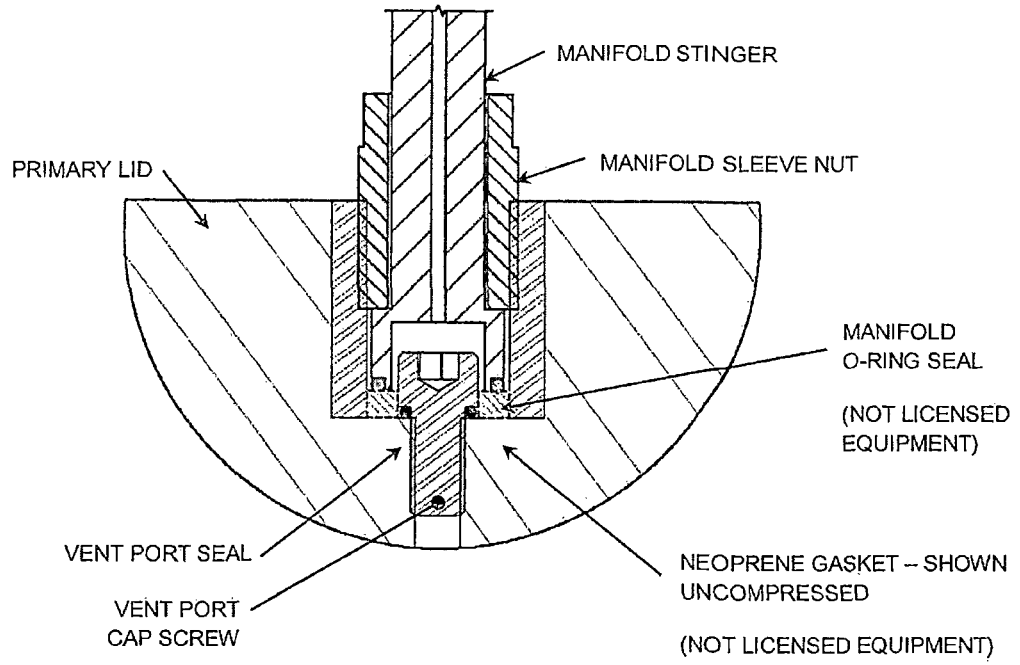
New 8-120B lids went into service in September 2013. It was found that the manifold sometimes had problems sealing with the vent port on these new lids. EnergySolutions personnel found that adding an extra neoprene gasket helped to reduce the false test failures. Since the pre-shipment leak rate test is performed in a radiation environment, false failures are undesirable because they increase the personnel exposure. The personnel did not realize that the gaskets had the potential to reduce the test sensitivity.

The neoprene gasket can constrict on the head of the vent port plug cap screw when it is compressed by the bottom end of the test manifold stinger, which could reduce the sensitivity of the pre-shipment leak test. Consequently, the vent port pre-shipment leak tests performed using the neoprene gasket may not have provided the required test sensitivity of 1×10^{-3} ref-cm³/sec.

The pre-shipment leak test of the vent port is a pressure drop test performed using a dedicated test manifold. The test manifold is not a part of the licensed package. It includes a stinger (shown below), an O-ring seal that contacts the stinger and the bottom of the vent port hole, and a sleeve nut to compress the O-ring seal. The test manifold was designed so that it surrounds the vent port cap screw, leaving a small gap between itself and the vent port cap screw. The 8-120B cask fleet began to ship with a new lid design in September 2013, and operations staff noted more frequent difficulty getting the manifold to seal. It became desirable to find a better way to seal the bottom of the manifold in order to minimize operator exposure. They found that adding a neoprene gasket (also not part of the licensed package) under the base of the stinger as shown below helped reduce testing time and exposure.
