**GE Hitachi Nuclear Energy**

September 10, 2015  
MFN 15-042 R2

**Subject: Closure of Part 21 60-Day Interim Report Notification:  
Potential Failure of Electromatic Relief Valve Cutout Switch**

Description of Evaluation

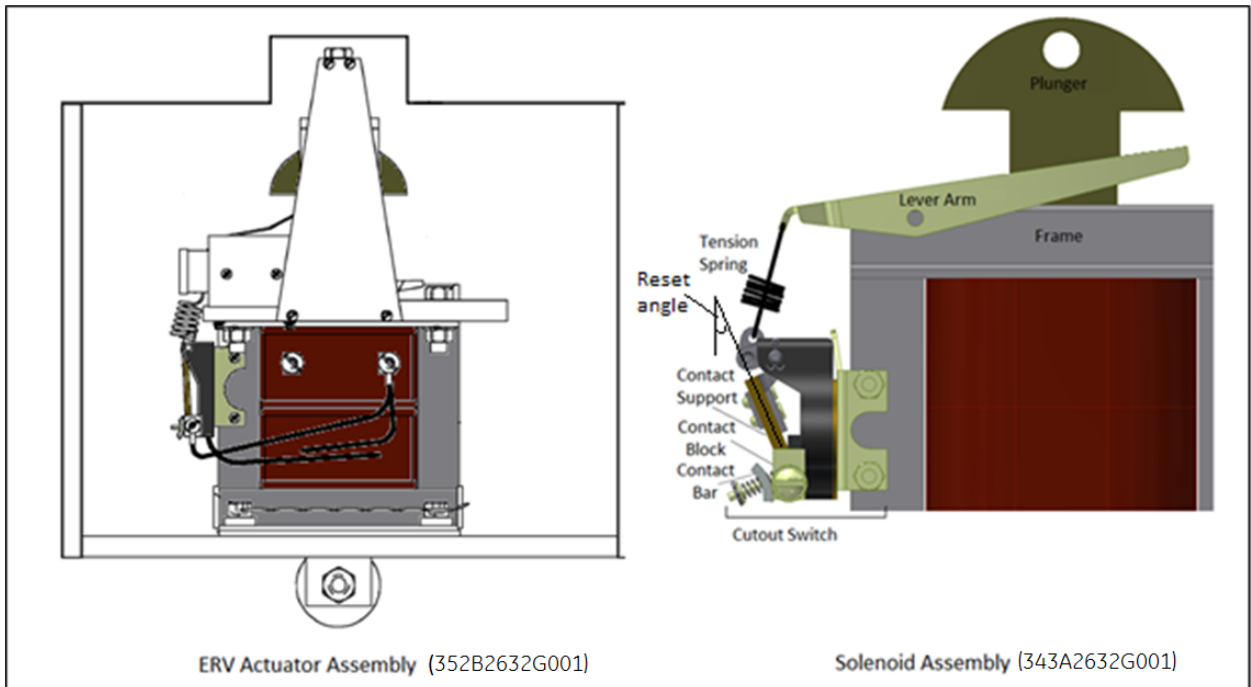
**Figure 1 Actuator and Solenoid Assembly in the reset position**

GEH provides various parts and components that are designed to actuate Electromatic Relief Valves (ERVs). The only manner in which these valves can be opened is from an electrical signal received by the actuator. The ERV Actuator Assembly contains the Solenoid Assembly which contains the cutout switch assembly as shown in Figure 1.

The cutout switch bypasses the secondary holding coil in order to develop the magnetic field energy to engage the plunger. When the plunger is fully seated the cut out switch is open allowing current flow thru the secondary coil providing additional inductance to be introduced into the circuit. Upon the actuation of the solenoid the plunger lowers and impacts the back end of the plunger lever arm. The lever arm pivots, raising the front end of the arm which is connected to the tension spring. This causes the contact support to rotate (clockwise in Figure 2) creating a gap between the contact blocks and the contact bar. The gap between the contact bar and the contact blocks removes the bypass of the secondary coil. The purpose of the secondary coil is to prevent burnup of the primary coil. When the electrical signal is removed the plunger lifts allowing the plunger lever arm to lift which releases the tension on the tension spring and allowing the torsion spring to close the contacts, resetting the actuator. The resetting force is provided by a torsion spring by F2 which may be seen in Figure 1. If the secondary coil is not bypassed before the actuation signal is received the actuator will fail to provide the force necessary to actuate its valve.

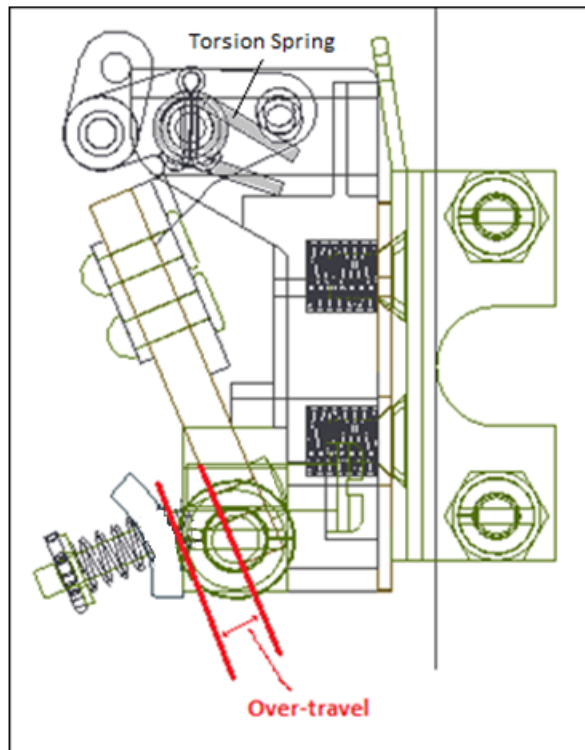
**Figure 2 Over travel of cutout switch**

Following the observed failures, an investigation was initiated to determine the cause of the failures, and to determine whether the condition applied to components previously supplied to and accepted by licensees. The investigation concluded that the ERV actuator assemblies failed to change state because of the failure of the cutout switch to fully close and provide the appropriate current path. When ERV Unit #5 failed, a 0.003 inch gap was present between the contact bar and one of the contact blocks. When ERV Unit # 8 failed, a 0.001 inch gap was present between the contact bar and one of the contact blocks. For both ERV Unit #5 and ERV Unit #8 contact existed between the contact bar and one of the blocks but and a gap existed between the contact bar and the other contact block.

Proper contact in the cutout switch is dependent on the reset angle. For discussion purposes the term reset angle refers to the angle of the contact support after the plunger lifts and the part resets. The solenoid assembly in Figure 2 is in the reset position therefore the contact support is in the reset angle. Unreliable performance occurs when the reset angle for a given part does not consistently ensure adequate contact. Conversely, reliability is achieved when the reset angle always ensures sufficient contact between the contact bar and the contact blocks.

If positive over travel has not been previously confirmed during maintenance activities, perform inspection at the next available opportunity to verify that the condition does not exist.

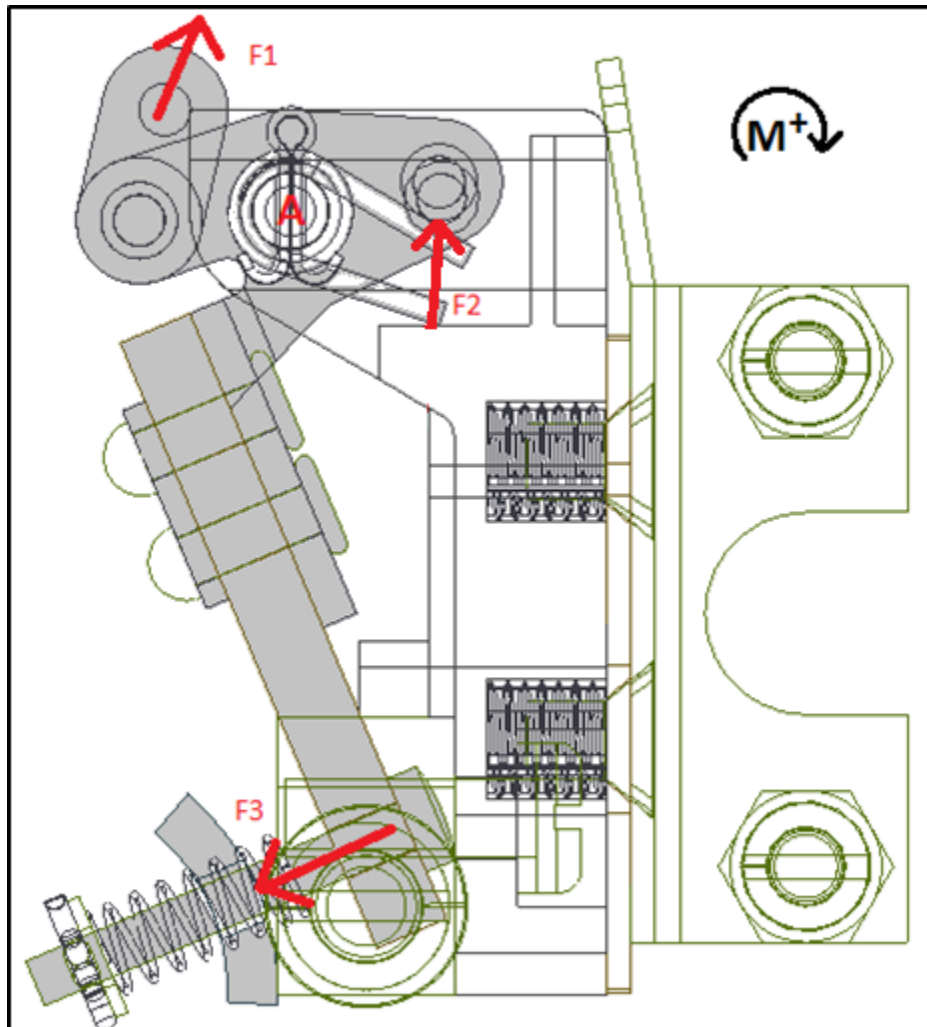
**Figure 3**

When a part resets there are four moments that determine the reset angle. Three of these are caused by the forces shown in Figure 3. The fourth is caused by friction. For a given part the moments caused by forces F1, F2, and, F3 are only dependent on the angle of the contact support. Therefore any variance in the reset angle is due to variation of the moment due to friction in the part. The amount of over travel, as shown in Figure 2, is a good indication of the susceptibility of an assembly to unreliable operation. Positive over travel ensures proper contact is made despite frictional variation.

Friction is present when the assembly is reset, not allowing the contact support to proceed entirely to its neutral, zero friction reset angle. As energy is added to the system sufficient to

overcome the frictional moment, the contact bar will tend to drift towards its zero friction angle. This means an assembly that doesn't consistently make contact when initially reset would be expected to do so as energy is added, as by normal system vibration. ERV Units #5 and #8, which were previously observed to exhibit inconsistent operation, have been manually agitated during bench testing at GEH. These assemblies were found to function consistently in the presence of this agitation. This agitation was applied during bench testing which consisted of repeated instances of assembly actuation followed by mechanical agitation. Additional testing was performed to mimic vibrations and impact energies experienced on site. While this testing confirmed that added energy tended to increase reliability when a gap between the contact bar and the contact blocks was present, it was unable to model plant conditions with sufficient accuracy to draw application specific conclusions based on the results. The primary reason for this inability was lack of available plant data to describe agitation energies in all the situations where the ERVs would need to be functional.
