Sequoyah Nuclear Plant, Units 1 and 2
Facility Operating License Nos. DPR-77 and DPR-79
NRC Docket Nos. 50-327 and 50-328

Subject: Application to Revise Technical Specification 6.8.4.h, "Containment Leakage Rate Testing Program," (SQN-TS-14-03) (TAC Nos. MF5366 and MF5367), Response to Request for Additional Information

TENNESSEE VALLEY AUTHORITY SEQUOYAH NUCLEAR PLANT UNITS 1 AND 2

Response to Request for Additional Information

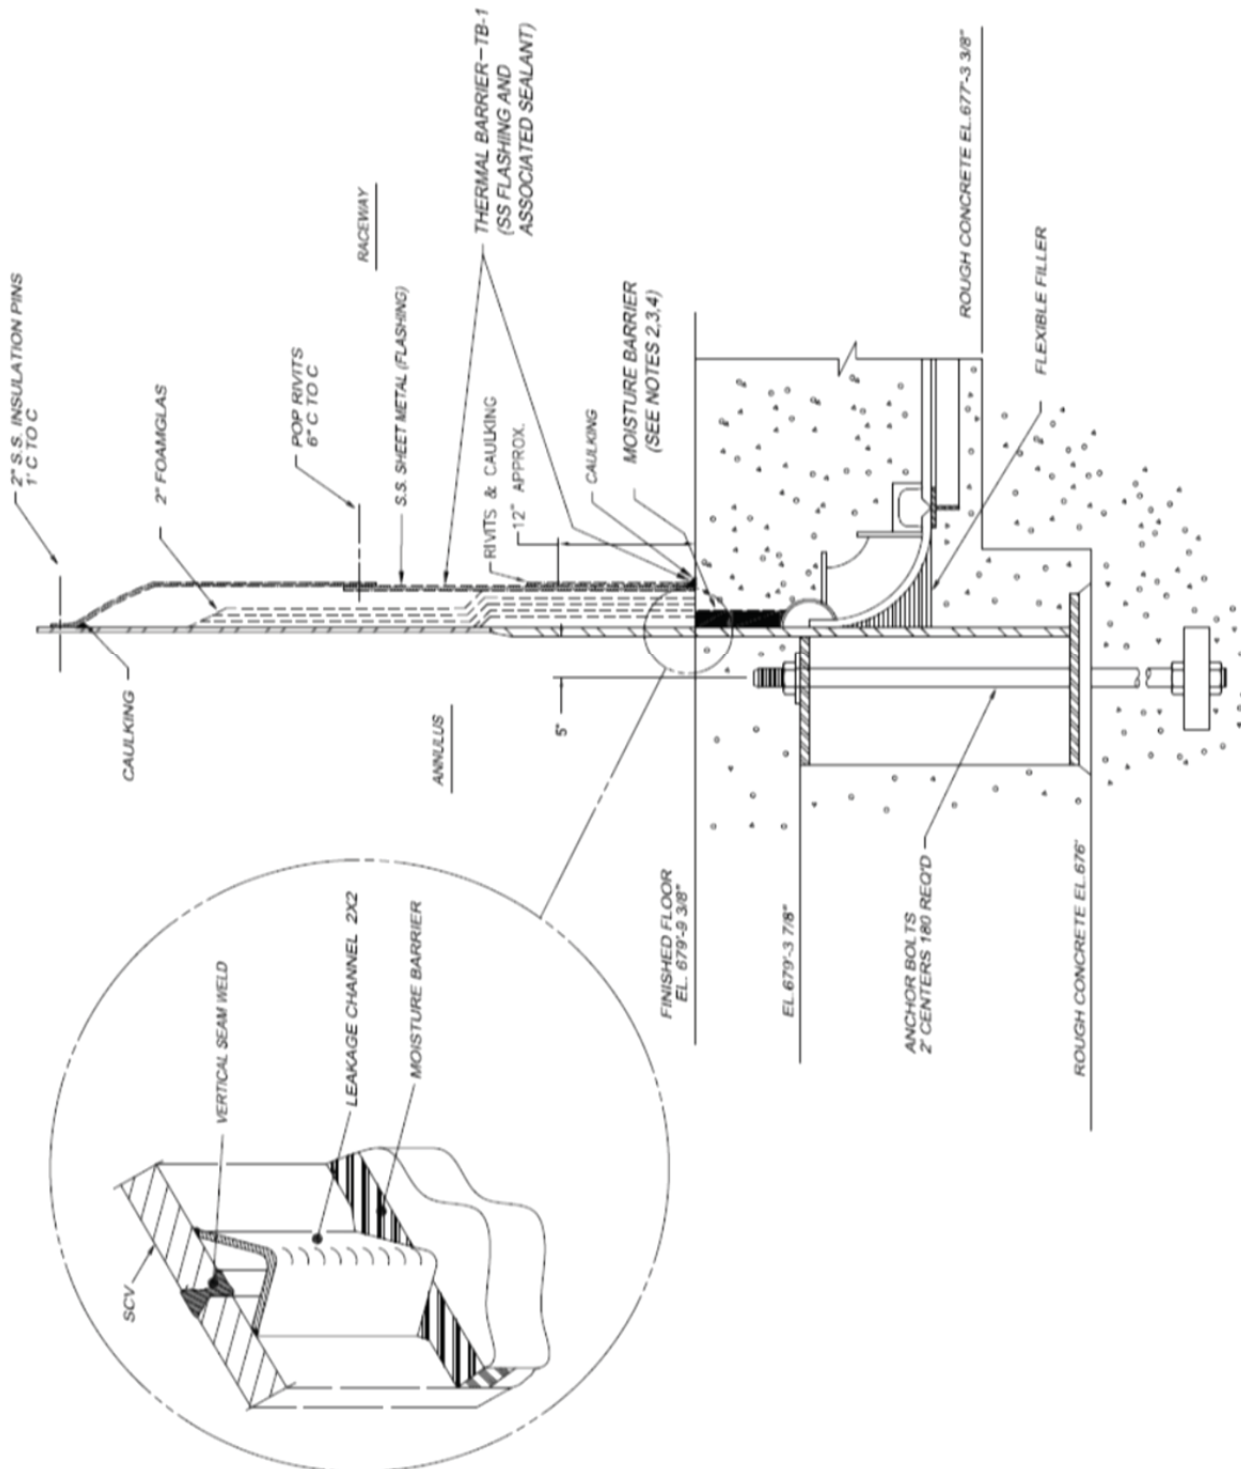
The moisture barrier is intended to prevent intrusion of moisture against inaccessible areas of the pressure retaining metal containment shell or liner at concrete to metal interfaces that are not seal welded. The moisture barrier is the sealant between the concrete to metal containment interface in the raceway behind the metal flashing. The raceway is an area inboard of the SCV between the Polar Crane Wall and the SCV on the bottom elevation of containment used for access to the accumulator rooms, fan rooms, and inside the polar crane wall. An examination of the moisture barrier is performed each inspection period. The flashing covering the moisture barrier is removed to allow access for examination.

The SCV to concrete interface is visible in the Annulus. The annulus is the area in the reactor building between the SCV and the concrete shield building. No moisture barrier covers the SCV to concrete interface in the Annulus. The metal to concrete interface is examined in the Annulus each inspection period. The following detail provides a representation of the internal and external SCV to concrete interface.
