SUBJECT: LER 92-002-00: from 920128-29, Keowee Hydro Station supply of emergency power to util interrupted. Caused by equipment failure & inappropriate actions. Personnel counselled & LER supplement to be issued. W/920305 ltr.

Subject: Oconee Nuclear Station
Docket Nos. 50-269, -270, -287
LER 269/92-02

TITLE (4) **Equipment Failure In Emergency Power System and Inappropriate Action Result in Technical Specification Violation**

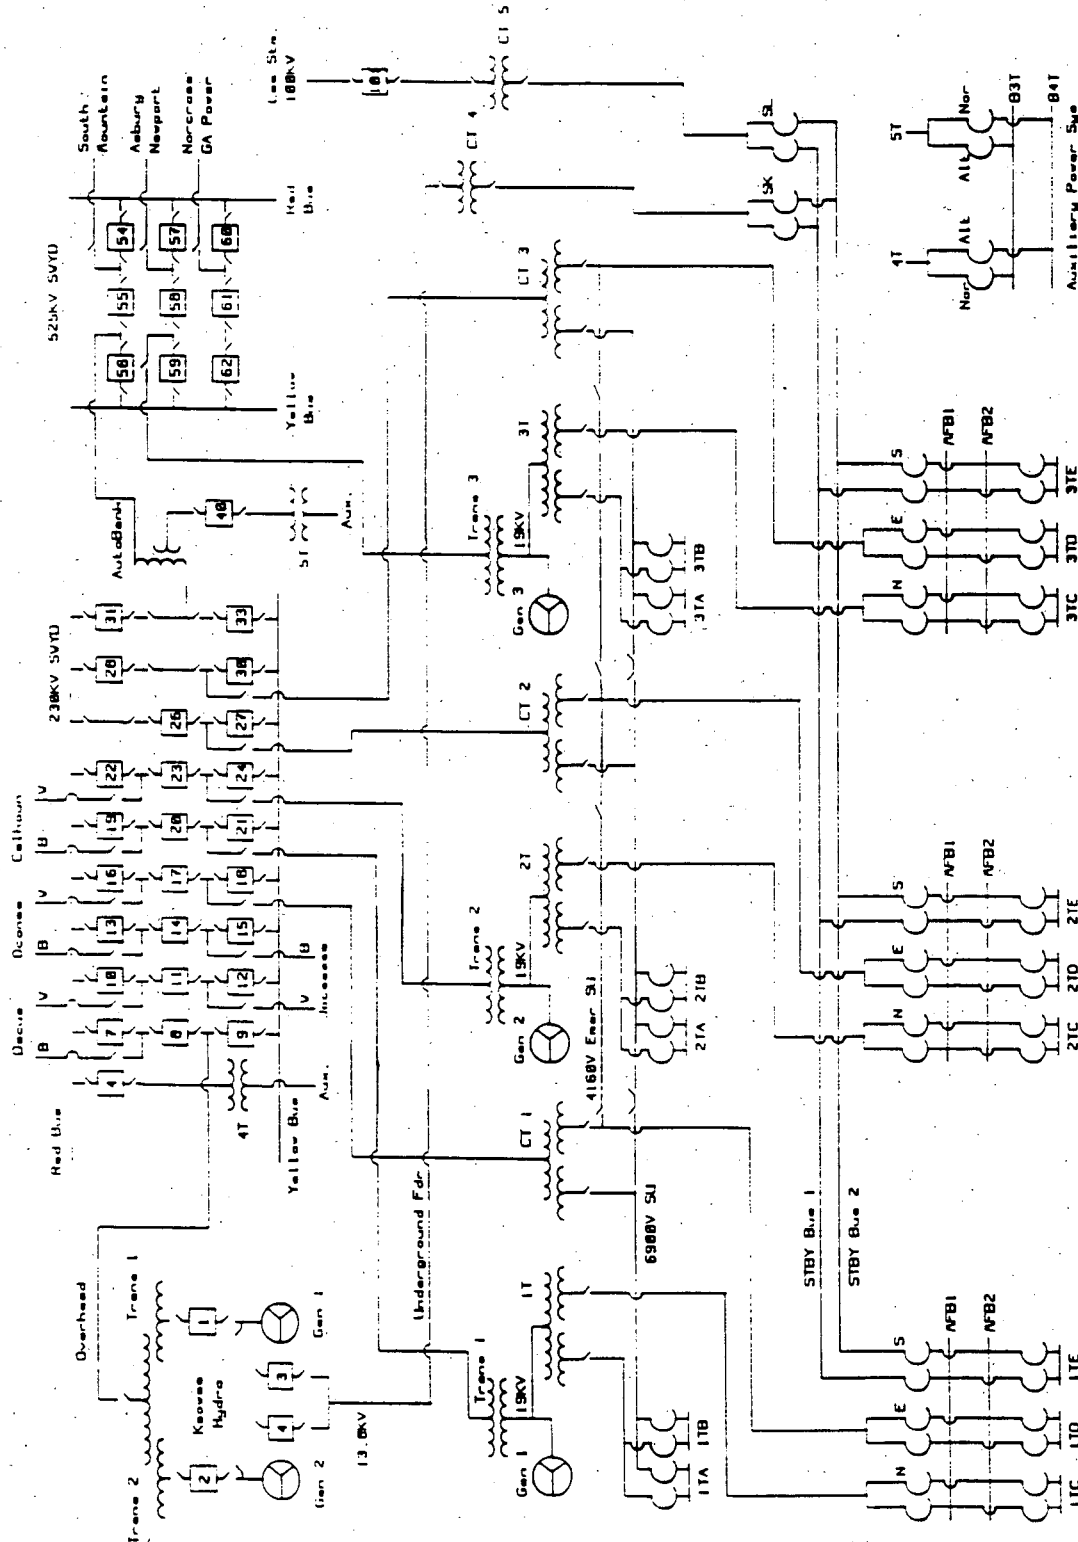
ATTACHMENT 1

The Keowee Emergency Power System [EIIS:EK] consists of two hydroelectric generators which provide an emergency onsite power source for the Oconee Nuclear Station via two separate and independent paths, one of which is the underground feeder through transformer CT4 and the standby buses [EIIS:EB] and the second is the overhead path through the 230 KV switchyard [EIIS:FK]. See Attachment 1.
