REGULATORY INFORMATION DISTRIBUTION SYSTEM (RIDS)

SUBJECT: LER 92-004-01: on 920508, reactor tripped from 14% full power on RPS anticipatory trip signal. Caused by mgt deficiency & low discharge pressure on main feedwater pump. Task-specific procedure developed. W/920715 ltr.

Subject: Oconee Nuclear Station
Docket Nos. 50-269, -270, -287
LER 269/92-04, Revision 1

FACILITY NAME (1) Oconee Nuclear Station, Unit 1										DOCKET NUMBER (2) 0 5 0 0 0 2 6 9				PAGE (3) 1 OF 0 7		
TITLE (4) Reactor Trip Results From Low Main Feedwater Pump Discharge Pressure Due to Management Deficiency																
EVENT DATE (5)			LER NUMBER (6)				REPORT DATE (7)			OTHER FACILITIES INVOLVED (8)						
MONTH	DAY	YEAR	YEAR	SEQUENTIAL NUMBER	REVISION NUMBER	MONTH	DAY	YEAR	FACILITY NAMES				DOCKET NUMBER(S)			
0 5	0 8	9 2	9 2	0 0 4	0 1	0 7	1 5	9 2					0 5 0 0 0			
OPERATING MODE (9)		THIS REPORT IS SUBMITTED PURSUANT TO THE REQUIREMENTS OF 10 CFR §: (Check one or more of the following) (11)														
N		20.402(b)				20.405(c)				<input checked="" type="checkbox"/> 50.73(a)(2)(iv)				73.71(b)		
POWER LEVEL (10)		20.405(a)(1)(i)				50.36(c)(1)				50.73(a)(2)(v)				73.71(c)		
0 1 4		20.405(a)(1)(ii

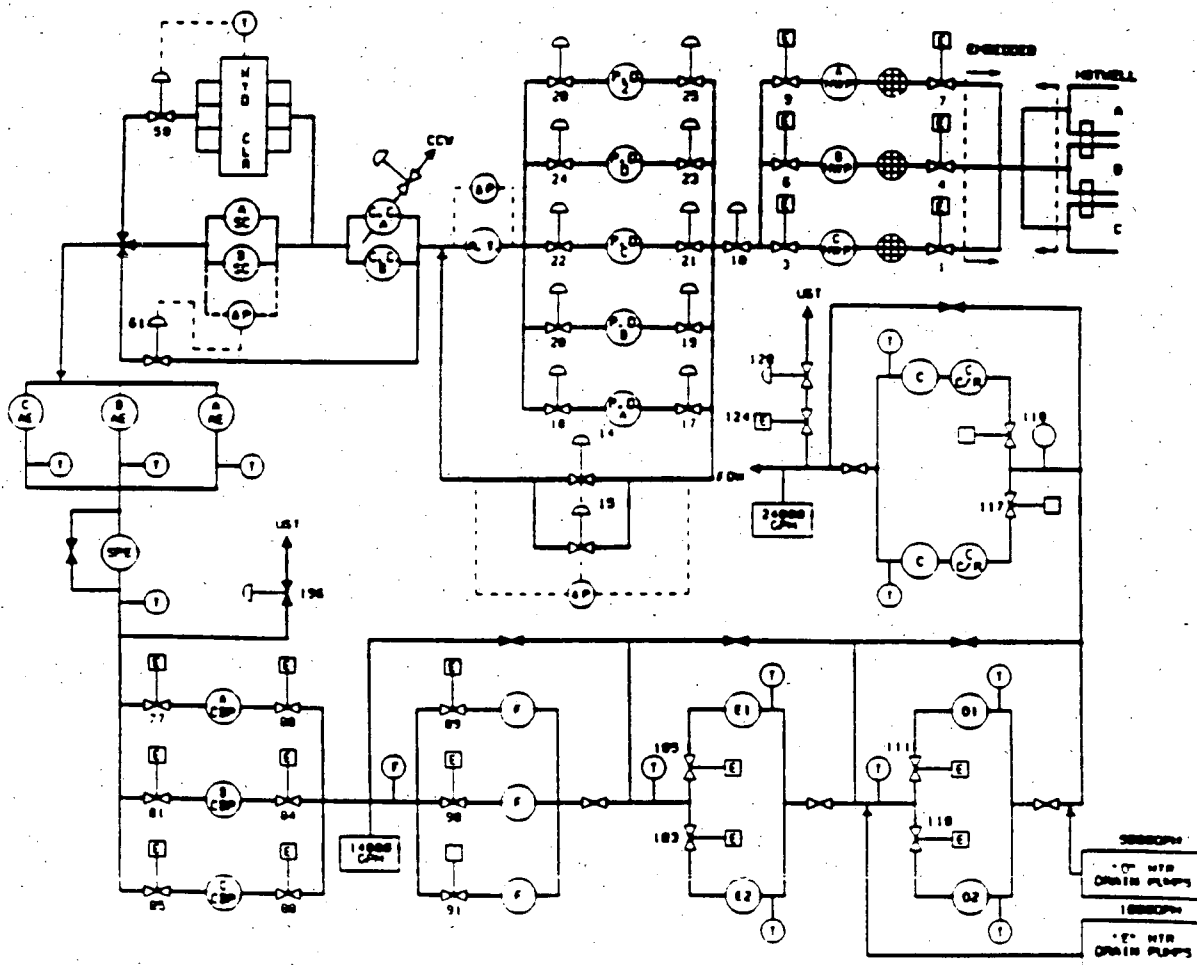
ATTACHMENT 1

The Condensate System [EIIS:SD] originates at the condenser hotwell. The Hotwell Pumps and Condensate Booster Pumps increase system pressure to that required for the Main Feedwater Pump (MFDWP) net positive suction head. The Upper Surge Tank provides a surge volume for the Condensate System. (See Attachment 1)

At 0340 hours, the CR SRO, Shift Manager, and Shift Supervisor decided on a method to reduce hotwell level, which only involved opening two valves in the Condensate System. This included opening 1C-124 (Condensate Recirc to Upper Surge Tank) and then opening 1C-128 (Condensate Recirc Control) to divert condensate to the Upper Surge Tank and then to the Condensate Storage Tank. After completing this lineup it would be transferred to another unit. The CR SRO stated that he had performed this method on other occasions. The CR SRO stated that actions in the Alarm Response Manual would not solve the high level, because the Alarm Response procedure (1SA6/C-12) did not address the unit's specific operating condition.

At approximately 0342 hours, the CR SRO told CRO to verify that 1C-128 (Condensate Recirc Control) was in the closed position. After verifying 1C-128 closed, the CR SRO instructed the RO to open 1C-124. Upon opening 1C-124, 1B MFDWP discharge pressure decreased to approximately 800 psig, causing Reactor Protective System Channels A, B, C, and D Feedwater Pump Anticipatory Trip to initiate a Reactor and Main Turbine Trip at 0342:16 hours. The CRO immediately closed 1C-124.

CONDENSATE SYSTEM ARRANGEMENT
