SUBJECT: LER 92-010-00: on 920819, determined that under postulated LOCA, coincident w/LOP, fault on nonsafety load could trip upstream Keowee auxiliary load ctr breaker. Caused by design defect. Breakers modified. W/920916 ltr.

FACILITY NAME (1) Oconee Nuclear Station, All Units		DOCKET NUMBER (2) 0 5 0 0 0 2 6 9	PAGE (3) 1 OF 0 9
---	--	---	-----------------------------

TITLE (4) **Design Deficiency Results In Technical Inoperability Of Oconee Emergency Electrical Power Sources**

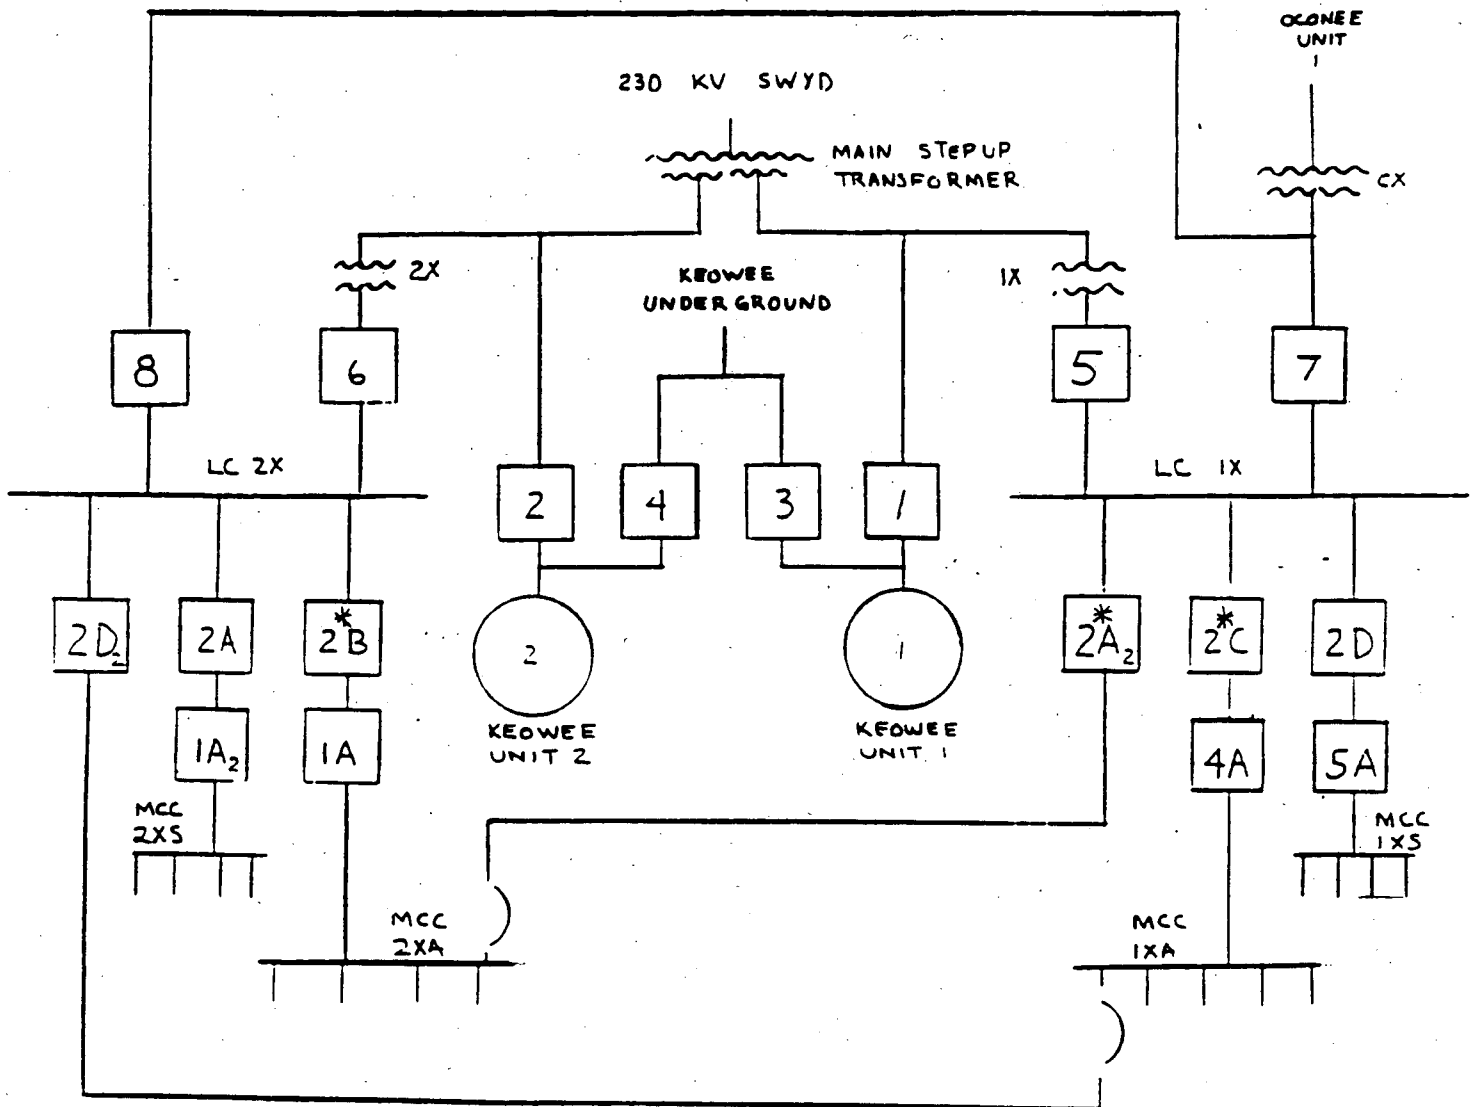
ATTACHMENT 1

The operability of the Keowee Hydro units depends on the ability to supply power to its own essential safety related auxiliary loads (see Attachment 1). These loads are normally supplied from the 230 KV transmission network or Keowee generator output via the Keowee main transformer and transformers 1X and 2X [EIIS:EC]. The CX transformer, powered from Oconee Unit 1, is required for the unit aligned to the underground path to be operable. The auxiliary transformers (1X, 2X or CX) supply the 1X and 2X load centers [EIIS:EC] which, in turn, supply motor control centers 1XA, 2XA, 1XS, and 2XS. 1XA and 2XA supply safety related loads at the Keowee Hydro station and also some non-safety related loads.

The existence of a breaker coordination problem made both Keowee units technically inoperable. After a Loss of Offsite Power (LOOP), if a fault were to occur on a non-safety related load powered from 1XA or 2XA, the discriminator circuit may isolate the load center before the individual load can be isolated. Under these conditions, the Keowee units would start when required. The amount of time that they would run prior to tripping due to low governor oil pressure depends on the initial governor oil pressure, the amount of load supplied by the unit, and the rate at which load is increased. The Keowee operators have local indication of the loss of the load center and various alarms due to the loss of motor control center loads. It is possible that the loss of Keowee auxiliary power might be diagnosed and corrected prior to the Keowee unit trip.

KEOWEE HYDROELECTRIC STATION AUXILIARY POWER SYSTEM

*BREAKERS AFFECTED BY DISCRIMINATOR

- 1) A modification was performed to jumper out the discriminator circuitry. After the installation of the modification, the LCO was exited.
