SUBJECT: CONFIRMATORY ACTION LETTER (CAL NO. 2-97-003) UPDATE - RESTART OF  
OCONEE UNITS 2 AND 3

# Oconee Nuclear Station Restart Activities Meeting

NRC/Duke Meeting  
May 16, 1997

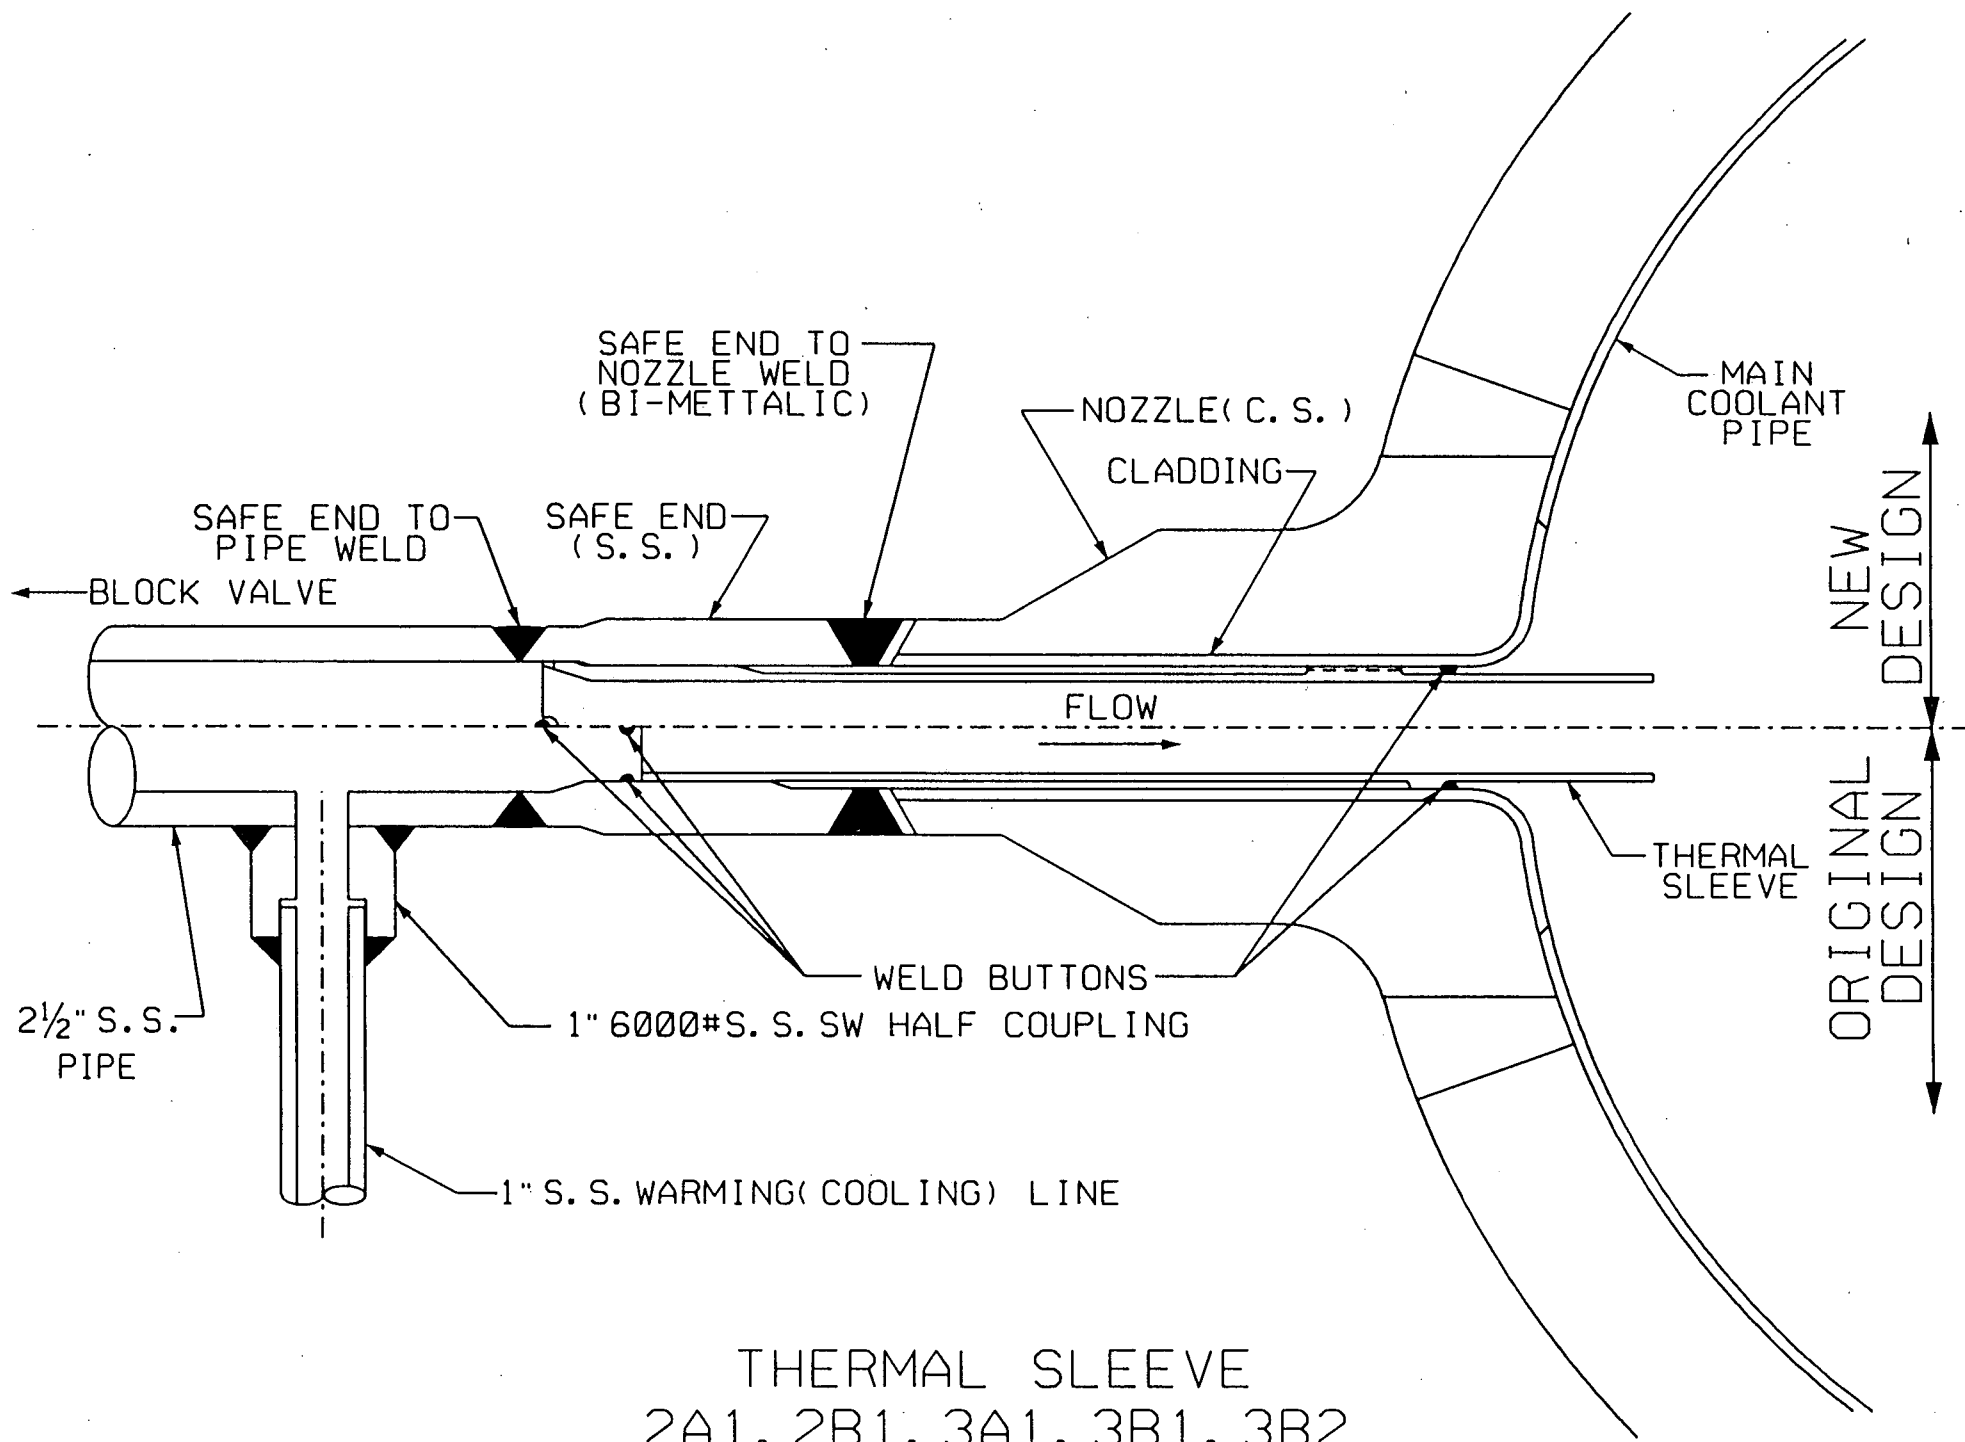
THERMAL SLEEVE  
2A1, 2B1, 3A1, 3B1, 3B2

- Failed to recognize indications of thermal sleeve gap increase A1 nozzles

- » Replaced thermal sleeve and safe end with new design for 2A1 HPI normal injection line
- » Examined other Unit 2 HPI nozzle components
- » Shut down Unit 3 to examine nozzle components
- » Replaced thermal sleeve and safe end with new design for 3A1 HPI normal injection line
- » Installed temporary instrumentation for monitoring of Unit 2 nozzles
- » Installing instrumentation on Unit 3

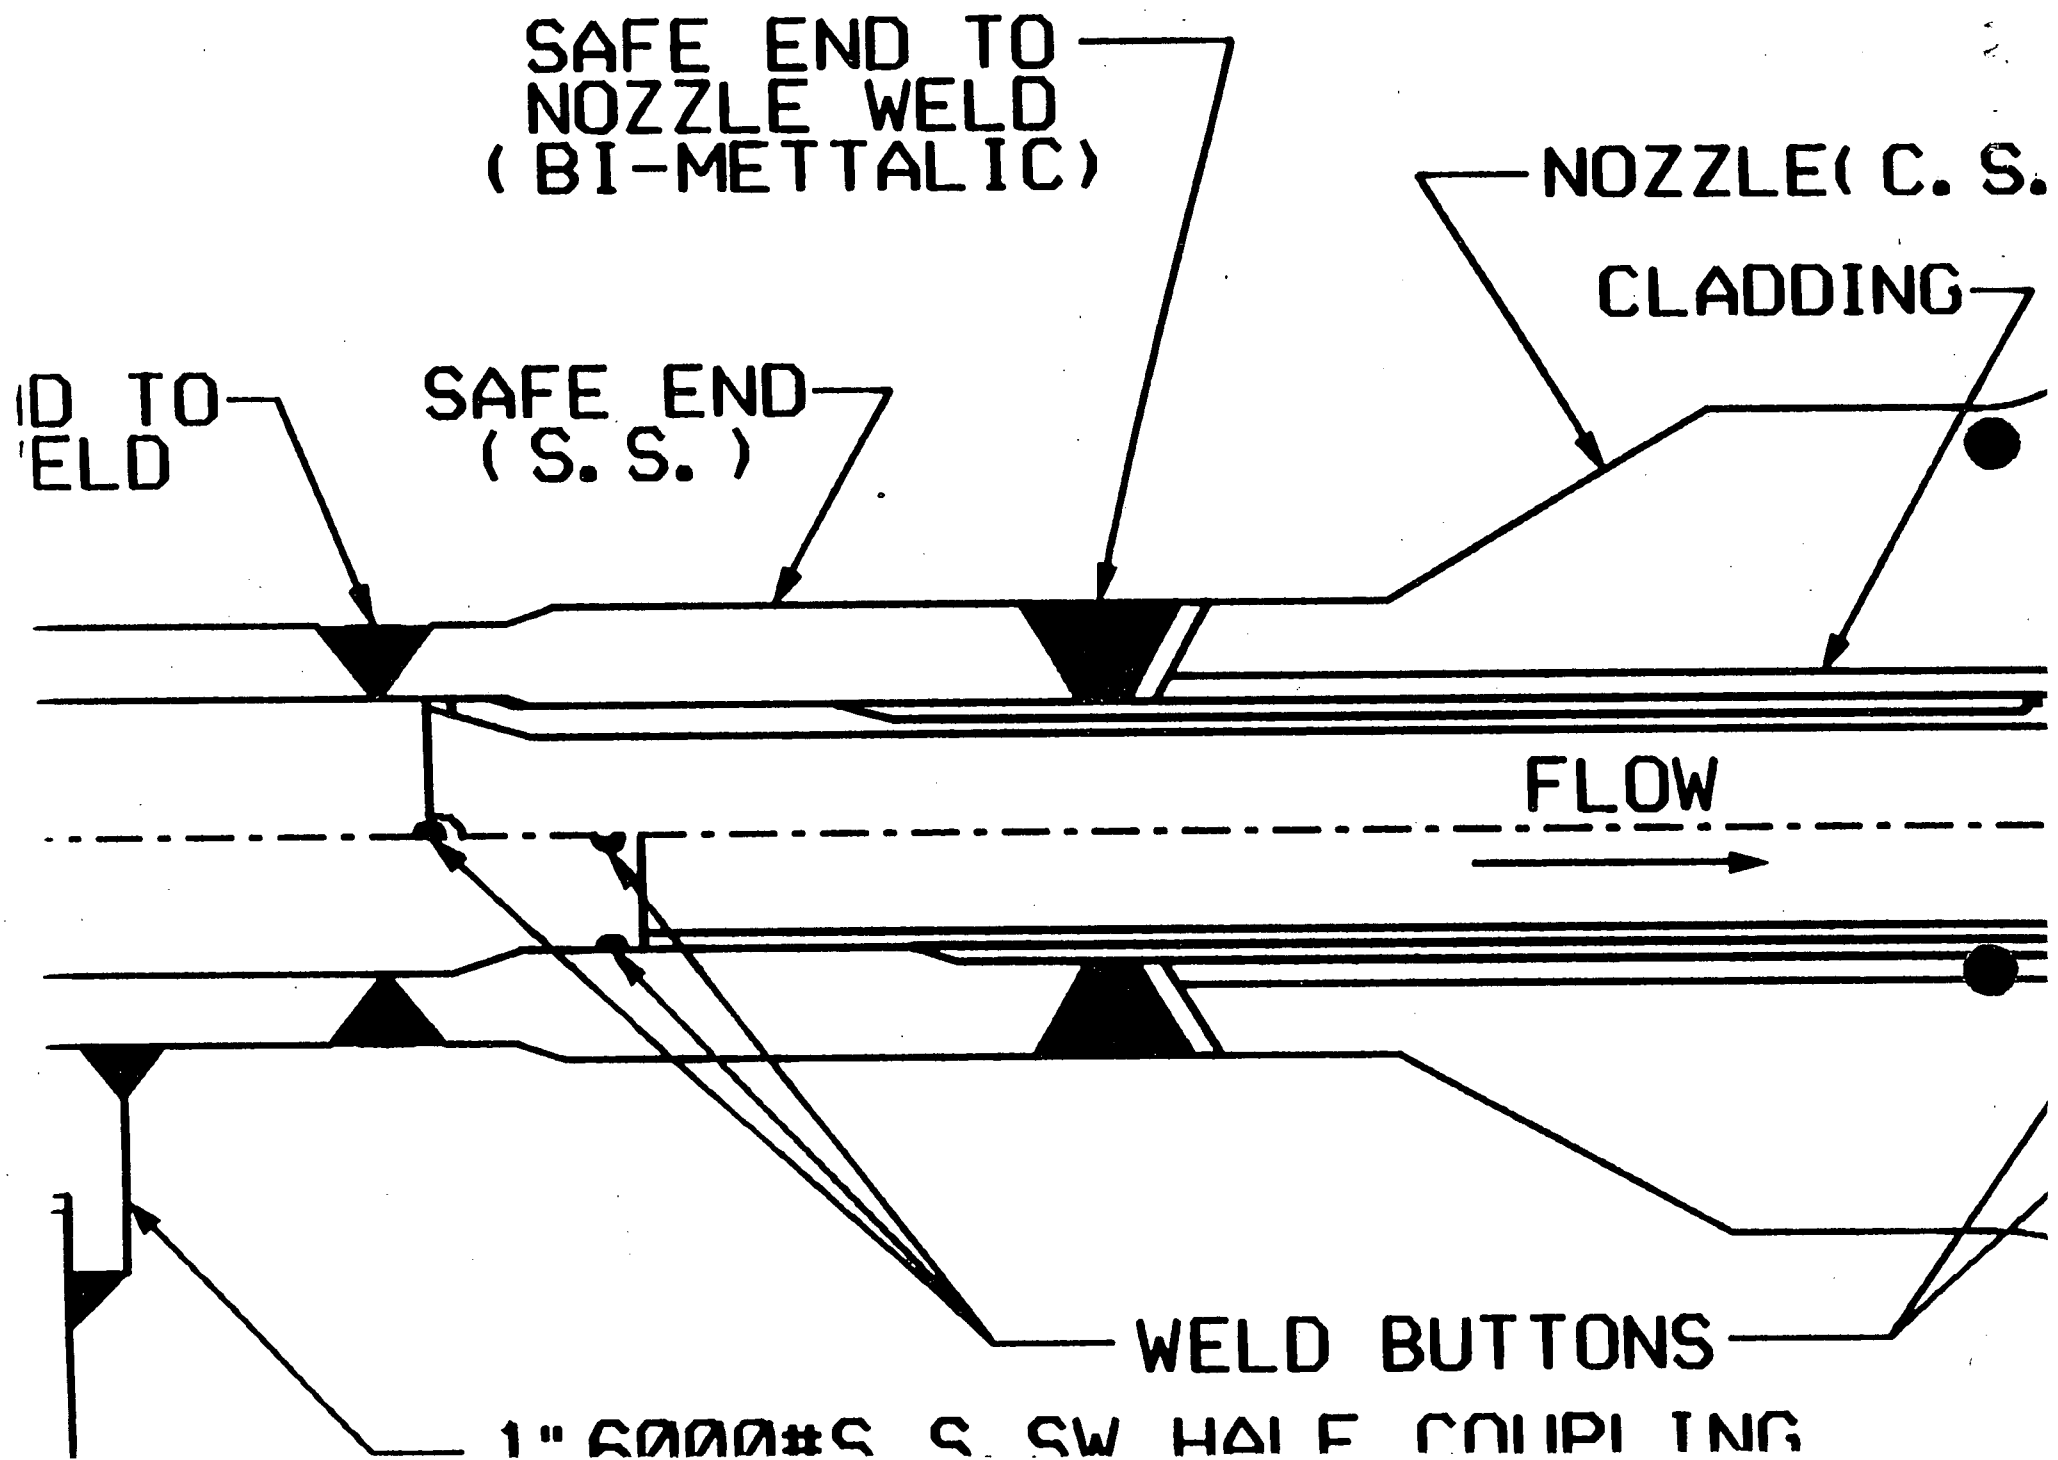
- » A leak occurred in the pipe to safe end connection weld at the 2A1 HPI nozzle
- » Crack in weld was circumferential, with a portion being through-wall
- » Crack propagated slowly
- » Details of crack described in JCO for Unit 1

- » High cycle low / stress thermal fatigue initiated failure in weld
- » Flow induced vibration contributed to thermal sleeve failure after loosening

OD crack tip @ 344° (100%TW)

OD crack tip @ 61° (100% TW)

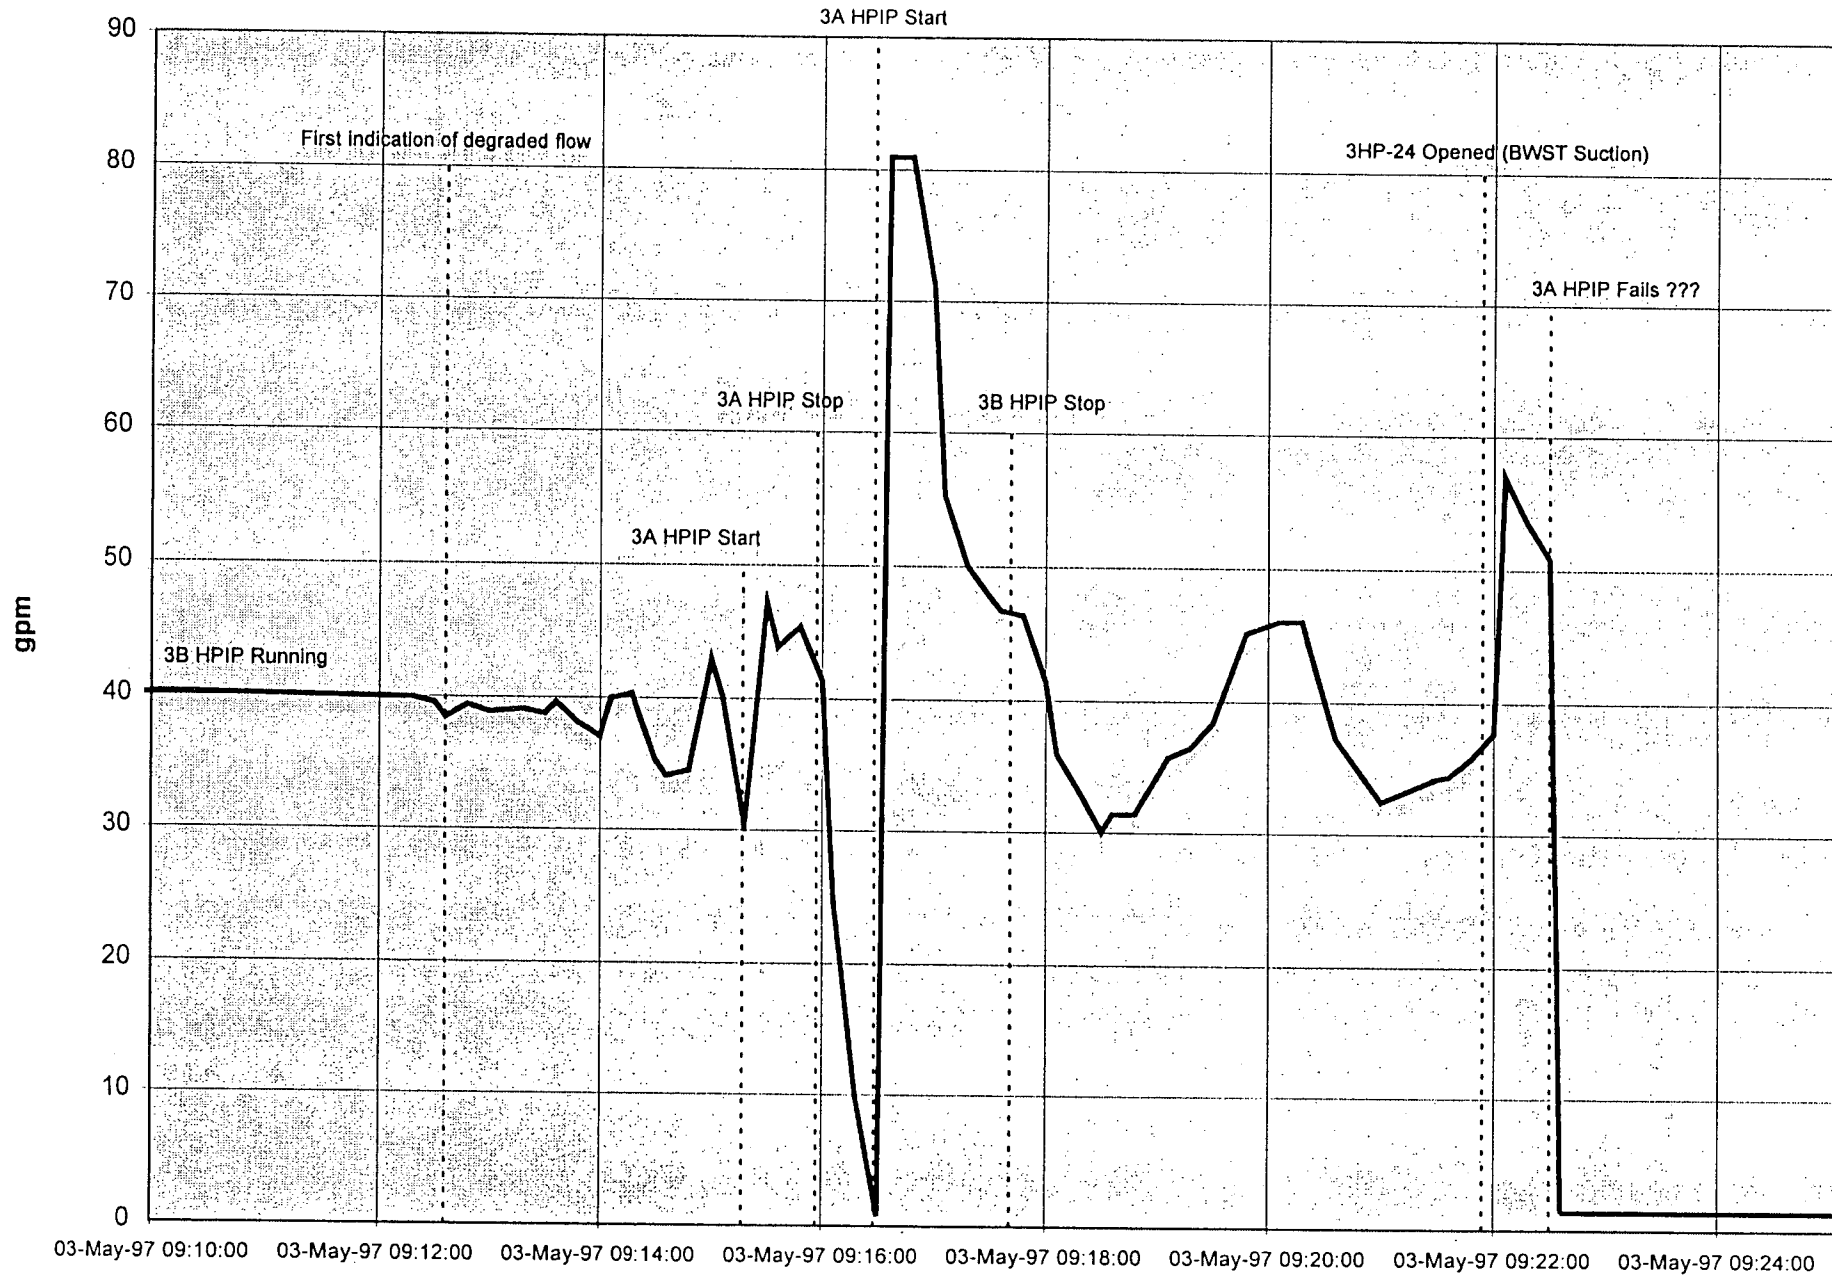
# Oconee 3 5/3/97 HPI Event

- » Design weakness of a common reference leg for LDST level instruments combined with a leaking instrument fitting that resulted in inaccurate LDST level indication
- » Failure of Control Room team to properly monitor and detect the inaccurate level indications given the existing plant conditions.
