# **Chernobyl Disaster 25<sup>th</sup> Anniversary RBMK Reactor & Sequence of Events**

**Dr. Brian Sheron, Director  
Office of Nuclear Regulatory Research  
April 26, 2011**

## **CHERNOBYL – 25 YEARS LATER**

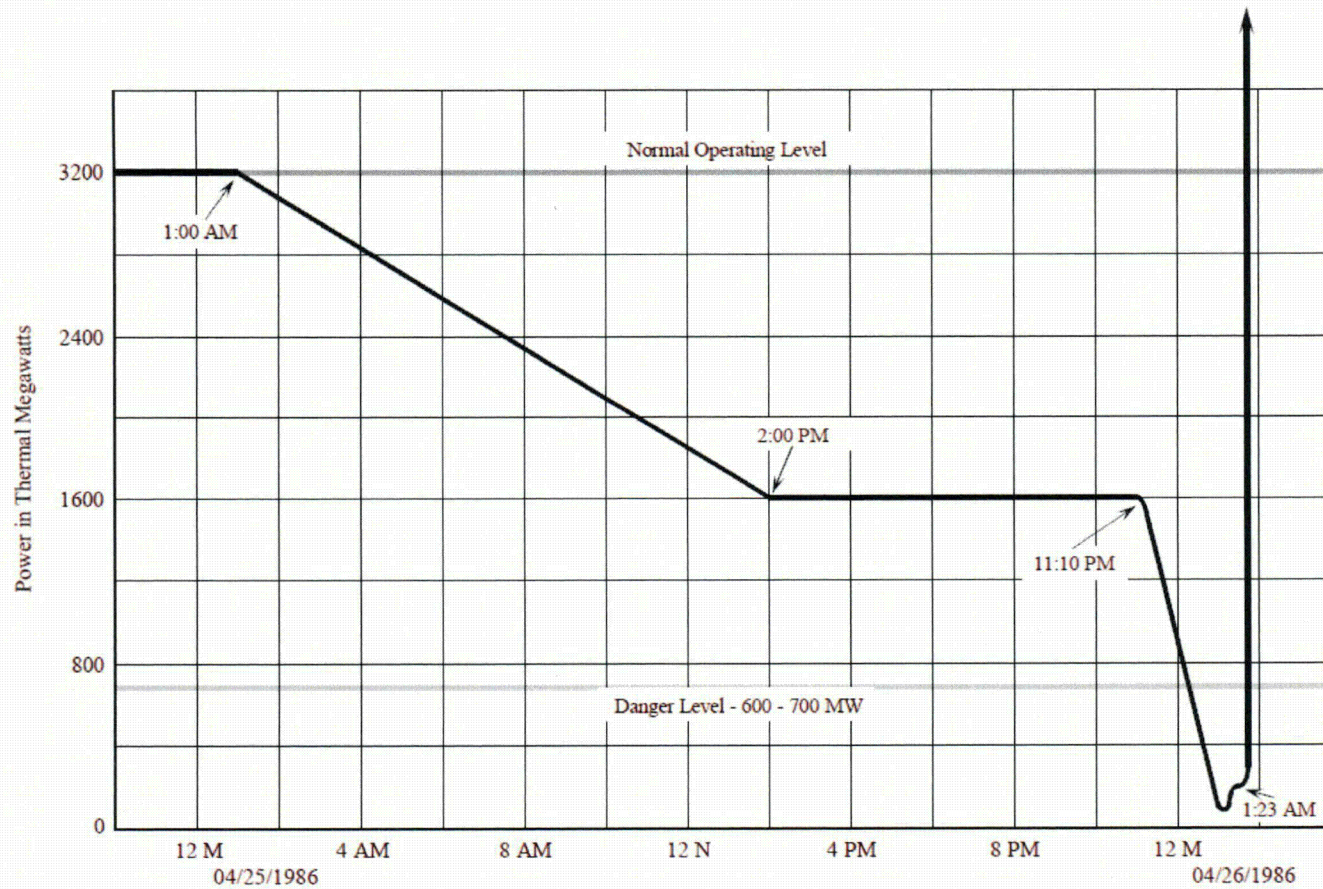
# Unit 4 – Reactor Power vs Time

- 1:23:04 am – turbine stop valve closed to begin test
  - Four main circulation pumps on the generator bus bar began to coast down
  - Power remained at 200 MW because auto reactor shutdown was disabled
  - Reactor power began to increase rapidly
- 1:23:40 am – scram button pushed at direction of unit shift manager
  - Reason unclear – because of reduced shutdown margin, rods would have to travel well into core to be effective
  - Shocks felt in control room
  - Operator determined rods had not inserted
  - Rods deactivated to hopefully fall by gravity
- Observers outside report two explosions

- Initial explosion
  - Prompt critical reactivity excursion
  - Power level exceeded 100 times full power
  - Fuel pellet temperature – 3,000 degrees C – fuel melted and expanded causing cladding failure
  - Massive energy release to coolant, along with particles of destroyed fuel
  - Massive steam explosion
- Second explosion 3 to 4 seconds later
  - Possible hydrogen and carbon monoxide explosion
  - Blew roof off of reactor building, and started 30 fires
- Graphite fires burned for 10 days

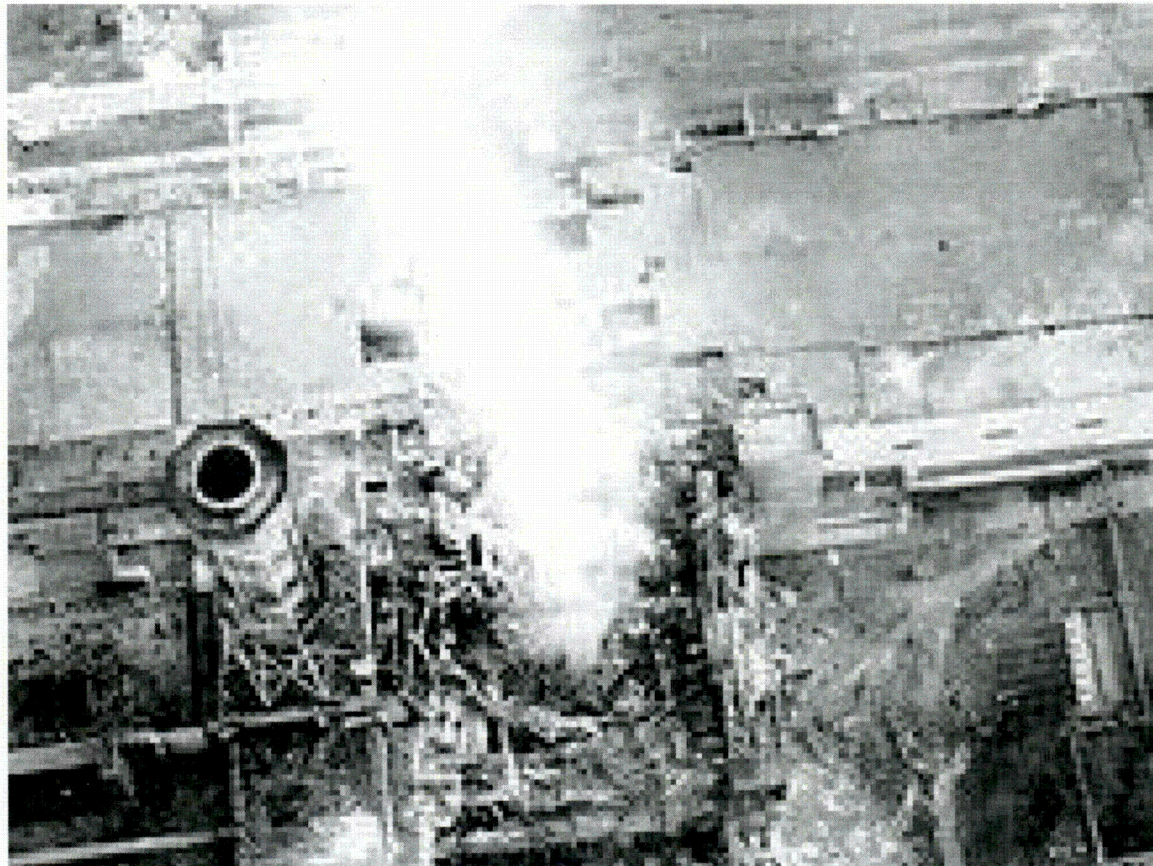
**AERIAL VIEW OF BURNING CORE**  
**Photo Taken During First Days of Accident**

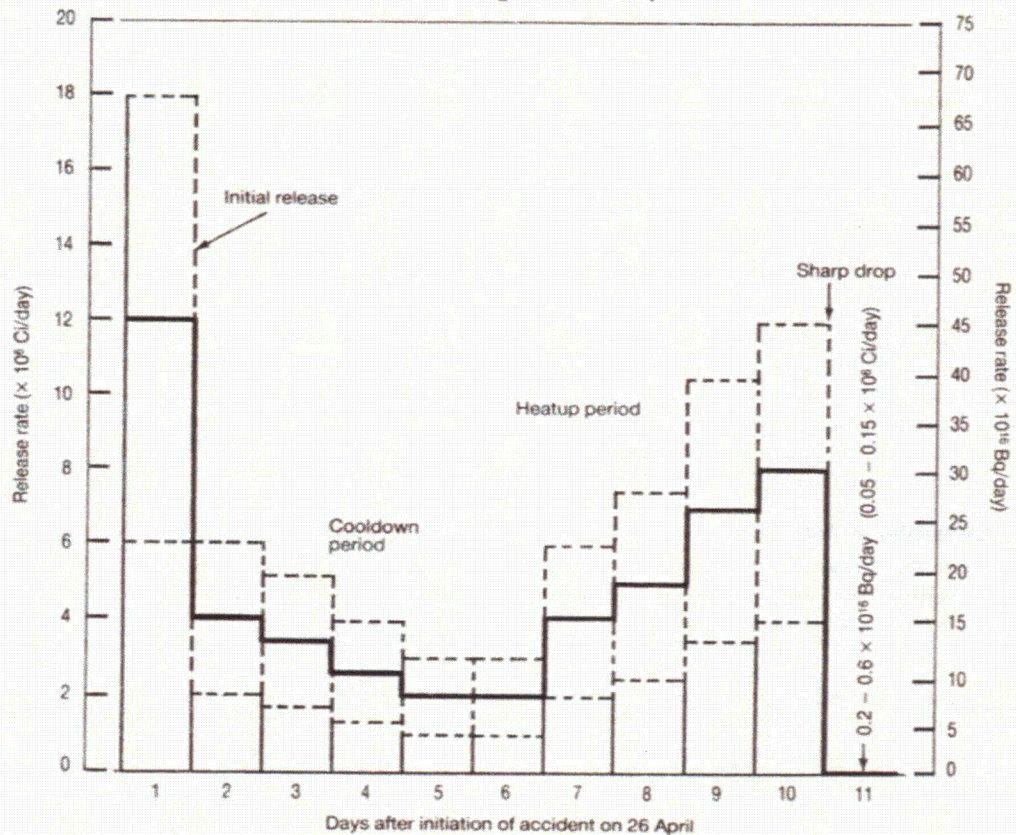
Figure 2. DAILY RELEASE OF RADIOACTIVE SUBSTANCES TO THE ATMOSPHERE DURING THE CHERNOBYL ACCIDENT (not including Noble Gases)

[The values shown are calculated for 6 May 1986, taking into account radioactive decay up until then. The radioactivity released on 26 April 1986 was  $75-80 \times 10^{16}$  Bq ( $20-22 \times 10^6$  Ci). The range of uncertainty for all releases is  $\pm 50\%$ .]

Dotted Lines Denote Error Bars

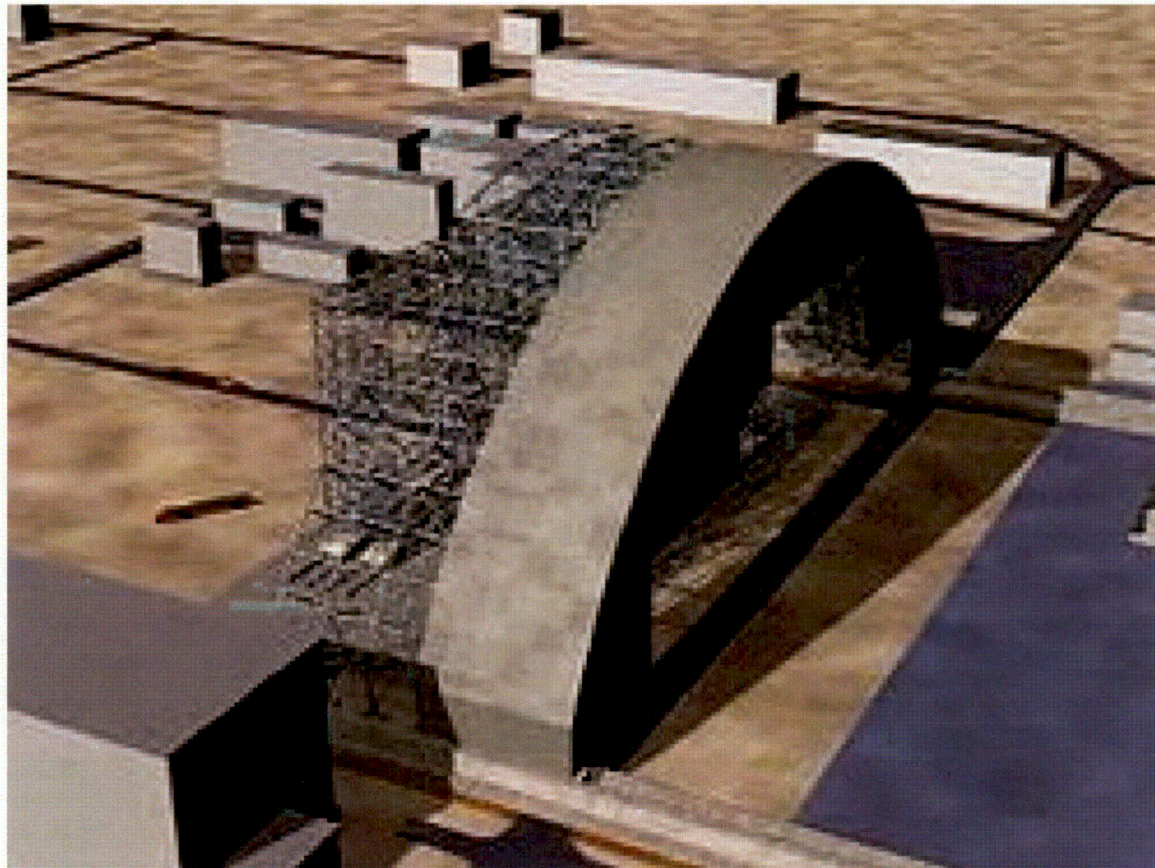
## **ARTIST RENDERING OF FUTURE SARCOPHOGUS**

**THE CURRENT BUILDING SURROUNDING CHERNOBYL 4 IS CRUMBLING.  
REPLACEMENT EXPECTED WITHIN NEXT FOUR YEARS**

**Cover moved over reactor on rails**
