**SUBJECT: SUMMARY OF CONFERENCE CALL WITH PALISADES NUCLEAR PLANT
REGARDING THE FALL 2015 STEAM GENERATOR INSPECTIONS (CAC
NO. MF6993)**

CONFERENCE CALL SUMMARY
REGARDING PALISADES NUCLEAR PLANT
FALL 2015 STEAM GENERATOR INSPECTIONS

**STEAM GENERATOR TUBE INSPECTION DISCUSSION DURING
PALISADES 2015 (RF24) OUTAGE (Preliminary Information)**

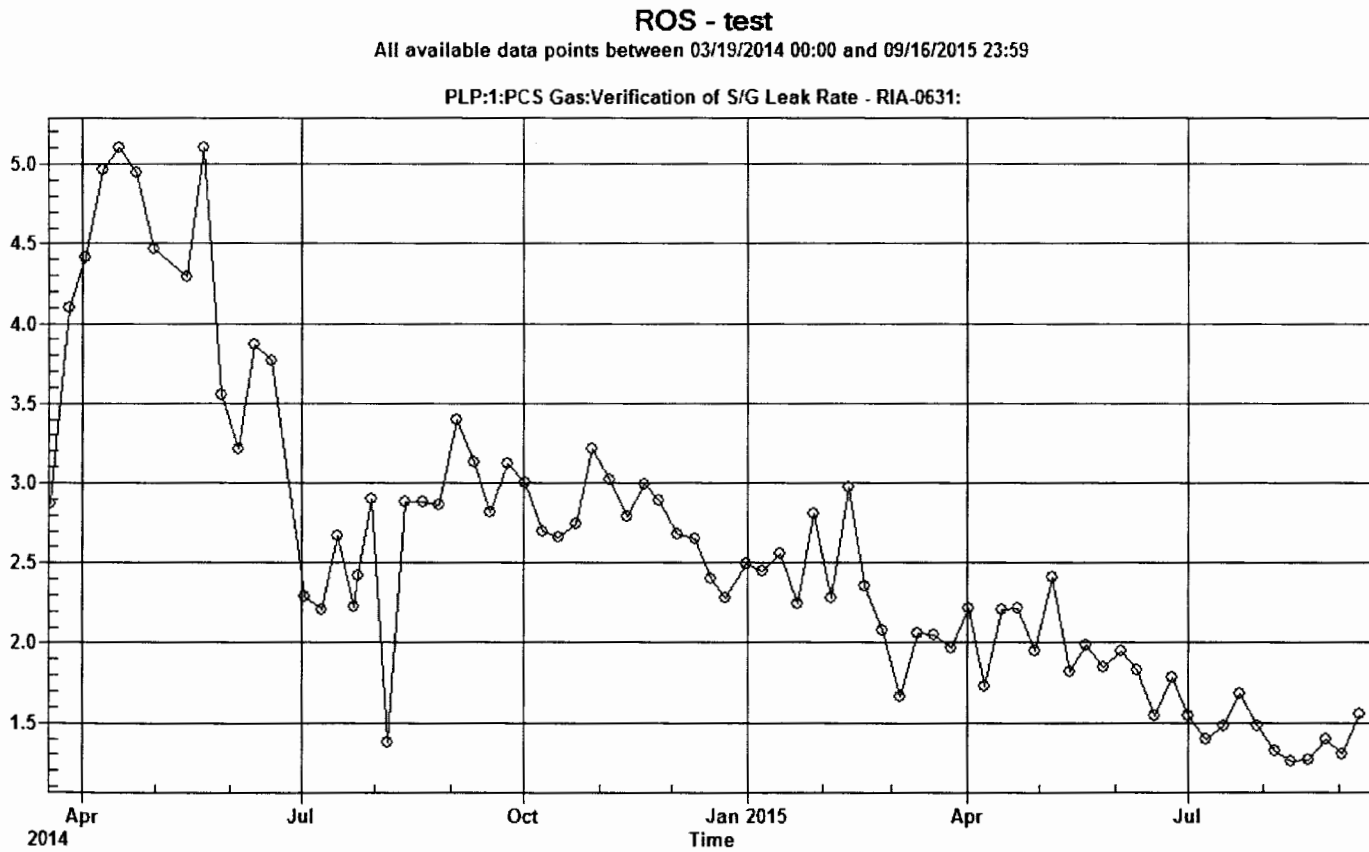
The following is a trend of the Main Condenser Off-Gas Rad-Monitor in GPD

- The indications identified during the inspection are not considered to be large enough to contribute to primary-to-secondary leakage. The source of the primary-to-secondary leakage has not been identified.

Refer to attached Primary to Secondary Leak Rate for Operational Cycle 24 Primary to Secondary Leak Rate graph. Leakage has been minimal all cycle.
