## **STEAM GENERATOR TUBE INSPECTION DISCUSSION DURING PALISADES 2015 (RF24) OUTAGE (Preliminary Information)**

**Currently Palisades is ~ 80% through the base scope eddy current inspection and starting the special interest as of 10/1/2015 at ~ 1200 hours**

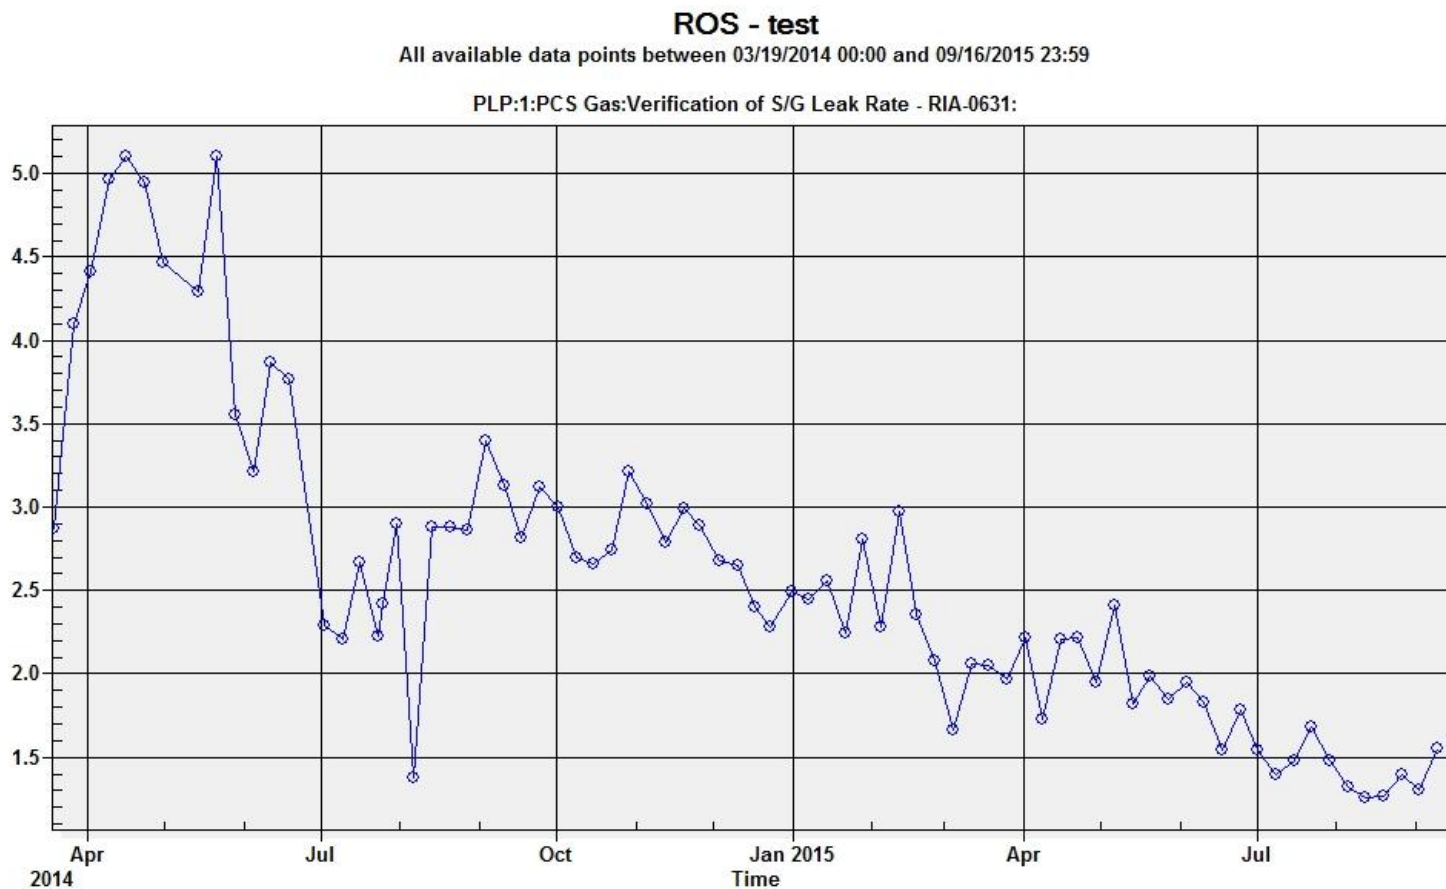
Refer to attached Primary to Secondary Leak Rate for Operational Cycle 24 Primary to Secondary Leak Rate graph. Leakage has been minimal all cycle.

The following is a trend of the Main Condenser Off-Gas Rad-Monitor in GPD
