STEAM GENERATOR TUBE INSPECTION DISCUSSION DURING PALISADES 2015 (RF24) OUTAGE (Preliminary Information)

Currently Palisades is ~ 80% through the base scope eddy current inspection and starting the special interest as of 10/1/2015 at ~ 1200 hours

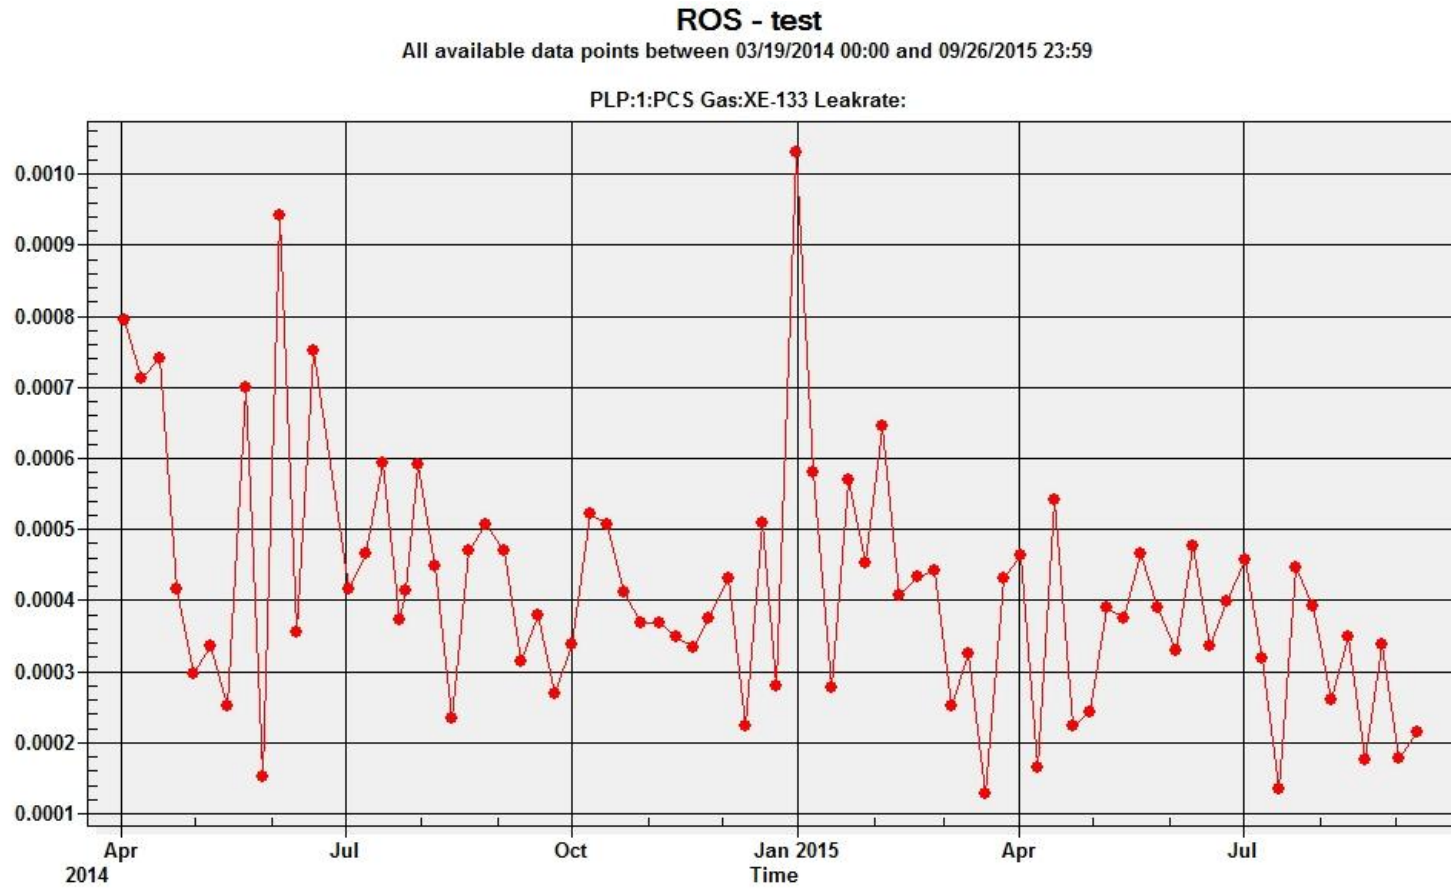
The following is the Primary to Secondary Leak Trend for the Last Fuel Cycle
Note: Units in Gallons per Minutes

Refer to attached Primary to Secondary Leak Rate for Operational Cycle 24 Primary to Secondary Leak Rate graph. Leakage has been minimal all cycle.
