SUBJECT: 10 CFR 71.95 Report Pursuant to 10 CFR 71.95 (a)(3) and (b)
Grand Gulf Nuclear Station, Unit 1
Docket No. 50-416
License No. NPF-29

Subject: 10 CFR 71.95 notification associated with the failure to observe Certificate of Compliance condition of the 8-120B secondary lid test port configuration.

Failure to Observe Certificate of Compliance Conditions for the 8-120B Secondary Lid Test Port Configuration

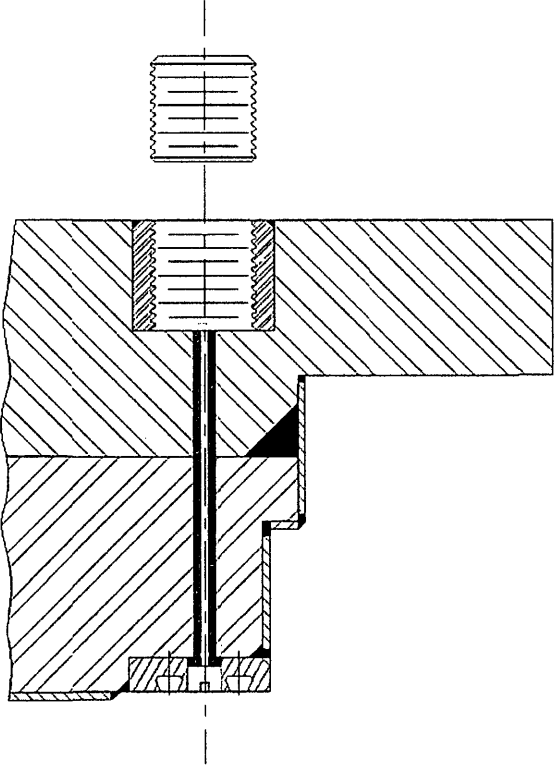
During a recent NRC inspection of EnergySolutions' facility in Columbia, SC, the inspection team identified that the secondary lids of four 8-120B casks¹ did not comply with the approved SAR drawings referenced by the latest revision of the Certificate of Compliance 9168 (CoC). The secondary lids on the subject casks were fabricated with a cladding tube inside the test port hole, but the tube is not shown on the SAR drawing referenced by the CoC. The conditions of approval in the CoC were therefore not observed for any shipments of Type B quantities of radioactive material made using the subject secondary lids. Attachment 1 illustrates the secondary lid test port and tube configurations.

The tube was shown as a design feature in the 8-120B SAR drawings referenced by Revision 17 of the CoC, and previous revisions, but the tube was not credited with any safety function in the SAR. The tube was inadvertently omitted when the lids were redesigned for operational enhancements in CoC Revision 19. The omission was identified by EnergySolutions' corrective action system while the subject lids were still in fabrication. A corrective action was assigned to measure the as-built test volumes, which included the void space between the thick plates since there were no tubes installed. The test volumes were found to exceed the volume basis for pre-shipment leak rate test hold time calculated in the SAR. The tubes were therefore installed, and the lids were placed on QA-hold using EnergySolutions' noncompliance procedure because they did not meet the lid configuration authorized by the CoC in effect at that time (i.e., CoC, Rev. 20). EnergySolutions subsequently made a determination that prior NRC authorization was not required (because the tubes had been part of the previous NRC-approved 8-120B cask design and were inadvertently omitted from the new secondary lid design), cleared the hold, and released the lids for use. The tubes were restored to the SAR drawings as part of a broader license amendment request submitted in May 2014, but the request was withdrawn for unrelated reasons. A new license amendment request submitted to the NRC on 9/16/2015 reintroduces the tubes to the secondary lid design.

The presence of the tubes in the subject secondary lid test ports has no safety consequence because the as-built test volume meets the basis for the pre-shipment leak rate test hold time.

Secondary Lid Test Port
with Cladding Tube
(subject secondary lids)

- *EnergySolutions* has removed 8-120B casks with the secondary lids that have the tube installed in the test port (i.e., secondary lid numbers 8-120B-5, -6, -7, and -8) from service until authorized to resume their use.

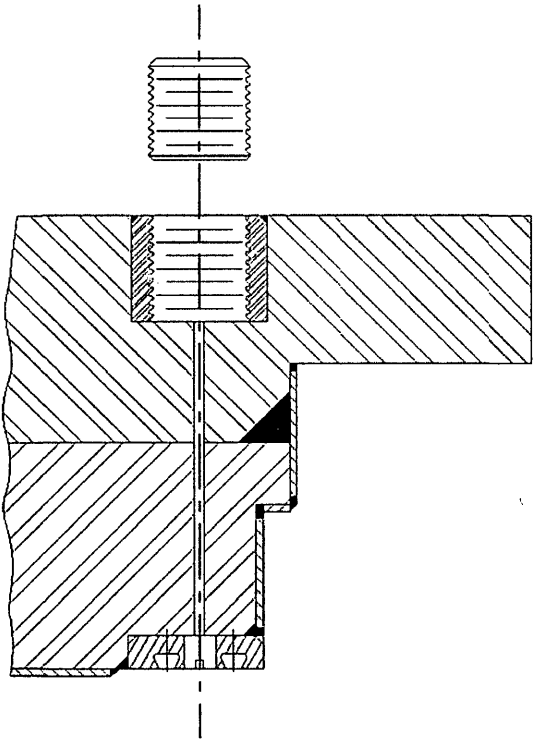
Secondary Lid Test Port
without Cladding Tube
(current CoC configuration)
