U.S. Nuclear Regulatory Commission
Pages from Mallinckrodt Folder
SET III

U.S. Nuclear Regulatory Commission
Pages from Mallinckrodt Folders
SET X-A

1. Notice of Violation (Appendix A)
2. List of Conditions/Recommendations (Appendix B)
3. Inspection Reports
No. 030-00001/88-002(DRSS); and
No. 030-12559/88-001(DRSS)

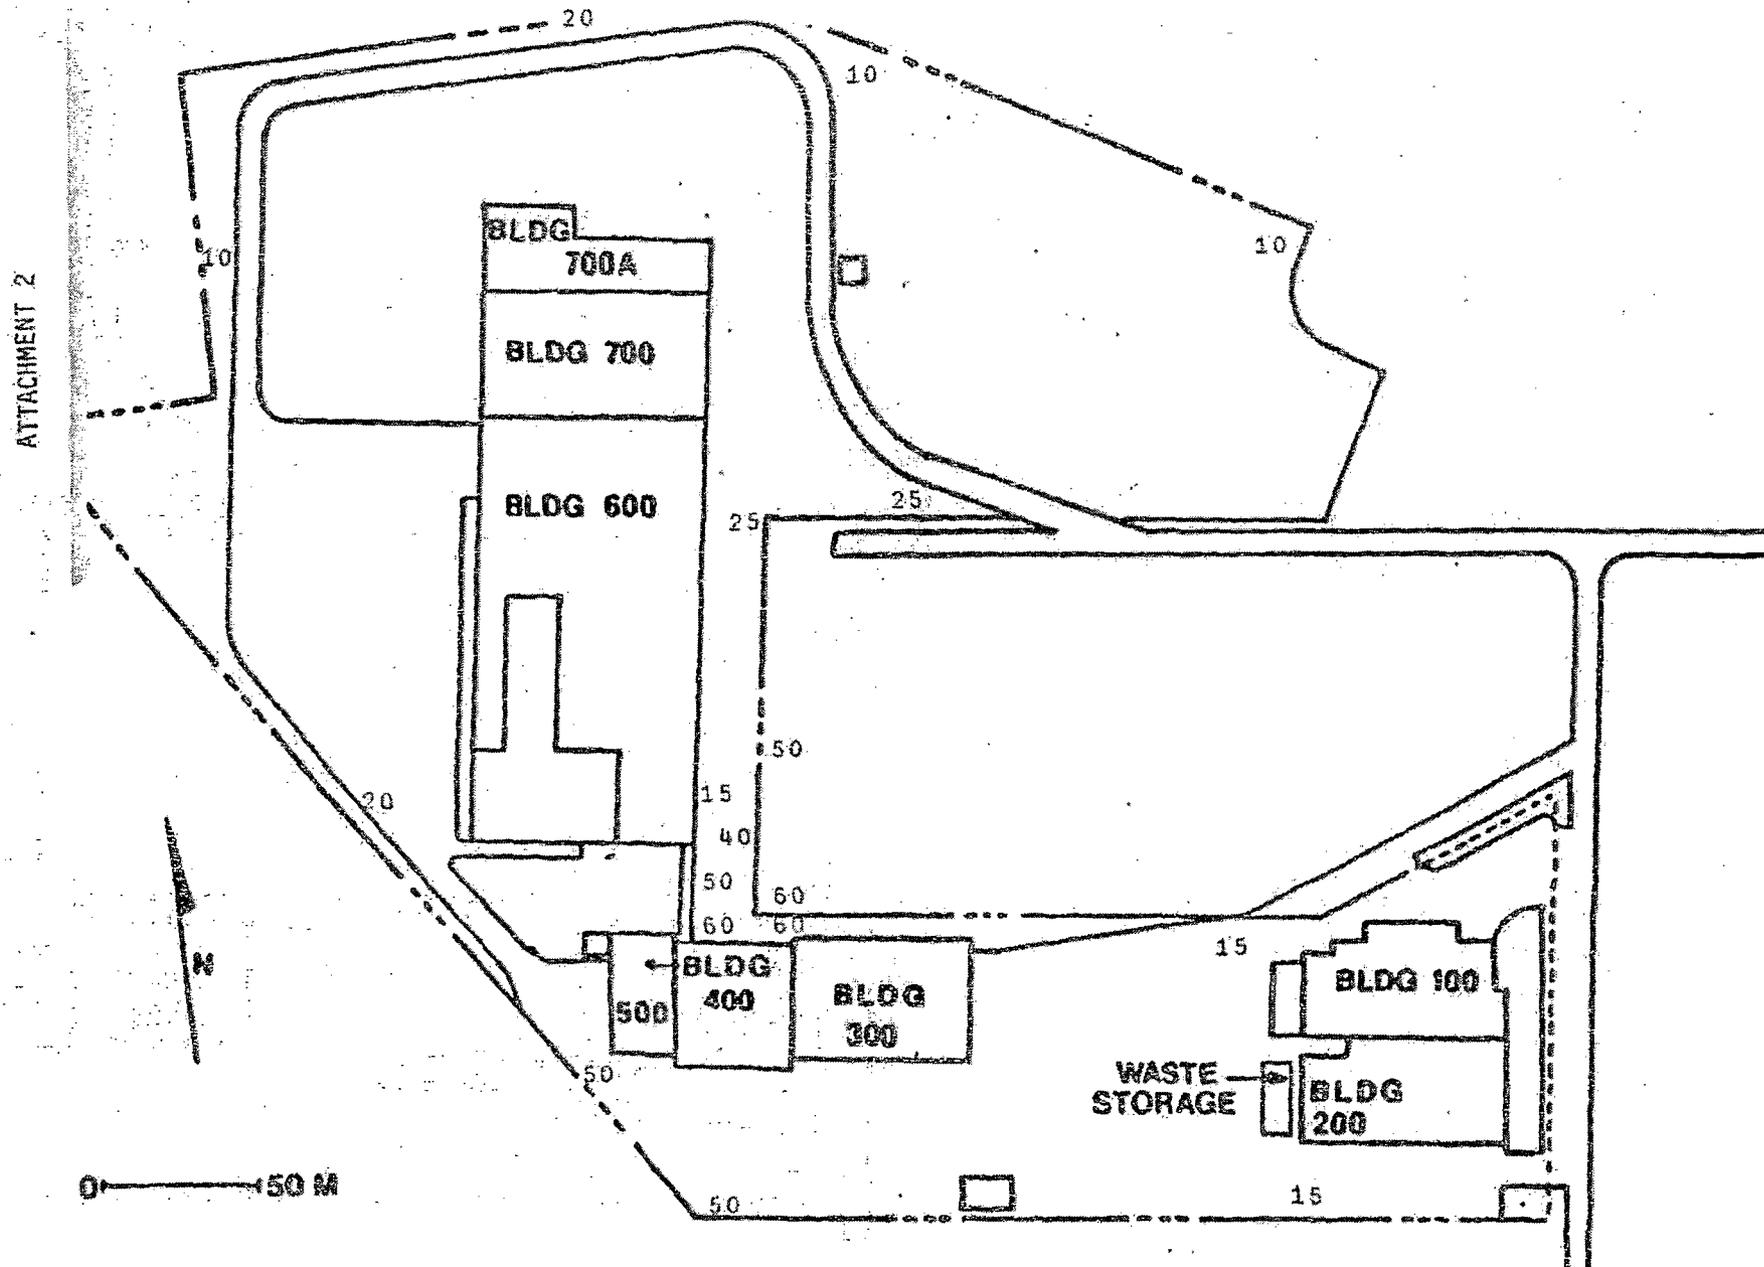
Layout of Mallinckrodt Diagnostics Facility showing results of a direct radiation survey in $\mu\text{R/hr}$.
