Edwin I. Hatch Nuclear Plant
10 CFR 71.95 Report on Non Conformance Involving Radwaste Cask 8-120B

10CFR 71.95 Notification on 8-120B Cask to NRC by EnergySolutions

Failure to Observe Certificate of Compliance Conditions for the 8-120B Secondary Lid Test Port Configuration

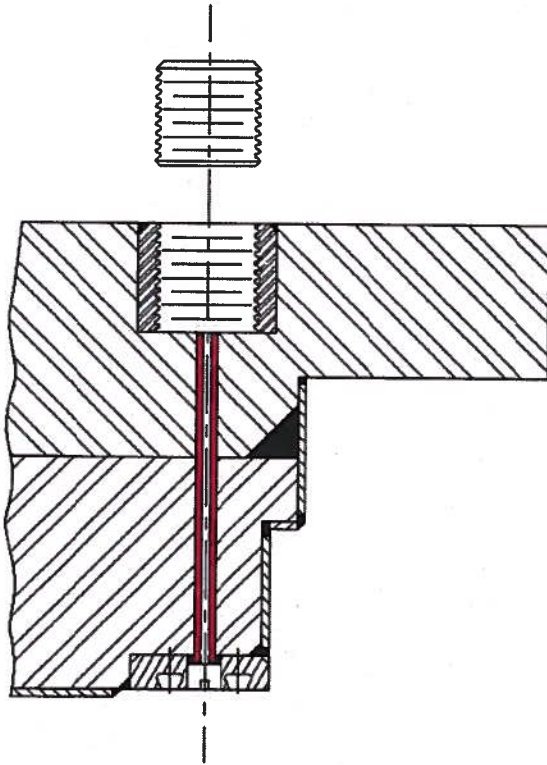
The purpose of the secondary lid test port tube is to isolate the pre-shipment test volume from the interspace between the two 3 1/4" thick plates that make up the secondary lid. The isolation of the test volume provided by the tube assures that the test volume does not exceed the limit on which the hold time for the pre-shipment leak rate test is based. However, if the free volume in the interspace between the plates is negligible, then the isolation function of the tube is not necessary.

The tube was shown as a design feature in the 8-120B SAR drawings referenced by Revision 17 of the CoC, and previous revisions, but the tube was not credited with any safety function in the SAR. The tube was inadvertently omitted when the lids were redesigned for operational enhancements in CoC Revision 19. The omission was identified by EnergySolutions' corrective action system while the subject lids were still in fabrication. A corrective action was assigned to measure the as-built test volumes, which included the void space between the thick plates since there were no tubes installed. The test volumes were found to exceed the volume basis for pre-shipment leak rate test hold time calculated in the SAR. The tubes were therefore installed, and the lids were placed on QA-hold using EnergySolutions' noncompliance procedure because they did not meet the lid configuration authorized by the CoC in effect at that time (i.e., CoC, Rev. 20). EnergySolutions subsequently made a determination that prior NRC authorization was not required (because the tubes had been part of the previous NRC-approved 8-120B cask design and were inadvertently omitted from the new secondary lid design), cleared the hold, and released the lids for use. The tubes were restored to the SAR drawings as part of a broader license amendment request submitted in May 2014, but the request was withdrawn for unrelated reasons. A new license amendment request submitted to the NRC on 9/16/2015 reintroduces the tubes to the secondary lid design.

The presence of the tubes in the subject secondary lid test ports has no safety consequence because the as-built test volume meets the basis for the pre-shipment leak rate test hold time. The secondary lid test port configuration of the subject lids is similar to the design previously authorized for use prior to CoC Revision 19.

Secondary Lid Test Port
with Cladding Tube
(subject secondary lids)

- *EnergySolutions* has removed 8-120B casks with the secondary lids that have the tube installed in the test port (i.e., secondary lid numbers 8-120B-5, -6, -7, and -8) from service until authorized to resume their use.

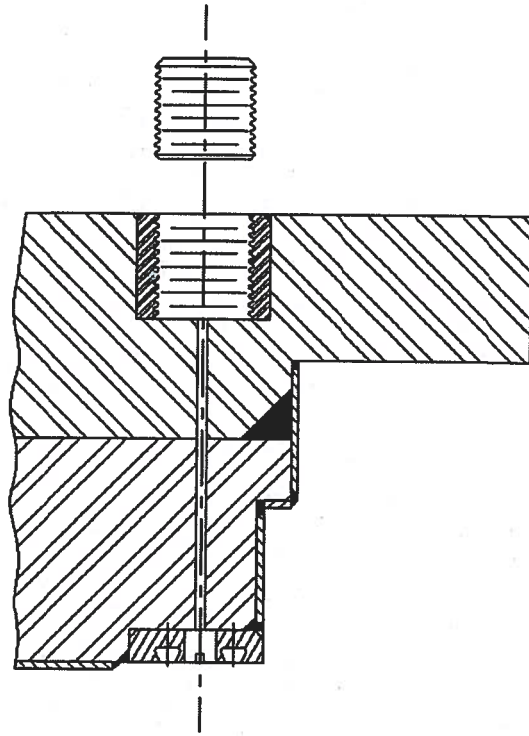
Secondary Lid Test Port
without Cladding Tube
(current CoC configuration)
