Edwin I. Hatch Nuclear Plant
10 CFR 71.95 Report on Non Conformance Involving Radwaste Cask 8-120B

10CFR 71.95 Notification on 8-120B Cask to NRC by EnergySolutions

Subject: 10 CFR 71.95 notification associated with the failure to observe Certificate of Compliance condition of the 8-120B secondary lid test port configuration.

Failure to Observe Certificate of Compliance Conditions for the 8-120B Secondary Lid Test Port Configuration

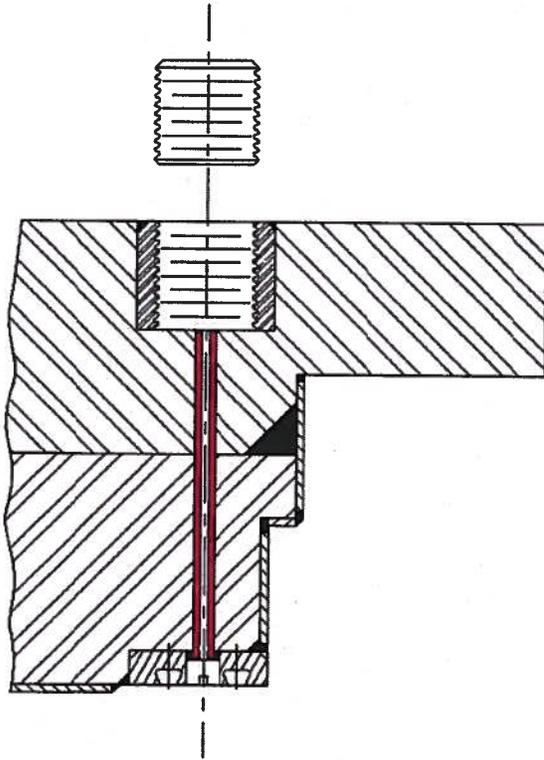
The purpose of the secondary lid test port tube is to isolate the pre-shipment test volume from the interspace between the two 3 1/4" thick plates that make up the secondary lid. The isolation of the test volume provided by the tube assures that the test volume does not exceed the limit on which the hold time for the pre-shipment leak rate test is based. However, if the free volume in the interspace between the plates is negligible, then the isolation function of the tube is not necessary.

The presence of the tubes in the subject secondary lid test ports has no safety consequence because the as-built test volume meets the basis for the pre-shipment leak rate test hold time.

Secondary Lid Test Port
with Cladding Tube
(subject secondary lids)

- *EnergySolutions* has removed 8-120B casks with the secondary lids that have the tube installed in the test port (i.e., secondary lid numbers 8-120B-5, -6, -7, and -8) from service until authorized to resume their use.

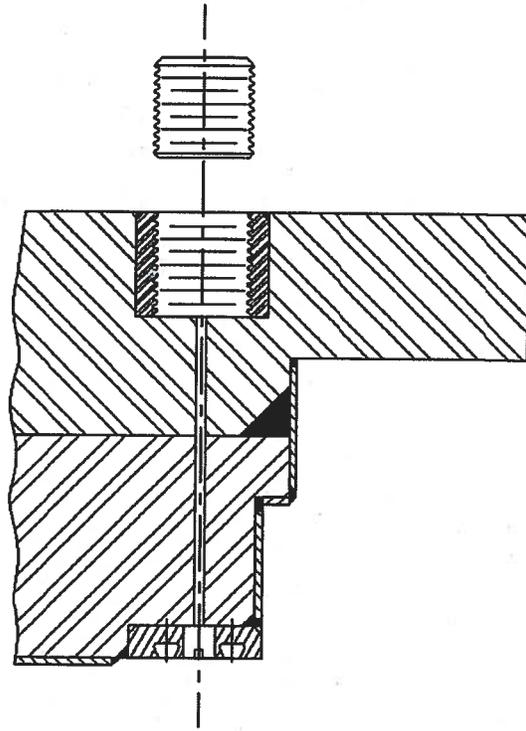
The tube was shown as a design feature in the 8-120B SAR drawings referenced by Revision 17 of the CoC, and previous revisions, but the tube was not credited with any safety function in the SAR. The tube was inadvertently omitted when the lids were redesigned for operational enhancements in CoC Revision 19. The omission was identified by EnergySolutions' corrective action system while the subject lids were still in fabrication. A corrective action was assigned to measure the as-built test volumes, which included the void space between the thick plates since there were no tubes installed. The test volumes were found to exceed the volume basis for pre-shipment leak rate test hold time calculated in the SAR. The tubes were therefore installed, and the lids were placed on QA-hold using EnergySolutions' noncompliance procedure because they did not meet the lid configuration authorized by the CoC in effect at that time (i.e., CoC, Rev. 20). EnergySolutions subsequently made a determination that prior NRC authorization was not required (because the tubes had been part of the previous NRC-approved 8-120B cask design and were inadvertently omitted from the new secondary lid design), cleared the hold, and released the lids for use. The tubes were restored to the SAR drawings as part of a broader license amendment request submitted in May 2014, but the request was withdrawn for unrelated reasons. A new license amendment request submitted to the NRC on 9/16/2015 reintroduces the tubes to the secondary lid design.

Secondary Lid Test Port
without Cladding Tube
(current CoC configuration)
