**UNITED STATES
NUCLEAR REGULATORY COMMISSION**
REGION IV
1600 E. LAMAR BLVD.
ARLINGTON, TX 76011-4511

**SUBJECT: WATERFORD STEAM ELECTRIC STATION, UNIT 3 – NRC INTEGRATED
INSPECTION REPORT 05000382/2015-003**

Enclosure:
Inspection Report 05000382/2015-003
w/ Attachment: Supplemental Information

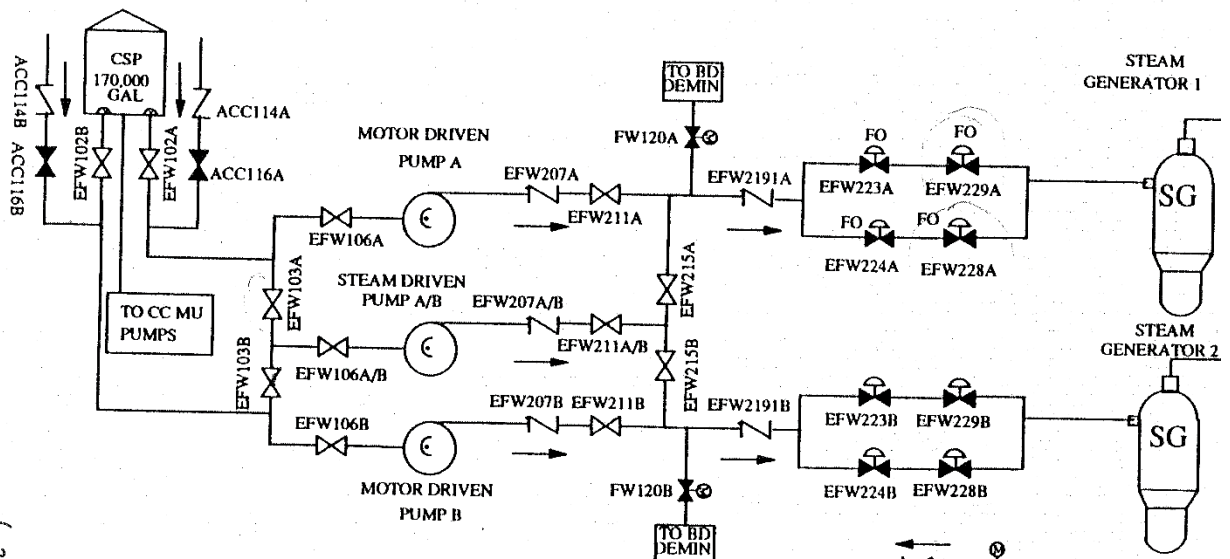
The configuration of the emergency feedwater system was important to the risk significance of this finding. Three trains of emergency feedwater pumps were available at Waterford-3. The pumps injected into a common header. The header had two discharge pathways, one going to each steam generator. Each discharge pathway separated into two parallel branches. Each branch included a primary flow control valve (EFW-224A/B) or a backup flow control valve (EFW-223A/B). Each branch also included a steam generator isolation valve (EFW-228A/B or EFW-229A/B). Either the primary or backup flow control valves could be used to maintain the desired flow to the steam generators.

In response to the malfunction, operators took manual control of the backup emergency flow control valves. Alternatively, the operators could have used the primary flow control valves (in automatic or manual control) to accomplish the safety function.

The analyst considered the use of the backup flow control valves in manual mode an additional recovery action. The analyst used the nominal manual action non-recovery probability of $1.1E-2$ from NUREG/CR-6883, "The SPAR-H Human Reliability Analysis Method." The analyst added this probability to the nominal failure probability of $9.5E-4$ /demand. The resultant failure probability was $1.1E-2$ /demand. The analyst assumed the maximum one year exposure period.

The dominant sequences included losses of offsite power, failure of the backup emergency feedwater valves in the closed direction, and random failures of the primary flow control valves in the closed direction. The primary emergency feedwater flow control valves and the diversity of the EFW system helped to minimize the risk.
