# ENERGYSOLUTIONS

**Subject: 10 CFR 71.95 Report on the 8-120B Cask**

## **Failure to Observe Certificate of Compliance Conditions for the 8-120B Vent Port Pre-Shipment Leak Test**

July 28, 2015

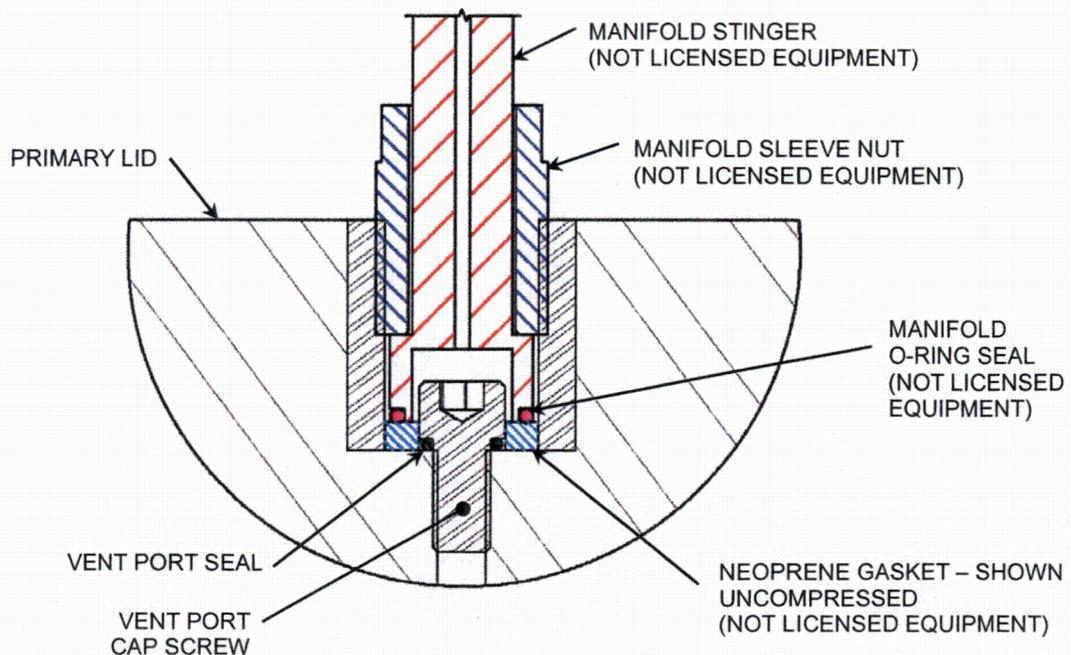
The neoprene gasket can constrict on the head of the vent port plug cap screw when it is compressed by the bottom end of the test manifold stinger, which could reduce the sensitivity of the pre-shipment leak test. Consequently, the vent port pre-shipment leak

On Monday June 1, 2015, an 8-120B cask user identified a concern that the neoprene gasket could potentially affect the integrity of the vent port seal pre-shipment leak test. Later that week EnergySolutions performed a bench test that confirmed that the neoprene gasket can constrict on the head of the vent port plug cap screw when it is compressed by the manifold, resulting in a reduction of the test sensitivity.

The pre-shipment leak test of the vent port is a pressure drop test performed using a dedicated test manifold. The test manifold is not a part of the licensed package. It includes a stinger (shown below), an O-ring seal that contacts the stinger and the bottom of the vent port hole, and a sleeve nut to compress the O-ring seal. The test manifold was designed so that it surrounds the vent port cap screw, leaving a small gap between itself and the vent port cap screw. The 8-120B cask fleet began to ship with a new lid design in September 2013, and operations staff noted more frequent difficulty getting the manifold to seal. It became desirable to find a better way to seal the bottom of the manifold in order to minimize operator exposure. They found that adding a neoprene gasket (also not part of the licensed package) under the base of the stinger as shown below helped reduce testing time and exposure.
