Susquehanna Siphon and Vent Block Leak

John Wise
Division of Spent Fuel Management
Regulatory Conference
November 18-19, 2015

Susquehanna spent fuel loading campaign – Nov. 2014

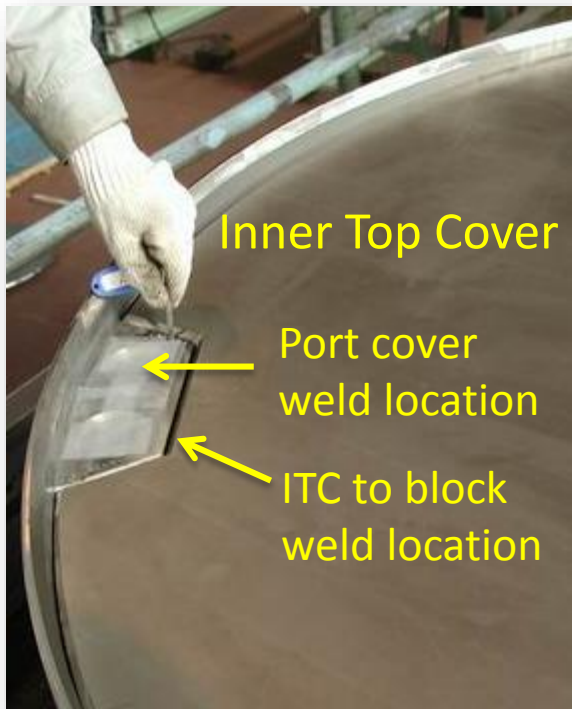
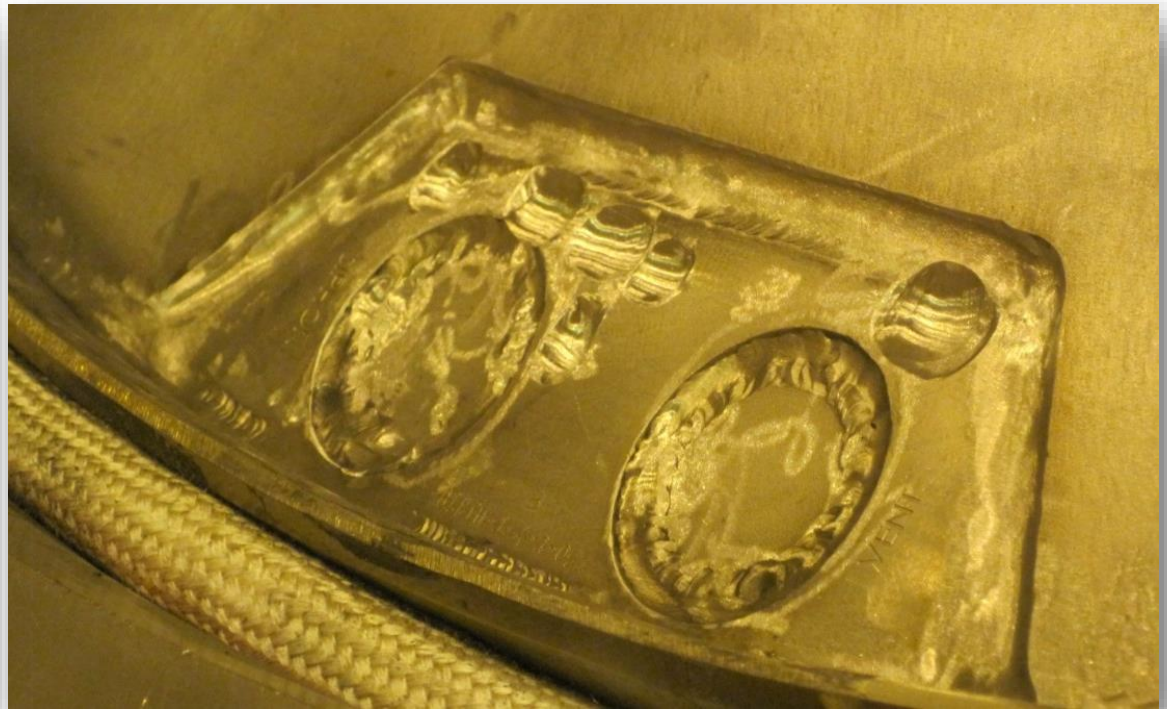
Indications after welding the port covers

PT examination identified six rejectable indications per the ASME Code – these areas were excavated to bring into Code compliance

- Subsequent helium leak testing identified leaks in two of the excavations
- Base metal buildups were performed on the six excavations and a 1/8th inch weld overlay was deposited over the entire repaired region
- This area ultimately passed liquid penetrant and helium leak testing
- The DSC met all the Technical Specification requirements before being placed on the ISFSI pad

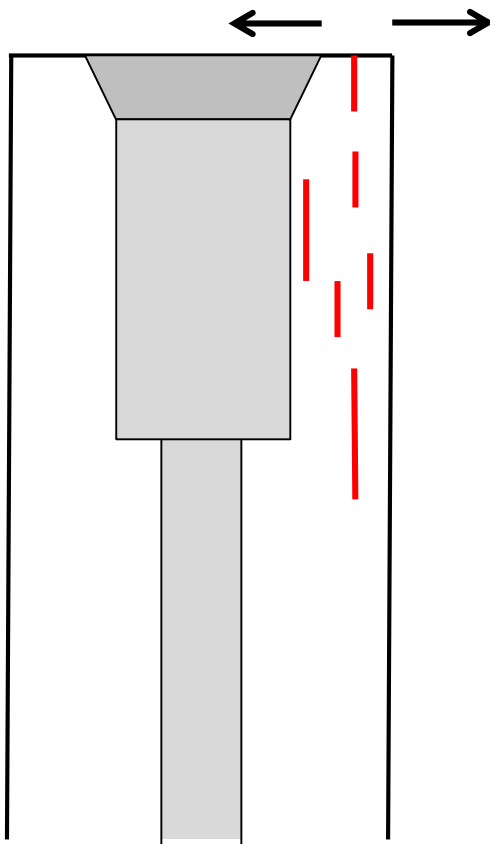
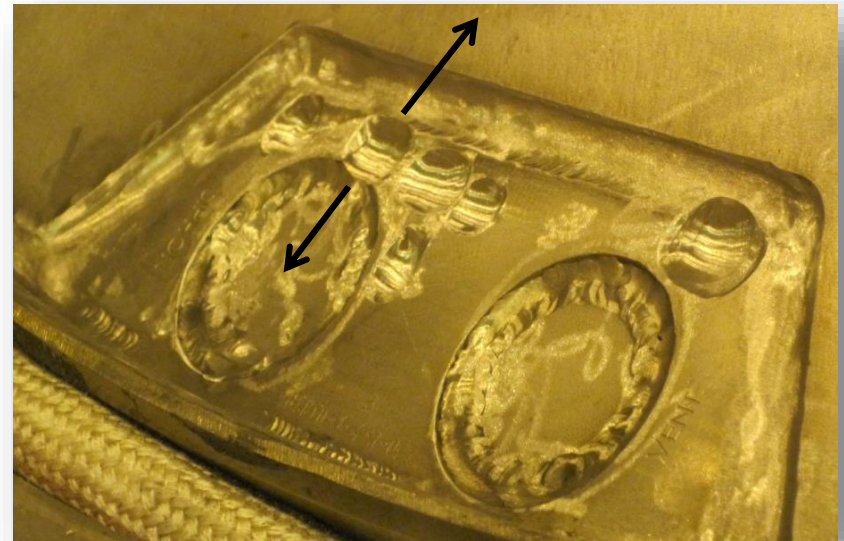
- Material separation at plate inclusions due to weld-induced stresses

Rolled plate inclusions

- Use of forged material rather than rolled plates
- Use of weld overlays
- Adjustments in welding practice to reduce stresses

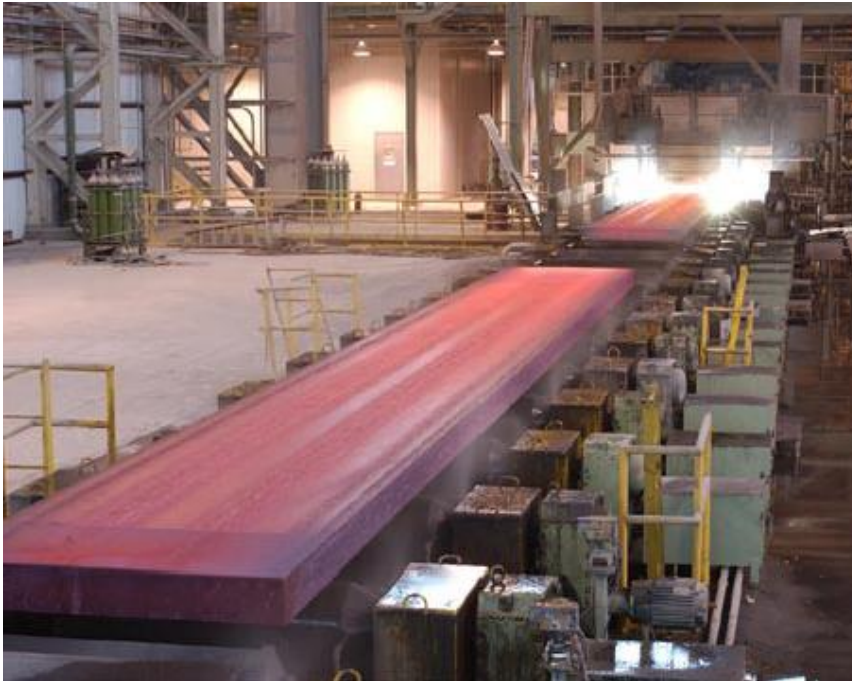
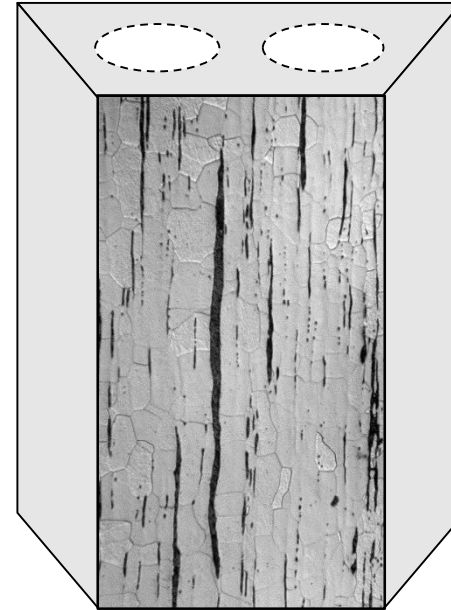
Elongated in rolling direction
