DOMINION NUCLEAR CONNECTICUT, INC.
MILLSTONE POWER STATION UNIT 2
LICENSEE EVENT REPORT 2015-002-01
DEGRADED EMERGENCY CORE COOLING SYSTEM CHECK VALVE

LICENSEE EVENT REPORT 2015-002-01
DEGRADED EMERGENCY CORE COOLING SYSTEM
CHECK VALVE

MILLSTONE POWER STATION UNIT 2
DOMINION NUCLEAR CONNECTICUT, INC.

4. TITLE
Degraded Emergency Core Cooling System Check Valve

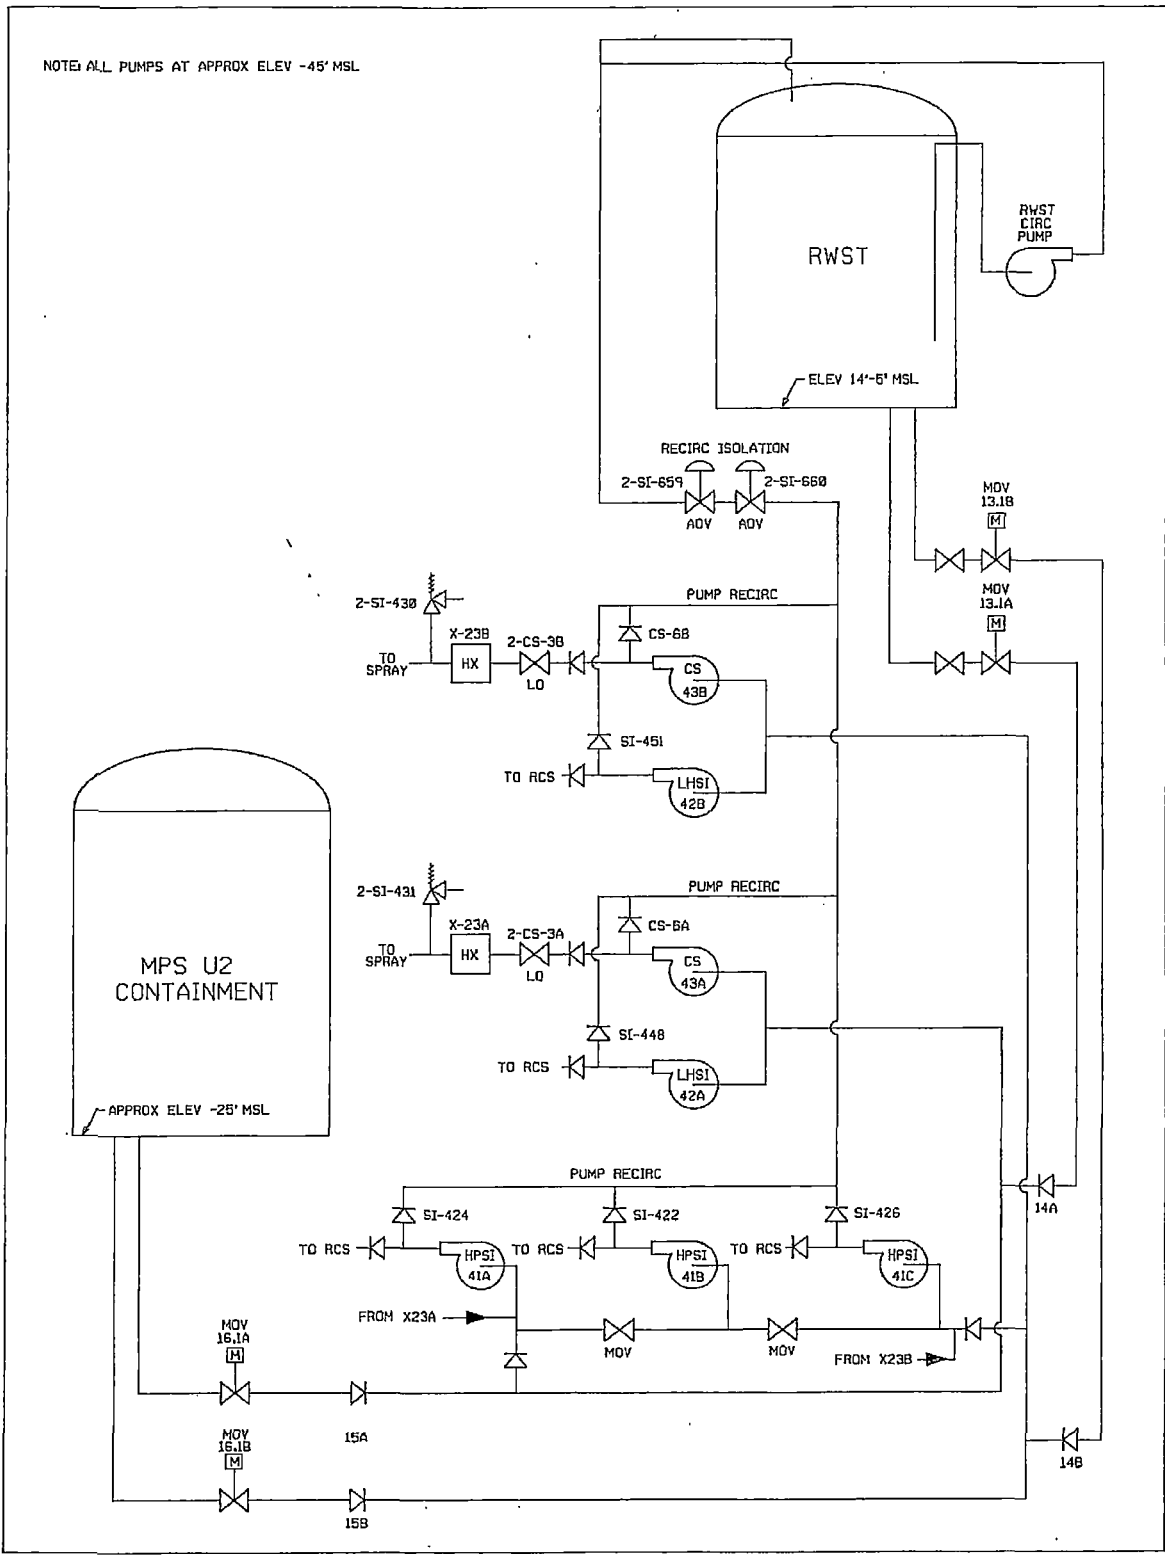
With the CS system operating during a design basis accident, a small portion of the CS pump discharge flow recirculates to the RWST during the injection phase; however, the recirculation line is isolated from the RWST when transferring to sump recirculation. All seven ECCS/CS pumps (2 LPSI, 2 CS, and 3 HPSI) have minimum flow recirculation lines that tie into one common header to the RWST. Exhibit A attached to this LER is a sketch depicting the configuration.

Evaluation of this failure identified that during a SBLOCA (Small Break Loss of Coolant Accident) concurrent with a loss of power to the "A" train associated with the leaking 2-CS-6A, the operating (opposite) train HPSI pump would pressurize the common recirculation header during the injection phase of the accident as was described above. In the operator response to this postulated event when the 2-CS-6A leaks to the RWST, suction 2-CS-13.1B is manually isolated terminating the release to the RWST. However, it was additionally identified that the "A" train suction header would pressurize because of the continued back leakage with none of the "A" train pumps flowing due to loss of power and no open flowpath (to containment spray or RWST). This pressurization would continue, exceeding the design pressure of the suction header (60 psig) ultimately reaching 500 psig, the lift setpoint for the two "A" train shutdown cooling heat exchanger relief valves downstream of the "A" LPSI and CS pumps. These relief valves discharge to the EDST (Equipment Drains Sump Tank) which is located outside the filtered ventilation boundary. Upon emptying of the RWST and initiation of sump recirculation, the described back-leakage flowpath would contain sump fluid. This additional unidentified release path from the original design of the plant was reported to the NRC as a follow-up notification on July 10, 2015.
