Safety Analysis Report for the Model 880 Series Transport Package

QSA Global, Inc.  
Burlington, Massachusetts

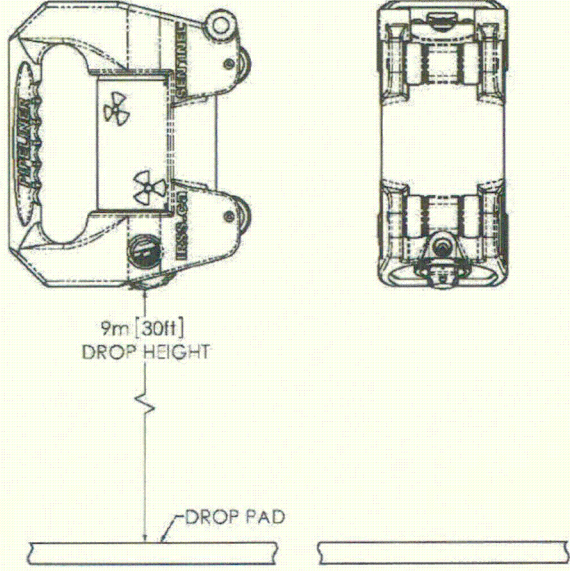
| Accident Conditions Test | Para. | Specimen | Diagram |
|---|---|---|--|
| 9m Drop 1. | 71.73(c)(1) | TP186(A) | <p>The diagram shows two views of a cylindrical specimen. The left view is a side cross-section showing internal components and a central vertical axis. The right view is a top-down view of the specimen. A vertical line with a zigzag break indicates a drop height of 9m [30ft] from the bottom of the specimen to a horizontal line labeled 'DROP PAD'.</p> |

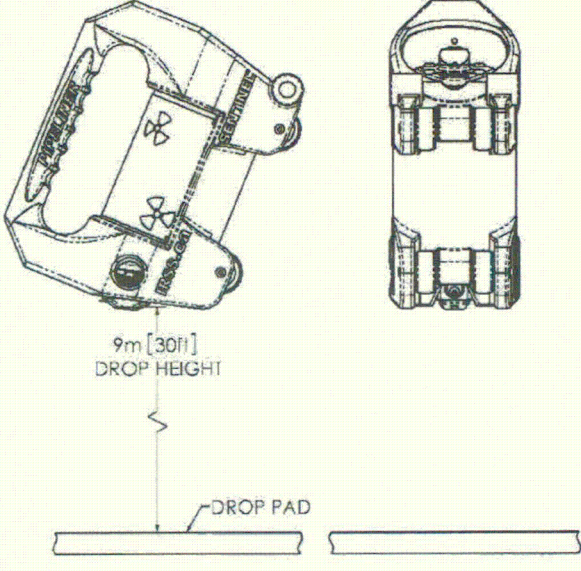
| 9m Drop 2. | 71.73(c)(1) | TP186(B) | <p>The diagram shows two views of a cylindrical specimen. The left view is a side cross-section showing the specimen tilted at an angle. The right view is a top-down view of the specimen. A vertical line with a zigzag break indicates a drop height of 9m [30ft] from the bottom of the specimen to a horizontal line labeled 'DROP PAD'.</p> |

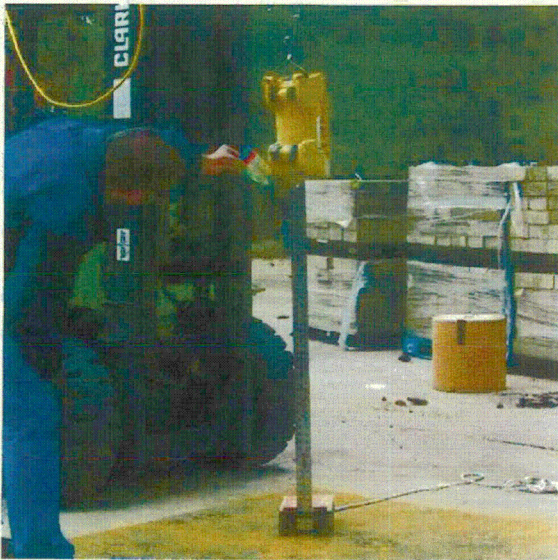
Initial setup for TP186A, 4' foot drop test, Pipeliner suspended from fork-truck over drop pad  
QSA Global 40 North Ave Burlington MA site and Post-drop damage.

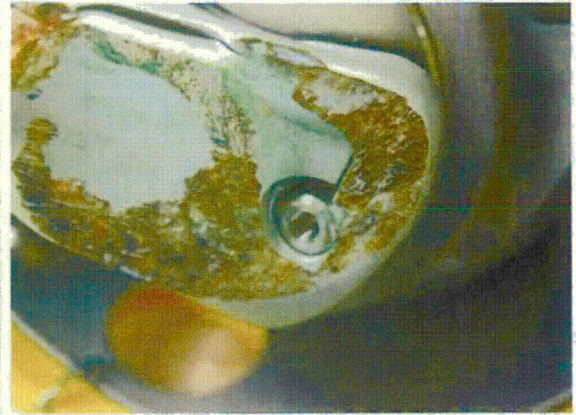
**Post drop showing damage to rear plate assembly**

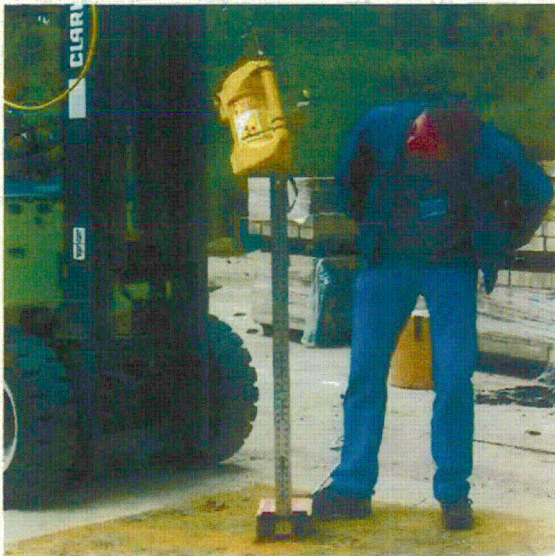
Initial setup for TP186B, 4' foot drop test, Pipeliner suspended from fork-truck over drop pad  
QSA Global 40 North Ave Burlington MA site and Post-drop damage.

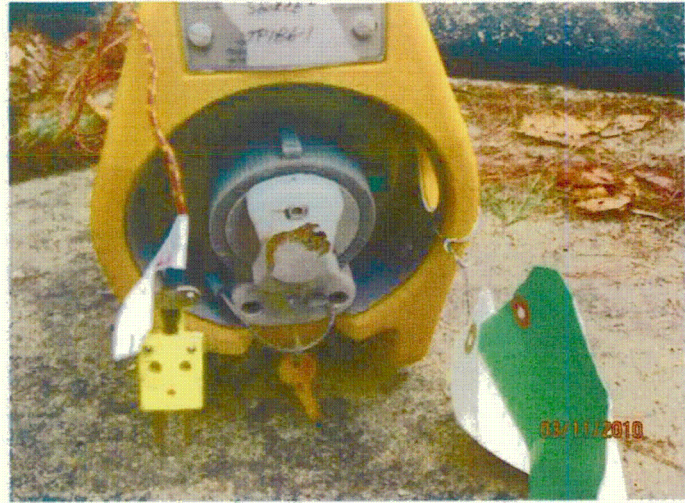
**Post drop showing damage to rear plate assembly**

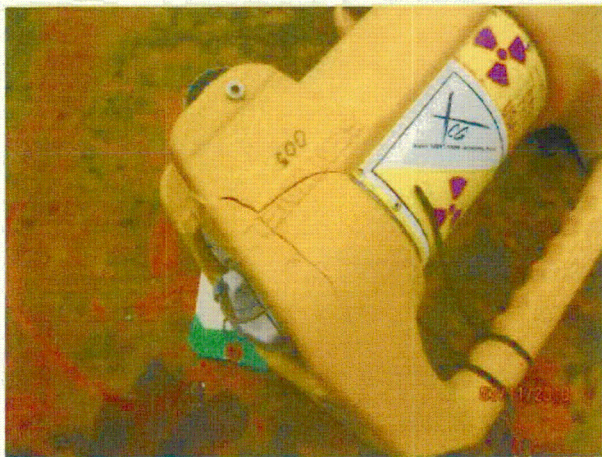
**Post drop showing cracks in jacket**

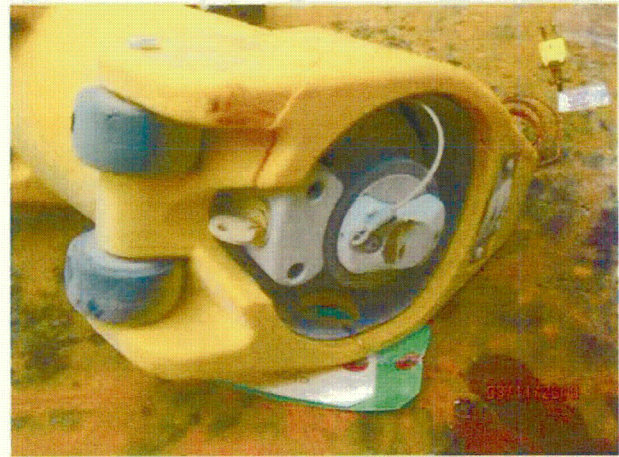
**Post drop showing overall damage to assembly**

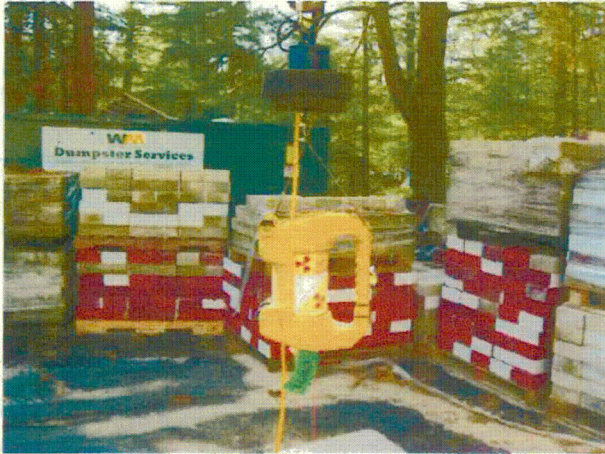
Initial setup for TP186A, 30' foot drop test, Pipeliner suspended from crane over drop pad  
QSA Global 40 North Ave Burlington MA site and Post-drop damage.

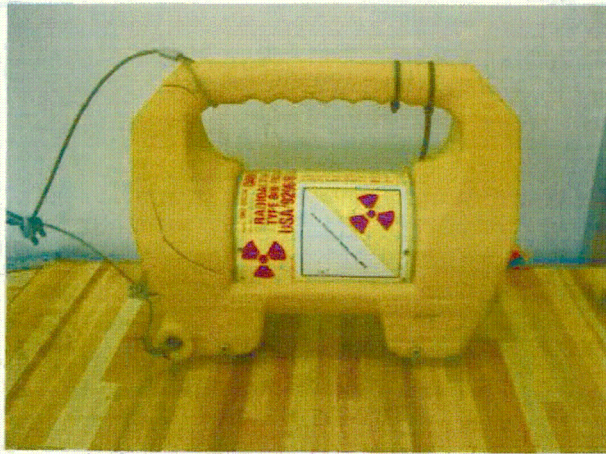
**Post drop showing cracks in jacket**

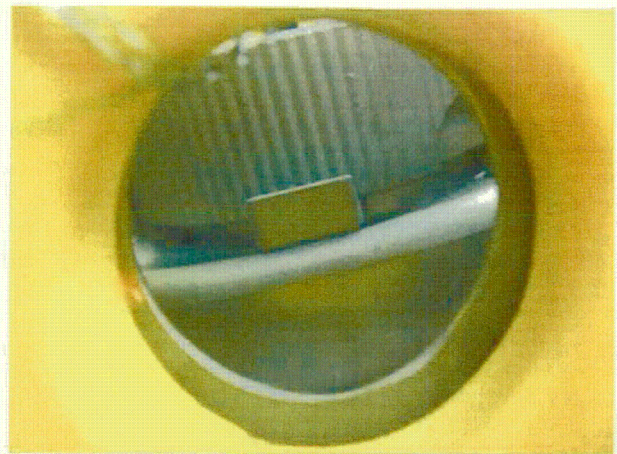
**Rear Plate PN 88021 bent in 1/8"**

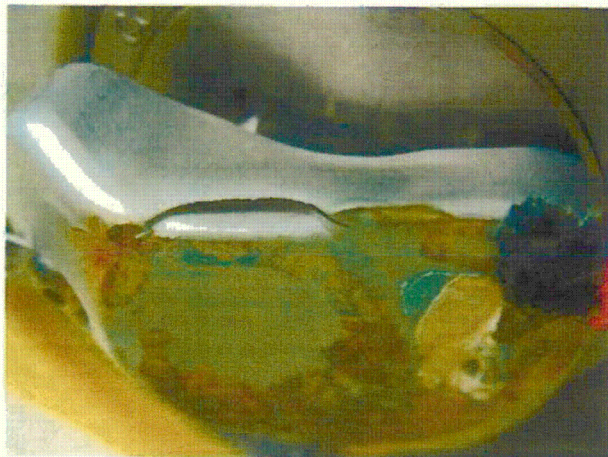
**Lock Cover PN 88023-1 Broken**

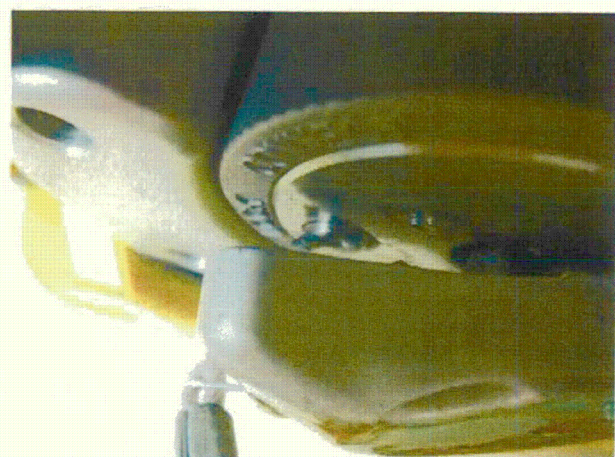
**Cover Pin PN 88023-2 Broken**

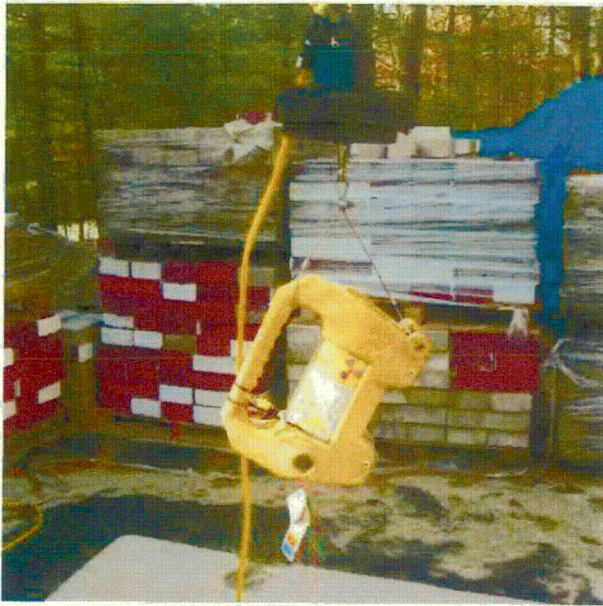
Initial setup for TP186B, 30' foot drop test, Pipeliner suspended from crane over drop pad  
QSA Global 40 North Ave Burlington MA site and Post-drop damage.

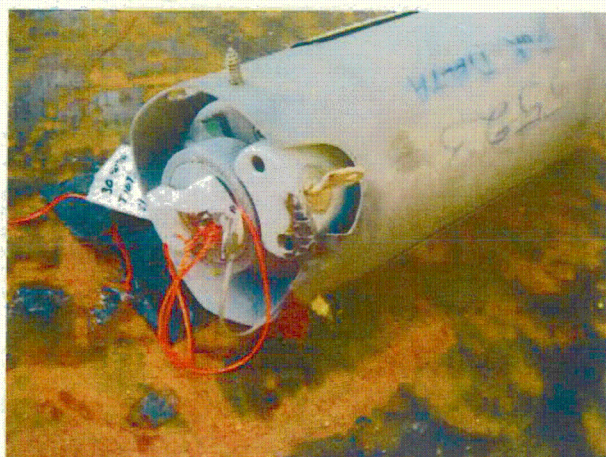
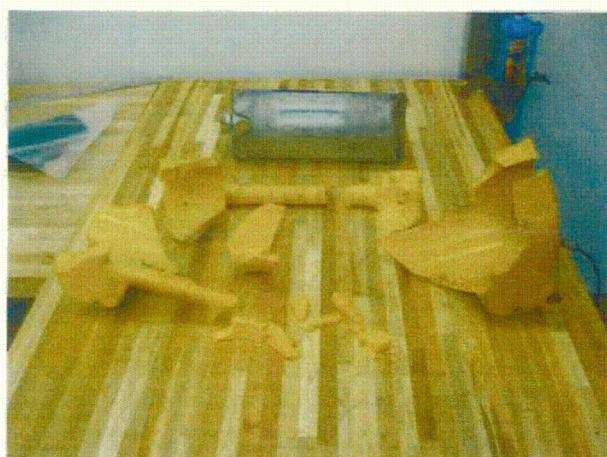
**Post drop showing damage to rear plate assembly    Post drop showing overall damage to assembly**

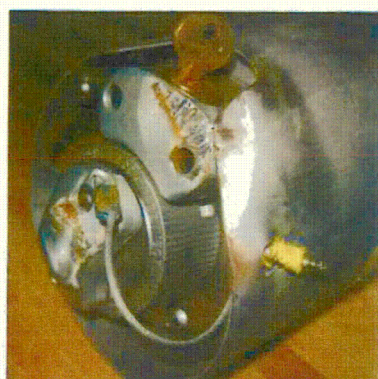
**Rear Plate assembly damage**

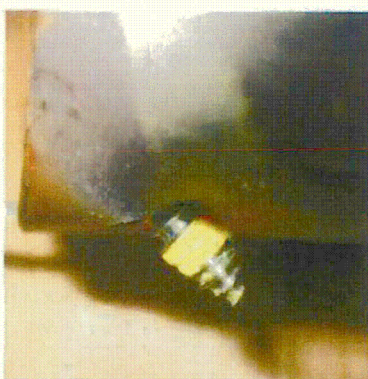
**Jacket mounting screw**

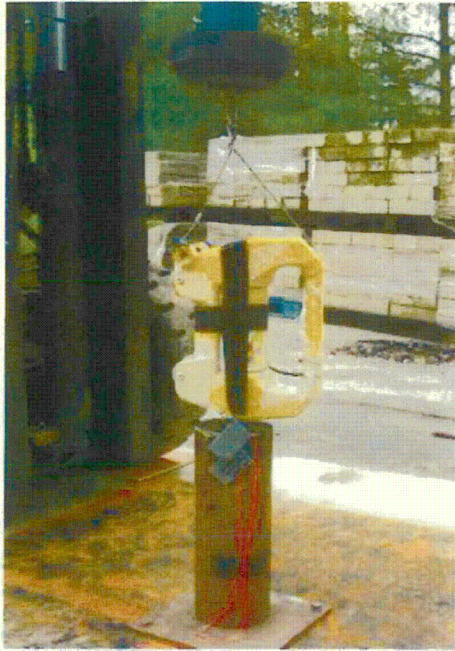
Initial setup for TP186A, 40 inch puncture test, Pipeliner suspended from fork-truck over drop pad  
QSA Global 40 North Ave Burlington MA site and Post-drop damage.

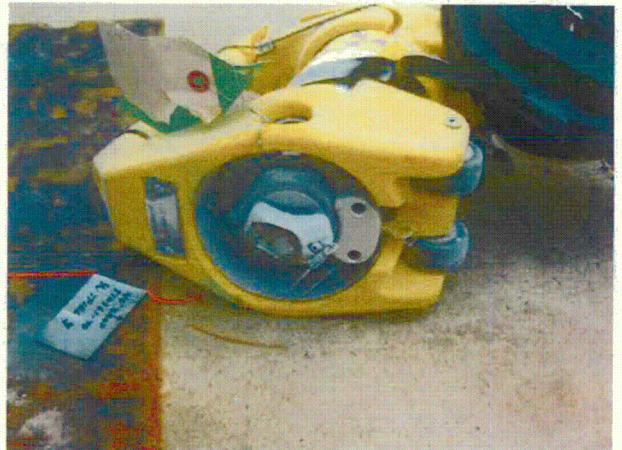
Post drop showing damage to rear plate assembly

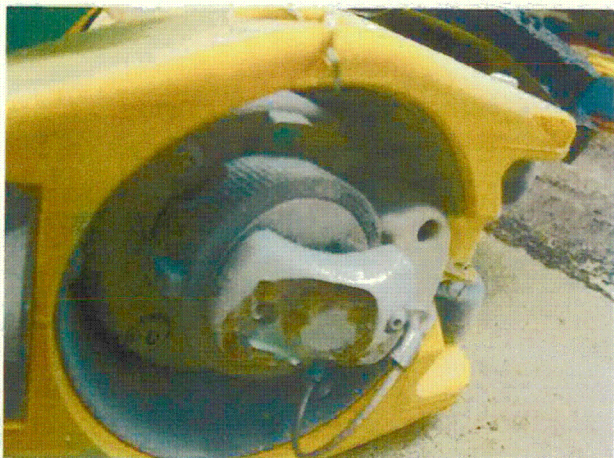
Post drop showing damage to rear plate assembly

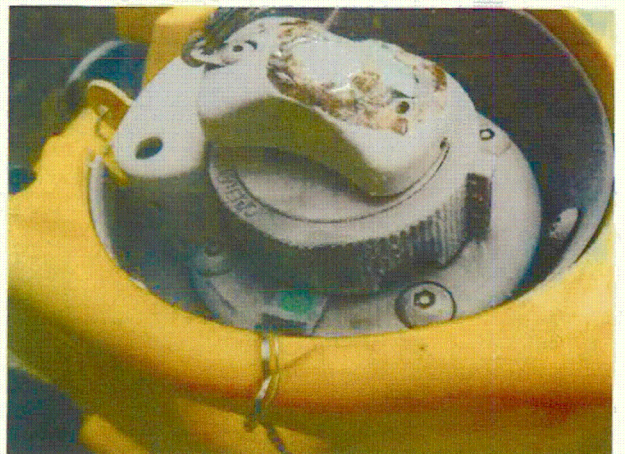
Post drop showing damage to rear plate assembly

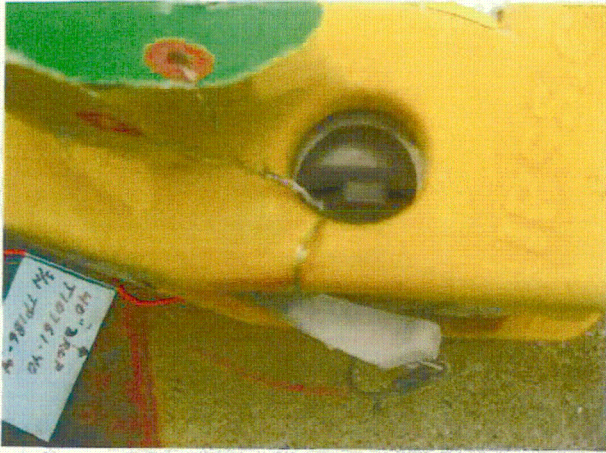
**Post drop showing damage to rear plate assembly**

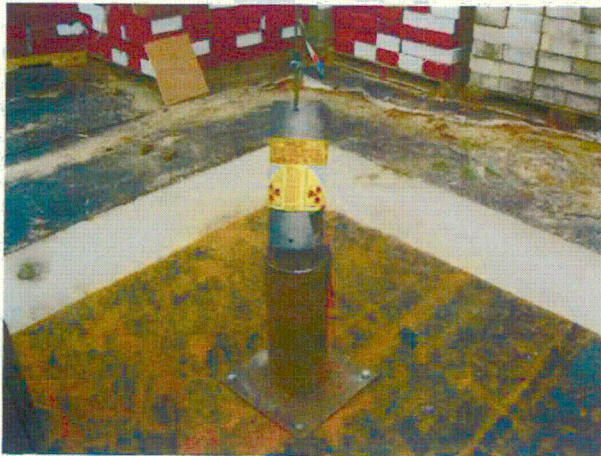
Test unit TP186B was not cooled for this test. The Pipeliner jacket assembly, the only component made from material not rated for  $-40^{\circ}$  F, was lost as a result of the previous test. As all other components of the device are rated for the full operational range of temperatures,  $-40^{\circ}$  F was no longer considered the worst case condition.

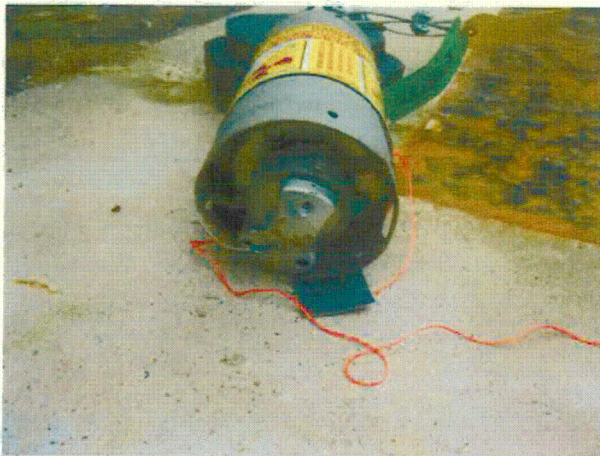
**Post drop showing damage to rear plate assembly**

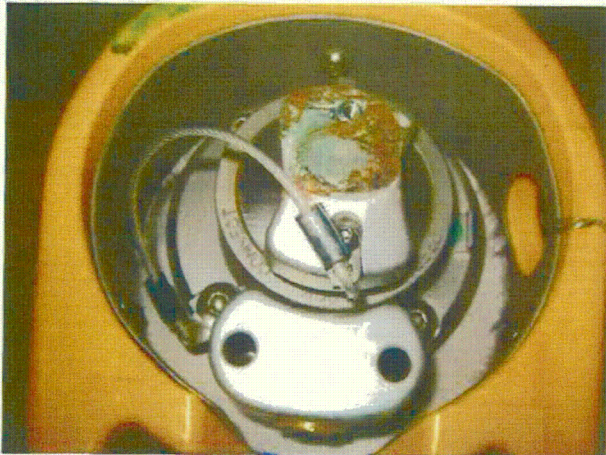
**Rear Plate assembly overall view**

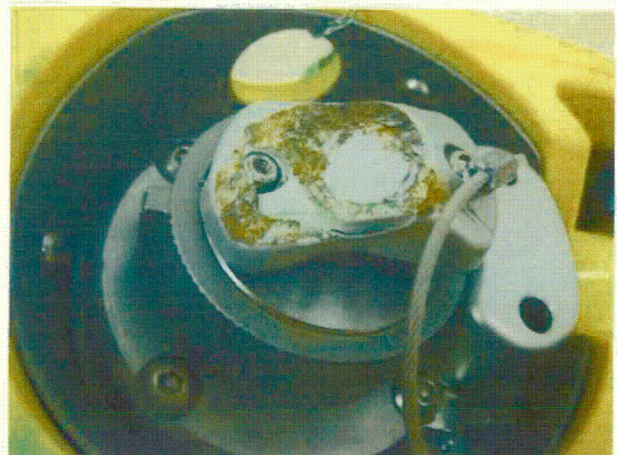
**Rear Plate assembly side view**

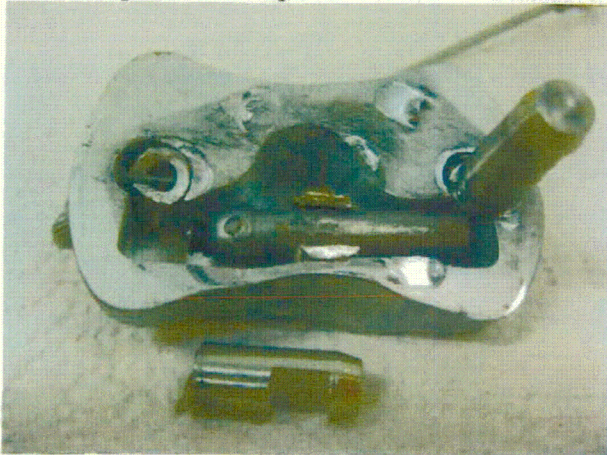
**Lock Cover assembly inside**

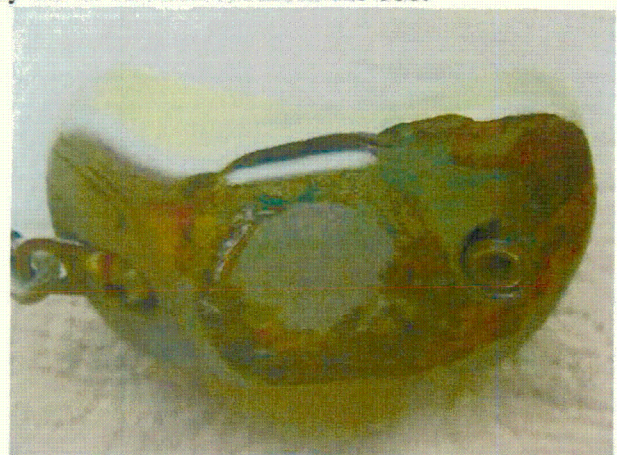
**Lock Cover assembly outside**

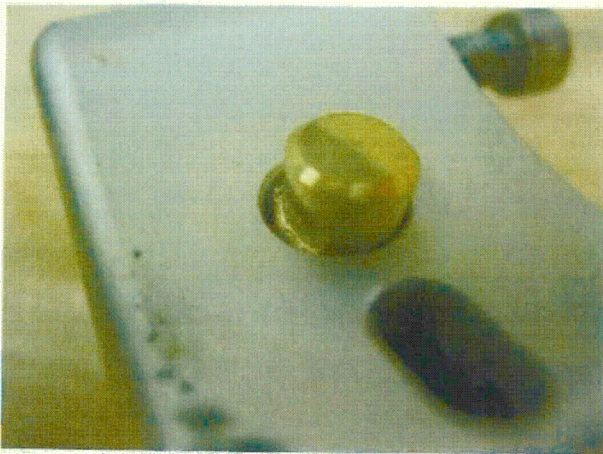
The lock cover was cracked, one screw was broken and one pin was broken. The pin mounting holes were deformed. The lock cover is an aluminum part designed to be sacrificial and protect the source connector and lock assembly.

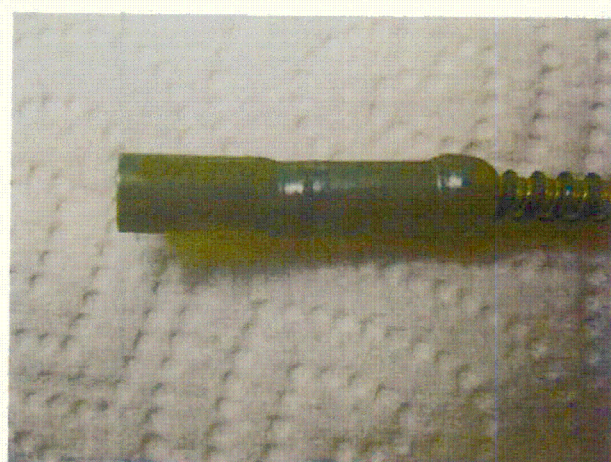
**Source Wire connector showing bend**

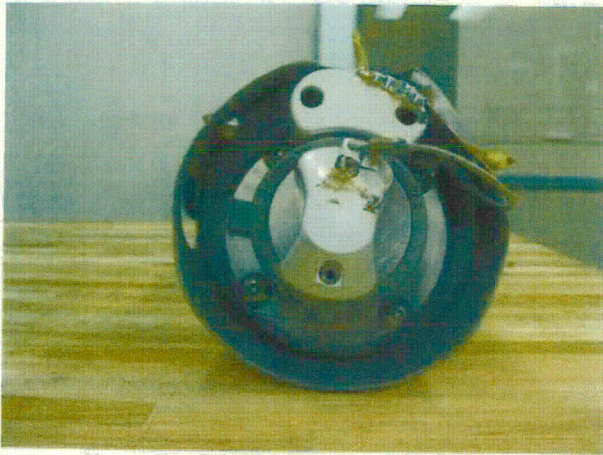
**Rear Plate assembly overall view**

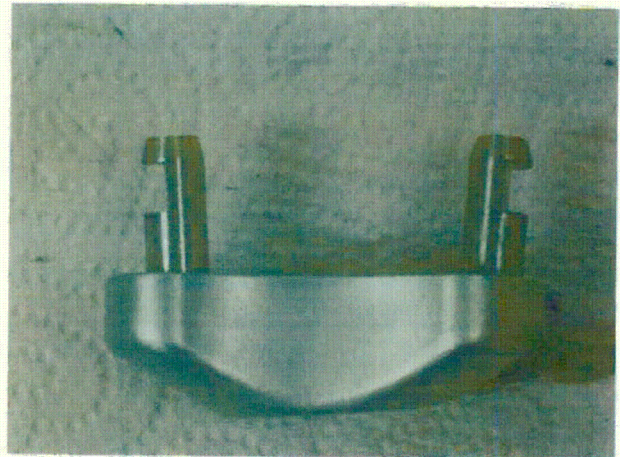
**Lock Cover assembly outside**

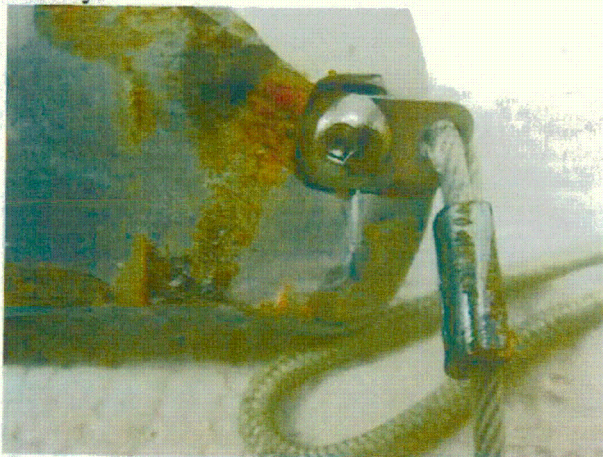
**Lock Cover assembly with crack at screw**

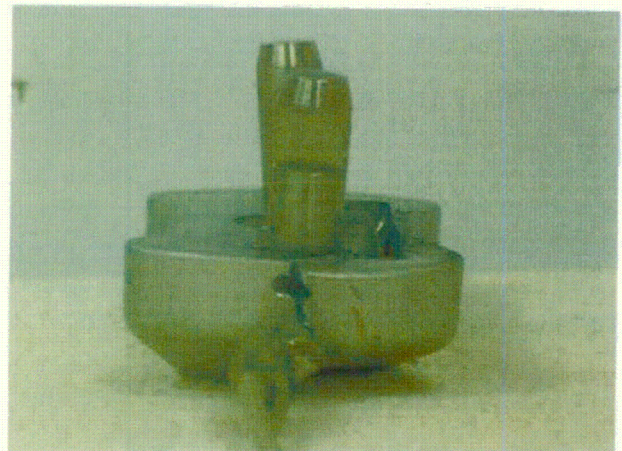
**Lock Cover assembly with crack at rollpin**
