Re: Oconee Nuclear Station
Docket Nos. 50-269, -270, -287

OCONEE NUCLEAR STATION
STEAM GENERATOR TUBE LEAK
STATUS REPORT

September 24, 1977

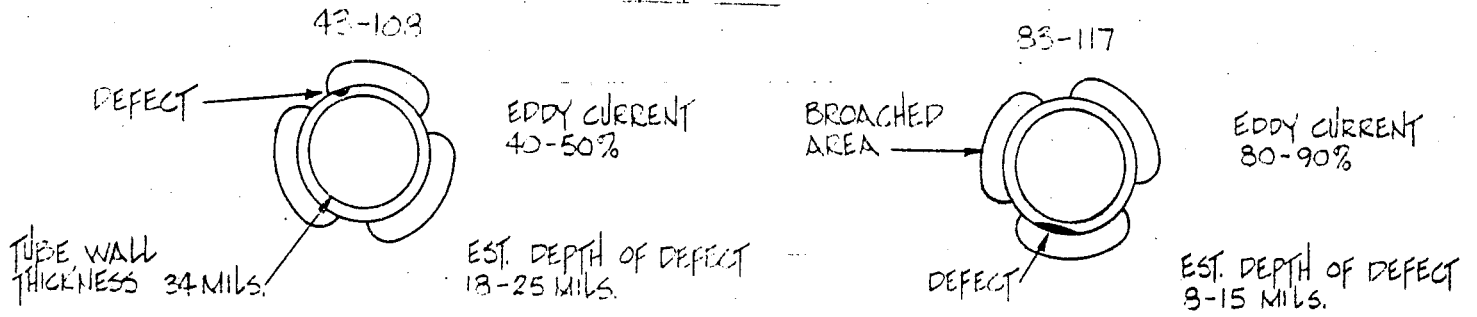
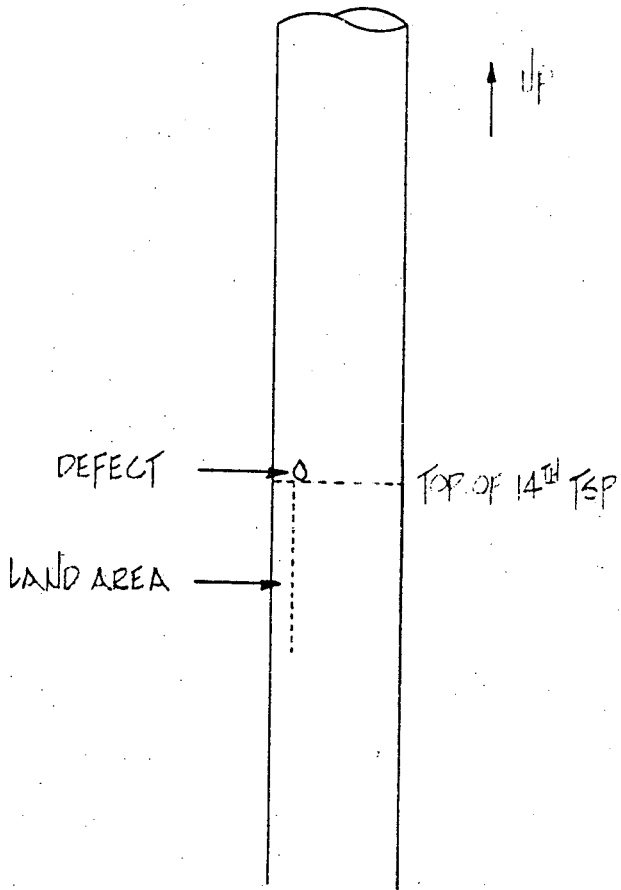
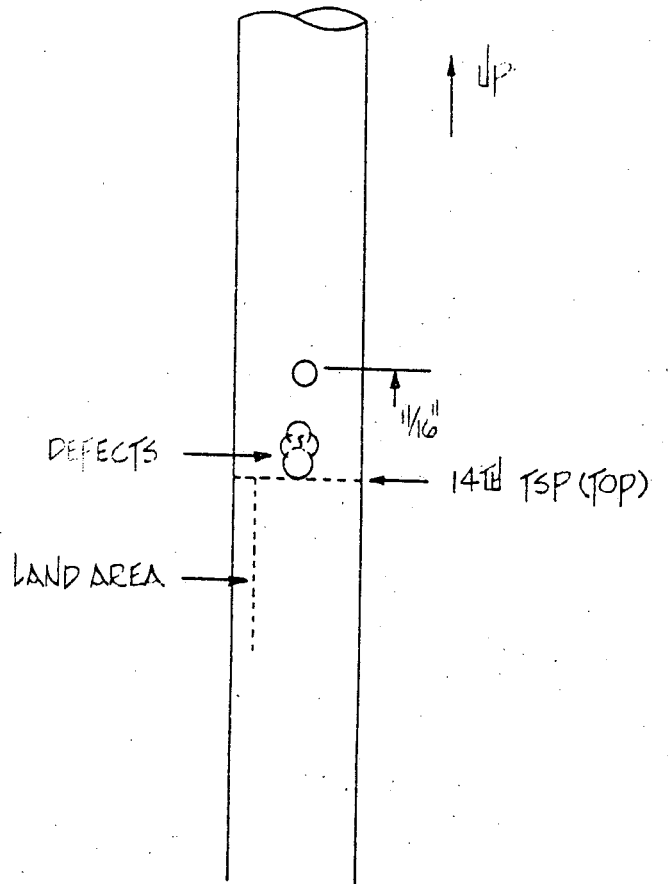
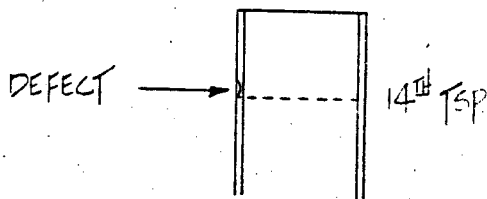
FIGURE 2

Due to the large number of defective eddy current indications, some of which indicated 90%-100% through wall, it was considered essential to obtain tube samples from the periphery for examination. A technique was developed and two tubes were removed and visually inspected on site, with detailed metallurgical analyses to be performed at a later date. The first tube removed was 43/108 which had an eddy current indication of 45-50% through wall at just above the 14th support plate. A visual inspection revealed an eroded area 1/8 inch long and 1/16 inch wide approximately .020 inches deep.

The second tube removed was 83/117 which had an eddy current indication of 80-90% through wall. This tube had erosion wear along a greater area approximately 1 inch long but appeared only to be about 0.010 inches deep. It appeared that the relatively large area of these defects caused the eddy current interpretation to be significantly overestimated. A diagram of these two defects is provided in Figure 2.
