Browns Ferry Nuclear Plant, Units 1, 2, and 3
Renewed Facility Operating License Nos. DPR-33, DPR-52, and DPR-68
NRC Docket No. 50-259, 50-260, and 50-296

Subject: **10 CFR 71.95 Notification Associated With the Failure to Observe Certificate of Compliance Condition of the 8-120B Secondary Lid Test Port Configuration**

Failure to Observe Certificate of Compliance Conditions for the 8-120B Secondary Lid Test Port Configuration

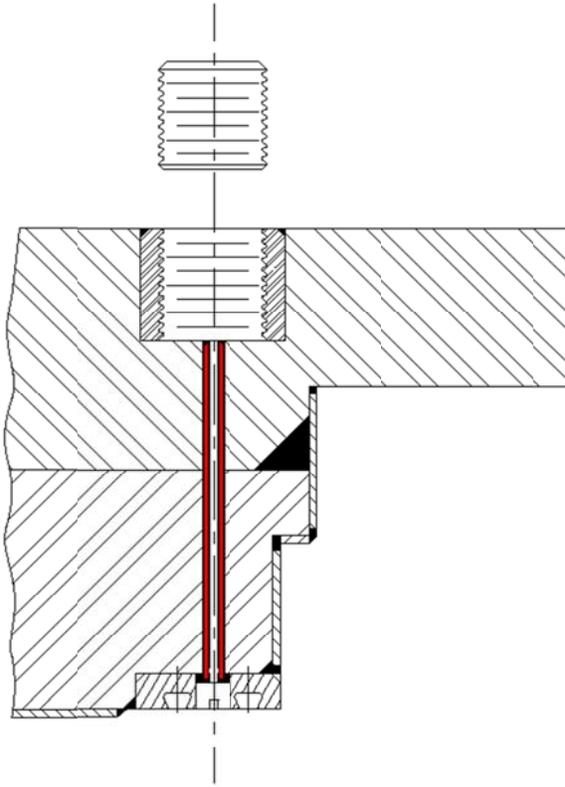
During a recent NRC inspection of EnergySolutions' facility in Columbia, SC, the inspection team identified that the secondary lids of four 8-120B casks¹ did not comply with the approved SAR drawings referenced by the latest revision of the Certificate of Compliance 9168 (CoC). The secondary lids on the subject casks were fabricated with a cladding tube inside the test port hole, but the tube is not shown on the SAR drawing referenced by the CoC. The conditions of approval in the CoC were therefore not observed for any shipments of Type B quantities of radioactive material made using the subject secondary lids. Attachment 1 illustrates the secondary lid test port and tube configurations.

The purpose of the secondary lid test port tube is to isolate the pre-shipment test volume from the interspace between the two 3 1/4" thick plates that make up the secondary lid. The isolation of the test volume provided by the tube assures that the test volume does not exceed the limit on which the hold time for the pre-shipment leak rate test is based. However, if the free volume in the interspace between the plates is negligible, then the isolation function of the tube is not necessary.

The presence of the tubes in the subject secondary lid test ports has no safety consequence because the as-built test volume meets the basis for the pre-shipment leak rate test hold time.

Secondary Lid Test Port
with Cladding Tube
(subject secondary lids)

- *EnergySolutions* has removed 8-120B casks with the secondary lids that have the tube installed in the test port (i.e., secondary lid numbers 8-120B-5, -6, -7, and -8) from service until authorized to resume their use.

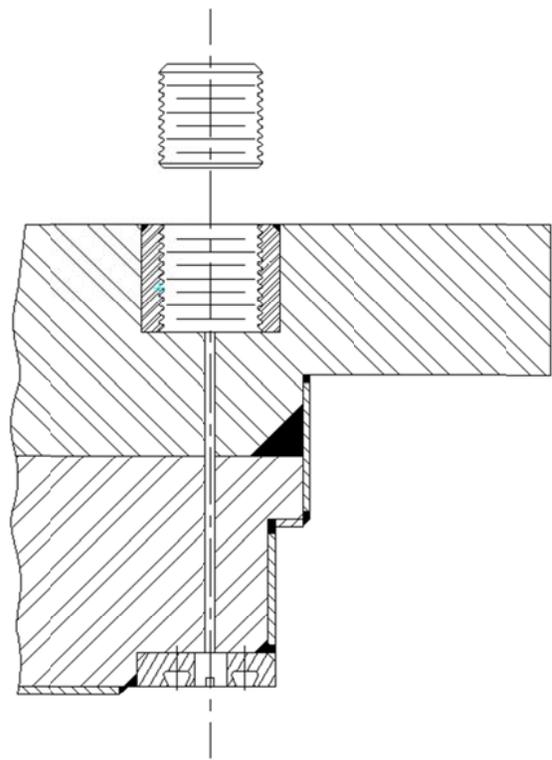
The tube was shown as a design feature in the 8-120B SAR drawings referenced by Revision 17 of the CoC, and previous revisions, but the tube was not credited with any safety function in the SAR. The tube was inadvertently omitted when the lids were redesigned for operational enhancements in CoC Revision 19. The omission was identified by EnergySolutions' corrective action system while the subject lids were still in fabrication. A corrective action was assigned to measure the as-built test volumes, which included the void space between the thick plates since there were no tubes installed. The test volumes were found to exceed the volume basis for pre-shipment leak rate test hold time calculated in the SAR. The tubes were therefore installed, and the lids were placed on QA-hold using EnergySolutions' noncompliance procedure because they did not meet the lid configuration authorized by the CoC in effect at that time (i.e., CoC, Rev. 20). EnergySolutions subsequently made a determination that prior NRC authorization was not required (because the tubes had been part of the previous NRC-approved 8-120B cask design and were inadvertently omitted from the new secondary lid design), cleared the hold, and released the lids for use. The tubes were restored to the SAR drawings as part of a broader license amendment request submitted in May 2014, but the request was withdrawn for unrelated reasons. A new license amendment request submitted to the NRC on 9/16/2015 reintroduces the tubes to the secondary lid design.

Secondary Lid Test Port
without Cladding Tube
(current CoC configuration)
