DUKE POWER COMPANY
OCONEE NUCLEAR STATION
UNIT 1

REACTOR COOLANT SYSTEM INCIDENT REPORT

DOCKET NO. 50-269

APRIL 4, 1972

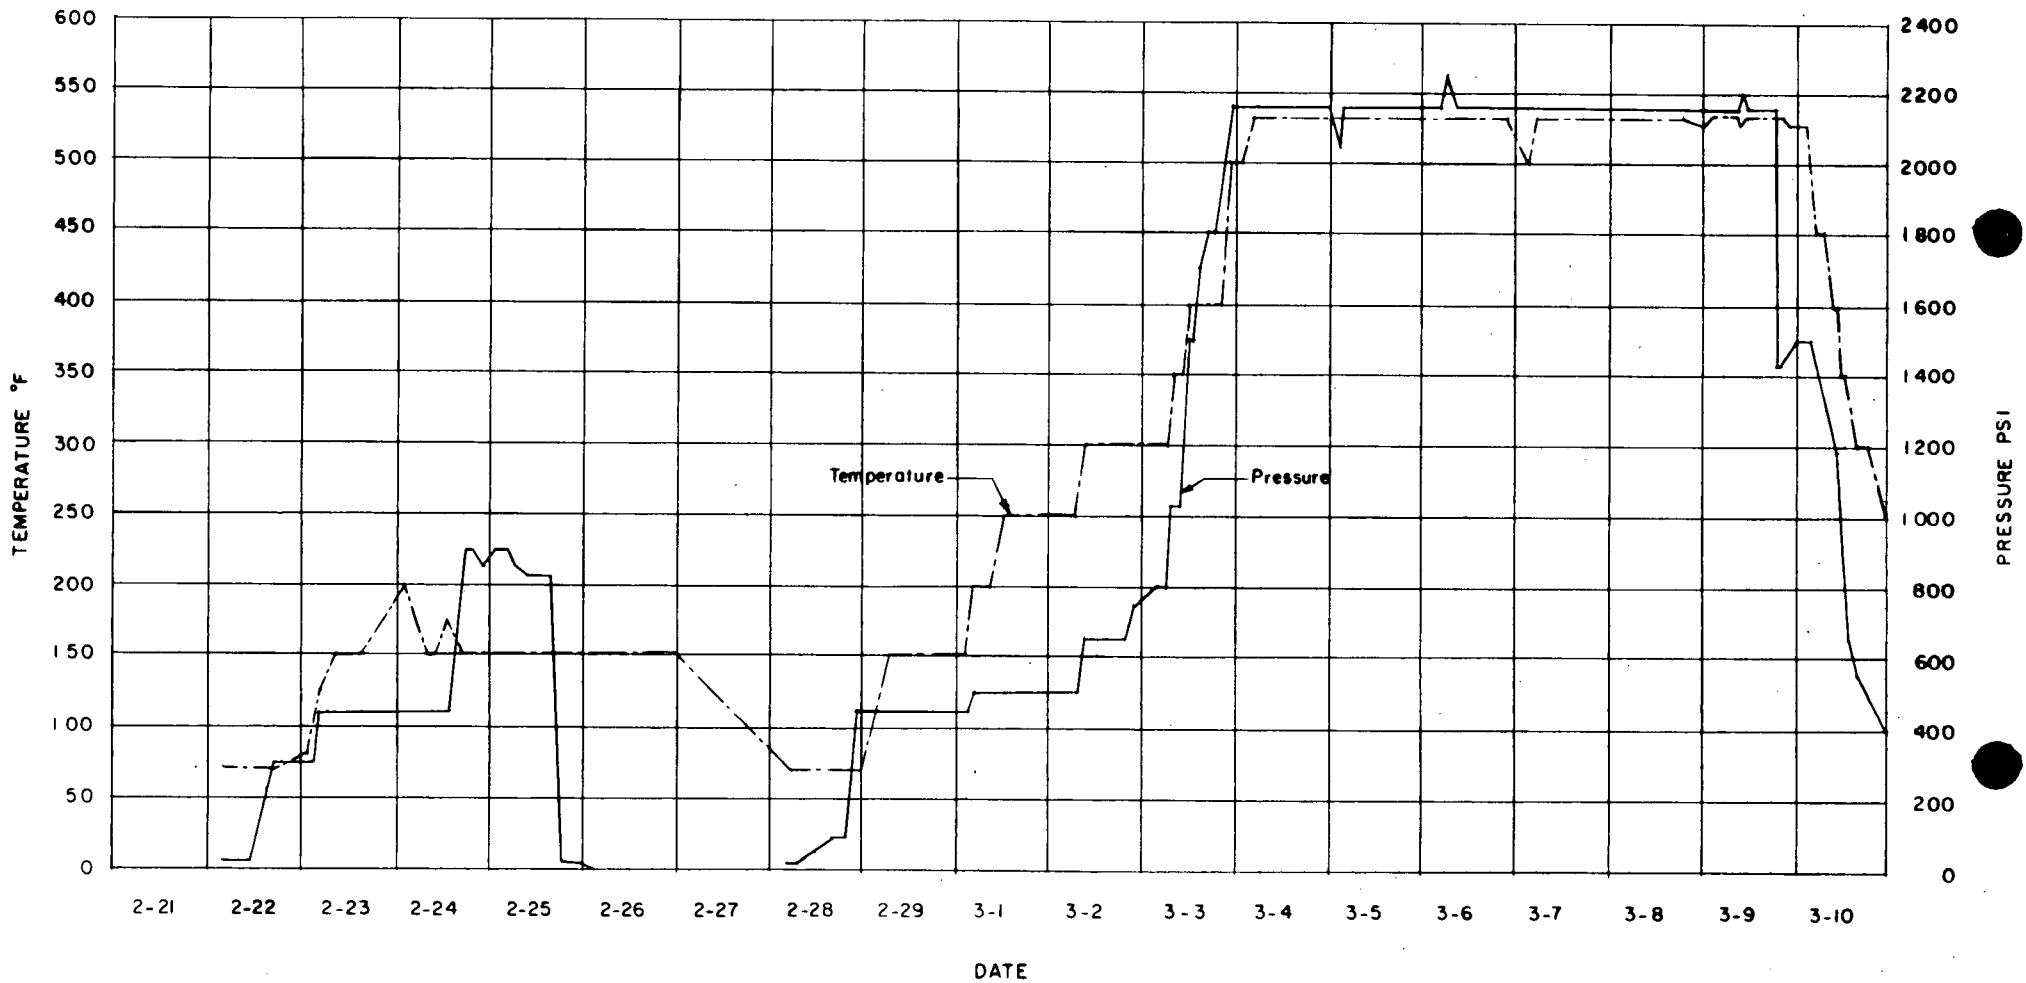
FIGURE 1

This section of the report presents a chronological sequence of events which are pertinent to the observed reactor coolant system damage, as derived from shiftlogs and discussions with test and operating personnel. In addition, a plot, Figure 1, is presented of the temperature and pressure during the first phase of the hot functional test from February 21 through March 10, 1972.

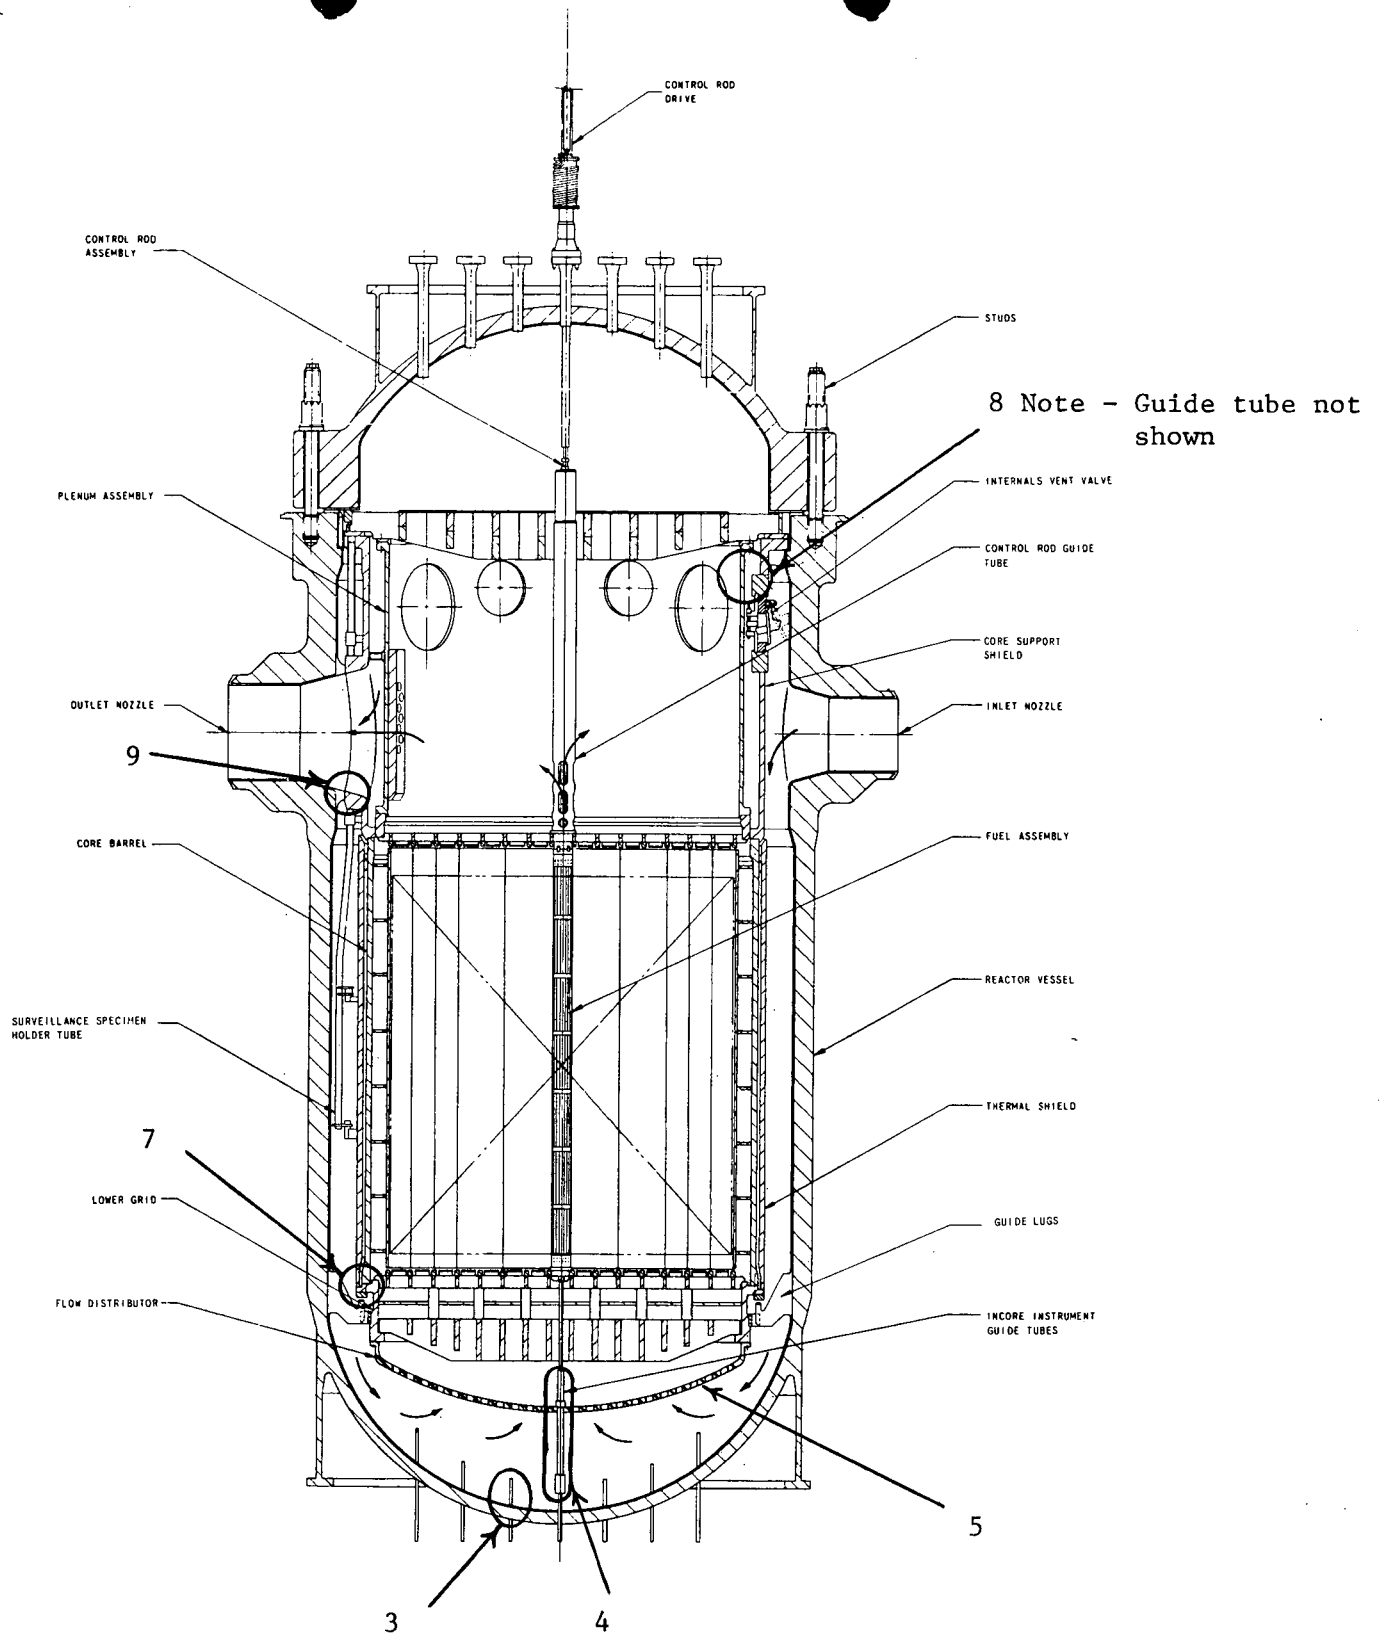
Figure 2

Inspection of the reactor coolant system revealed the following damage as of March 30, 1972: (Figure 2 illustrates the location of the damage for numbers 3, 4, 5, 7, 8, and 9 below)

3. Twenty-one 3/4" diameter incore instrument nozzles were broken off. Fourteen additional nozzles were cracked in the region above the weld. Seventeen nozzles showed no cracks.

4. Four incore instrument guide tube extensions were broken off below the lower flow distributor and their four spider assemblies were dislocated. One of these was also broken above the distributor. Four additional guide tubes were cracked in the region of the weld below the flow distributor. Forty-four tubes showed no cracks.

5. There are nicks and scratches on the lower flow distributor.
6. Nicks and impact marks were observed on the flow guide vanes and the bottom of the reactor vessel.

7. At the mating surfaces between the thermal shield and the lower grid assembly, some metal upset at the edges was observed. The retention weld on all eight dowels at the lower edge of the thermal shield were broken and one of the dowels had backed out approximately 3/4".

8. Two of six installed 1/2" diameter thermocouple guide tubes were broken off of the upper plenum assembly.
9. There are minor scratches on the face seal between the reactor vessel 36" outlet nozzle and the core support shield.

Repairs are underway on the OTSG "B" using approved factory repair procedures while on OTSG "A" investigation of damage and development of repair procedures continues.

An orderly investigation will determine the cause of the failures in the reactor vessel and will establish the basis for appropriate re-design and repairs. Approved procedures will be used during the investigations and repair work.
