DUKE POWER COMPANY
OCONEE NUCLEAR STATION
UNIT 1

REACTOR COOLANT SYSTEM INCIDENT REPORT

DOCKET NO. 50-269

APRIL 4, 1972

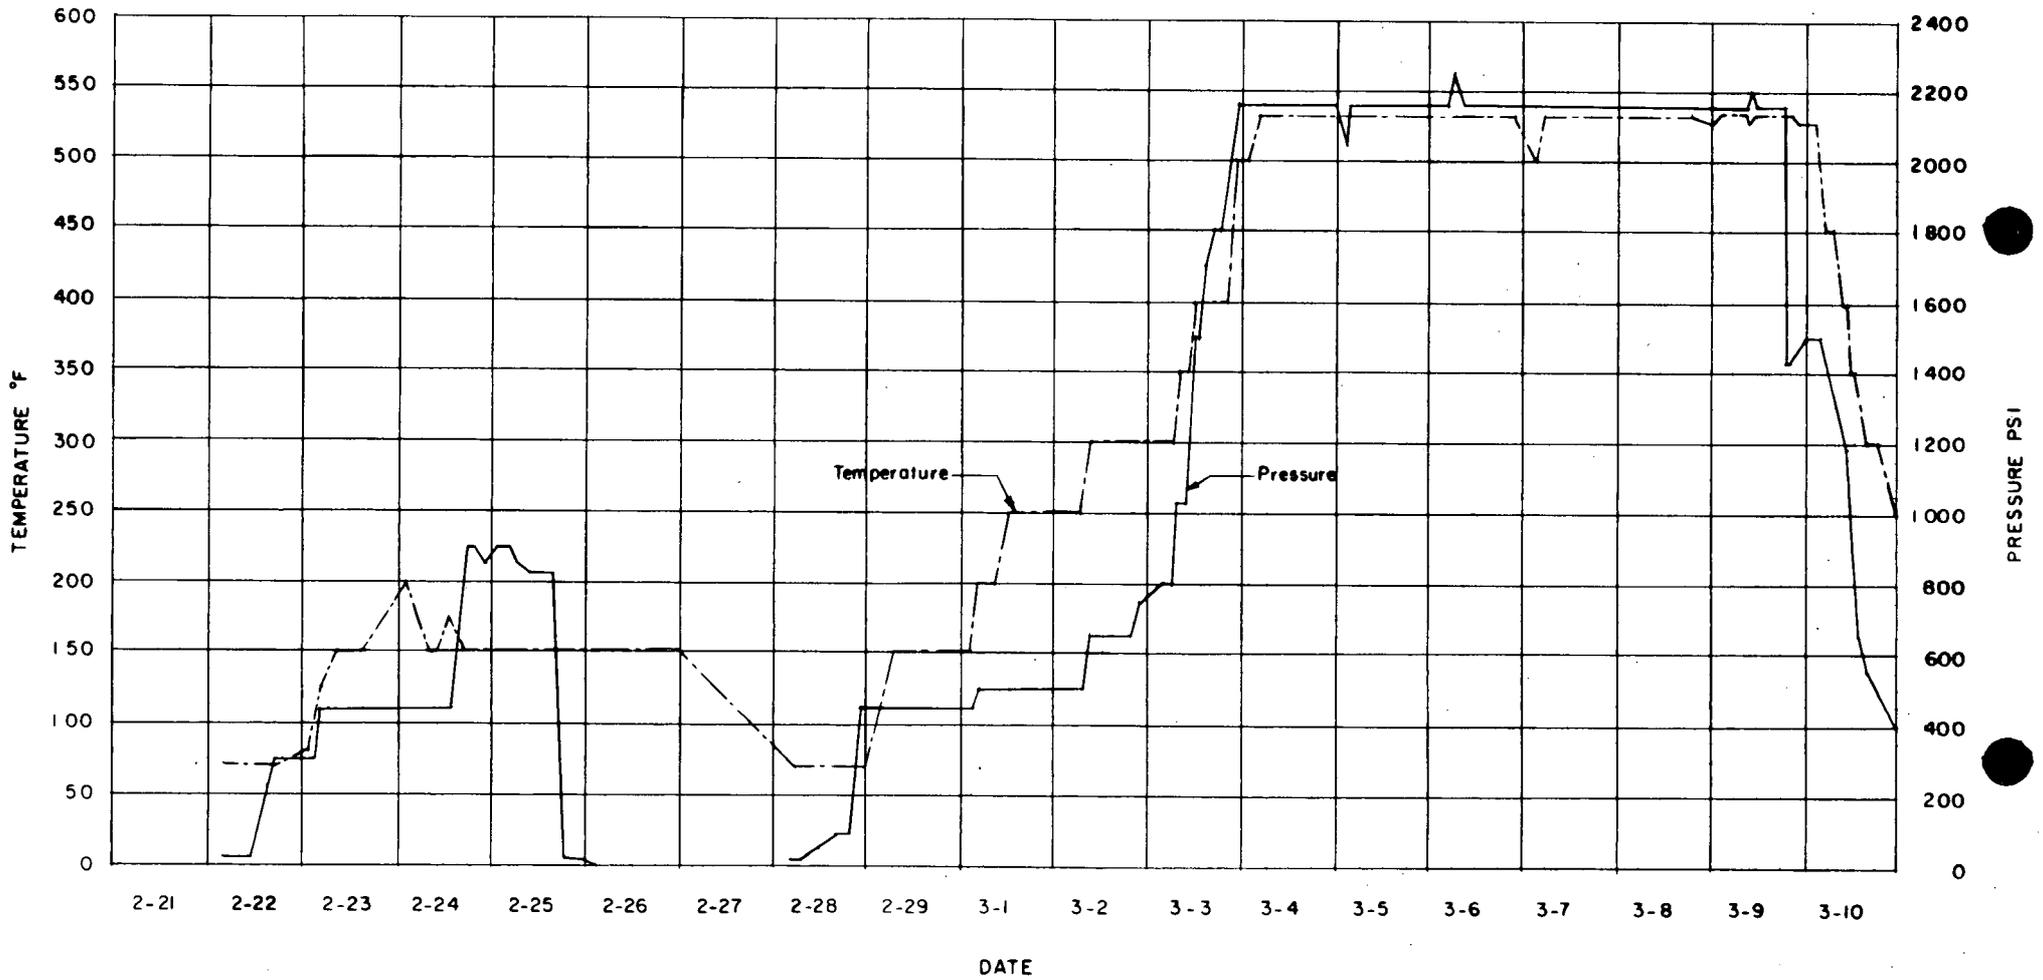
FIGURE 1

This section of the report presents a chronological sequence of events which are pertinent to the observed reactor coolant system damage, as derived from shiftlogs and discussions with test and operating personnel. In addition, a plot, Figure 1, is presented of the temperature and pressure during the first phase of the hot functional test from February 21 through March 10, 1972.

1. On March 3, 1972, a noise was heard on the "A" loop side of the reactor coolant system at a temperature of approximately 350°F. No noise was heard on the "B" loop side. The noise stopped when both "A" loop reactor coolant pumps were secured. Also on March 3, 1972, the signal from accelerometer SN104 located in the thermocouple guide tube began to show 60 Hz noise, indicating an open lead. B&W project management personnel were notified and arrangements were made for B&W engineering personnel to visit the station the next day. *why not stop*

2. On March 4, 1972, heat up from 500°F to 532°F was started. The noise level was approximately the same as observed on March 3. Of 60 temporary thermocouples installed in the once-through steam generator "B" (OTSG "B"), two now showed a slight divergence reading. Representatives of B&W engineering arrived at the site to monitor the noise levels in OTSG "A". Opinions varied among the observers as to whether the noise was louder at the top or bottom of the steam generator, but were consistent in locating the source of the noise within the OTSG "A". *subsonic in top of S/C*

6. On March 8, 9, and 10, the noise levels in OTSG "A" were essentially the same as observed on March 5 and 6. No specific conclusion could be reached regarding the source of the noise. OTSG "B" was checked frequently from March 3 through 10 and no noise was heard.

7. On March 10, 1972, the first phase of hot functional testing had been completed and the reactor coolant system was cooled down to 250°F and pressure reduced approximately 400 psig. The reactor coolant system was depressurized and drained on March 11 and 12. On March 13, 1972, the upper manway on OTSG "A" was opened and metallic objects of various shapes were seen on the tube sheet. The upper manway on OTSG "B" was also opened and inspection revealed approximately one-half of the temporary thermocouple conduit (which is part of the first-of-a-kind instrumentation for OTSG testing) was dislocated and four pieces of metallic tubular material were seen on top of the tube sheet.

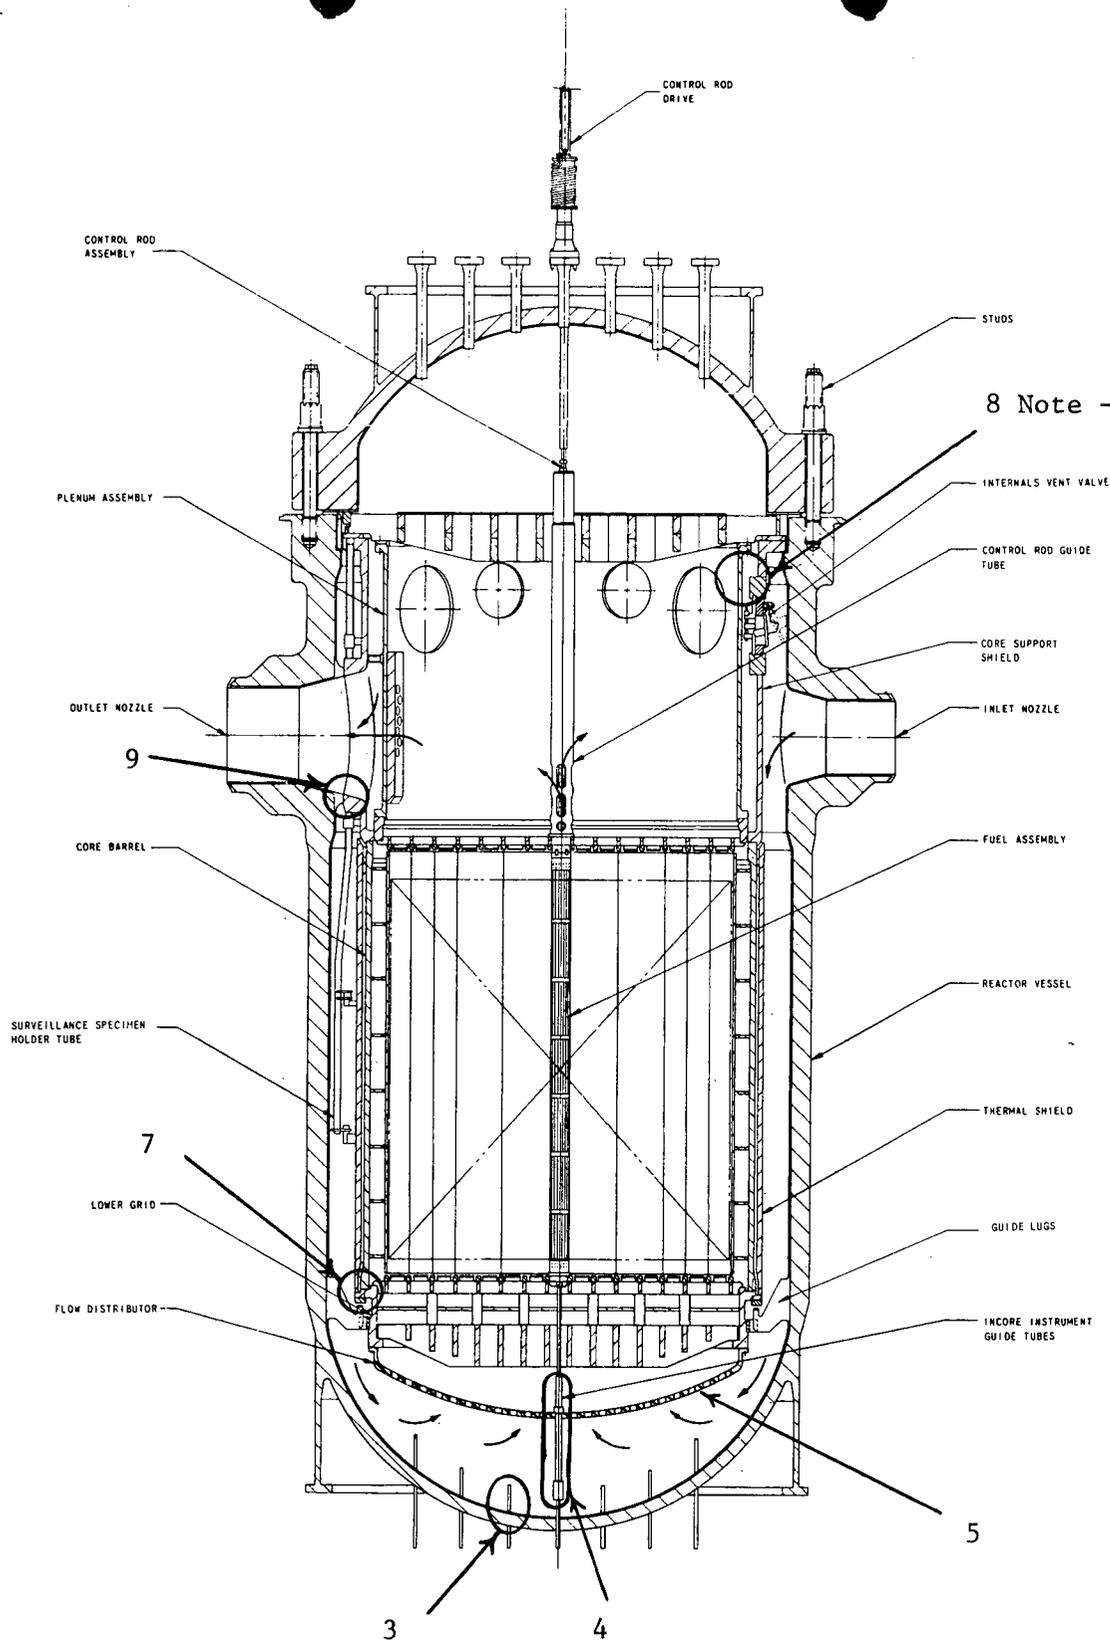
Figure 2

Inspection of the reactor coolant system revealed the following damage as of March 30, 1972: (Figure 2 illustrates the location of the damage for numbers 3, 4, 5, 7, 8, and 9 below)

3. Twenty-one 3/4" diameter incore instrument nozzles were broken off. Fourteen additional nozzles were cracked in the region above the weld. Seventeen nozzles showed no cracks.

4. Four incore instrument guide tube extensions were broken off below the lower flow distributor and their four spider assemblies were dislocated. One of these was also broken above the distributor. Four additional guide tubes were cracked in the region of the weld below the flow distributor. Forty-four tubes showed no cracks.

5. There are nicks and scratches on the lower flow distributor.
6. Nicks and impact marks were observed on the flow guide vanes and the bottom of the reactor vessel.

7. At the mating surfaces between the thermal shield and the lower grid assembly, some metal upset at the edges was observed. The retention weld on all eight dowels at the lower edge of the thermal shield were broken and one of the dowels had backed out approximately 3/4".

8. Two of six installed 1/2" diameter thermocouple guide tubes were broken off of the upper plenum assembly.
9. There are minor scratches on the face seal between the reactor vessel 36" outlet nozzle and the core support shield.

Repairs are underway on the OTSG "B" using approved factory repair procedures while on OTSG "A" investigation of damage and development of repair procedures continues.

An orderly investigation will determine the cause of the failures in the reactor vessel and will establish the basis for appropriate re-design and repairs. Approved procedures will be used during the investigations and repair work.
