**ENCLOSURES:**  
REPORT: March 6, 1973, 1A1 Reactor Coolant Pump Oil Fire Incident Report, dtd 5-4-73 for the Oconee Nuclear Station Unit 1.

**PLANT NAMES:** Oconee Nuclear Station Unit 1

DUKE POWER COMPANY  
OCONEE NUCLEAR STATION  
MARCH 6, 1973, 1A1 REACTOR COOLANT PUMP OIL FIRE  
INCIDENT REPORT

May 4, 1973

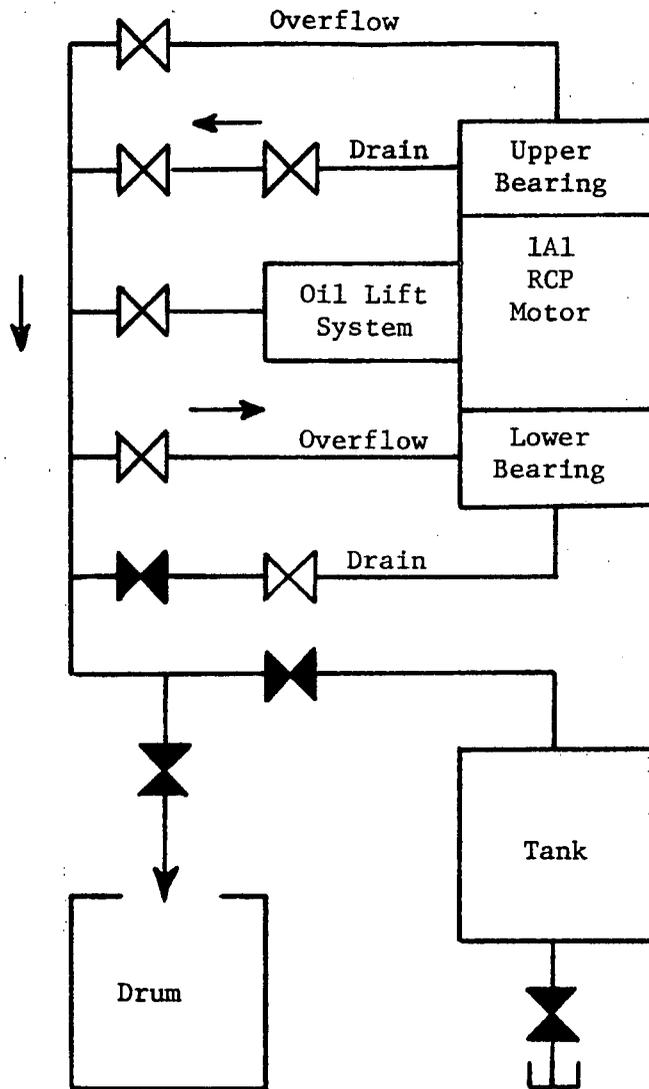
Figure 1

05:15-05:55  
(Approximate) Maintenance personnel commenced activities associated with the draining of oil from the upper bearing of the 1A1 reactor coolant pump motor. In the process of establishing flow from the upper bearing drain to a drum located in the reactor building basement a small quantity of oil leaked from a drain hose fitting and the oil drain line drain valve was closed to prevent further leakage. It was decided that before proceeding with draining of oil from the upper bearing that the oil on the reactor building floor should be wiped up to prevent it from entering the floor drains. The valve line-up which existed at this time is shown in Figure 1, and it can be seen that oil draining from the upper bearing was now entering the lower bearing via the lower bearing overflow line.

1A1 REACTOR COOLANT PUMP MOTOR DRAIN AND OVERFLOW SYSTEM  
As of 05:55 March 6, 1973

The operability of the motor oil lift system was not affected by the fire. However, the polyvinyl chloride (PVC) jackets on the oil lift system power cables sustained some damage and it was decided to replace these cables. To prevent a recurrence of a similar incident it was recommended that the reactor coolant pump motor drain and overflow system be revised.

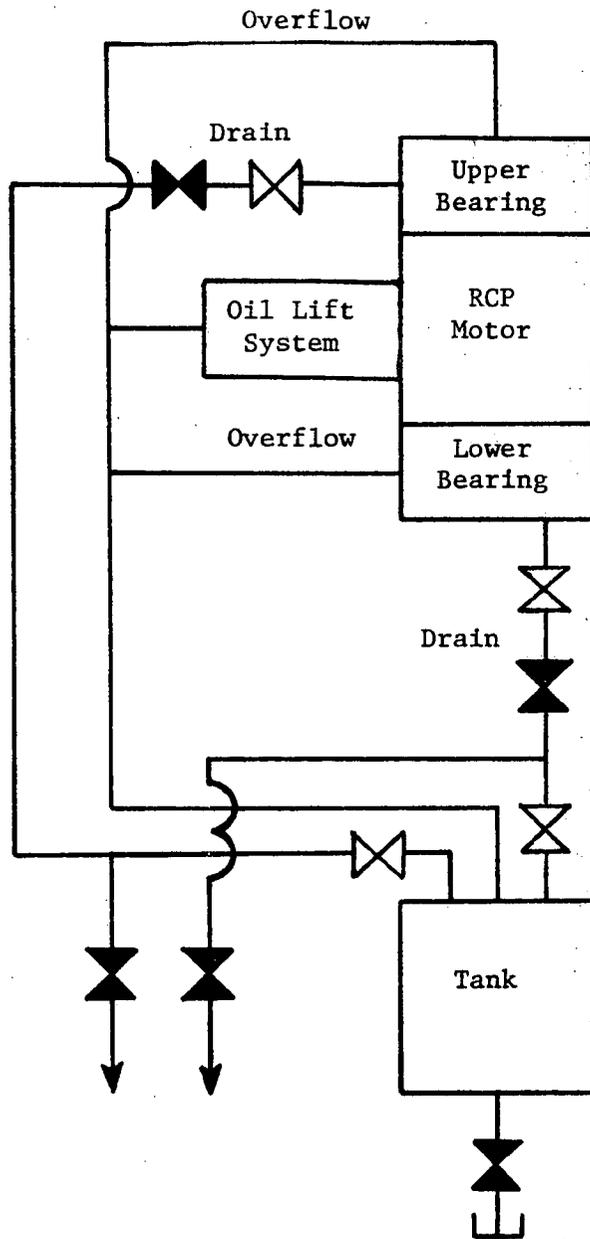
Figure 2

REVISED REACTOR COOLANT PUMP MOTOR DRAIN AND OVERFLOW SYSTEM  
(Typical)

The reactor coolant pump motor was moved from the reactor building and damaged wiring and components were removed. The motor was thoroughly cleaned with a solution of detergent and water, followed by a demineralized water rinse. All external surfaces and appropriate internal surfaces of the motor were repainted. New wiring and components were installed to replace those which had been removed. The replacement wiring was electrically checked prior to reinstalling the motor. The motor main power leads and oil lift pump system power cables were replaced and electrically checked before being reconnected for operation. The motor drain and overflow system was revised in order to prevent a recurrence of a similar incident - refer to Figure 2.
