Re: Oconee Unit 1
Docket No. 50-269

DUKE POWER COMPANY
OCONEE UNIT 1

Report No.: AO-269/75-3

Identification of Occurrence: Defects in a fuel rod of Spent Fuel Assembly
1A10

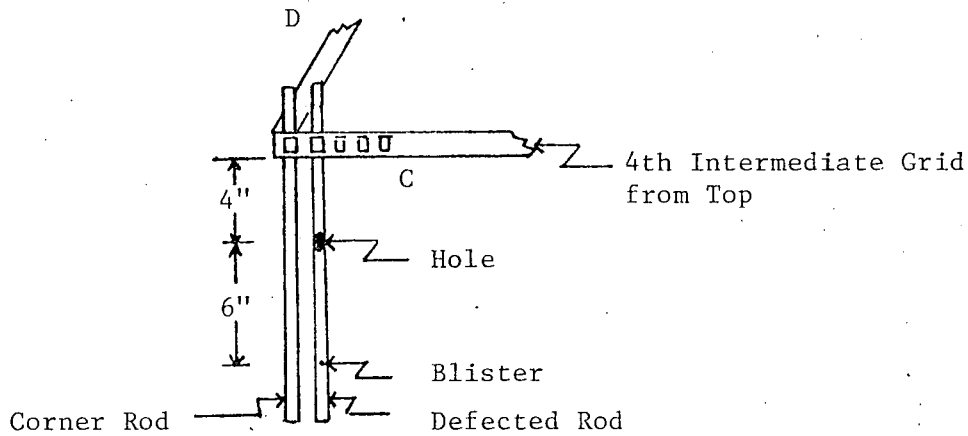
FIGURE 1

The defected fuel rod, a peripheral rod of Fuel Assembly 1A10, has two defects located between the fourth and fifth intermediate spacer grids (see Figure 1). One defect is in the form of a hole in the cladding (approximately $\frac{1}{2}$ " in diameter), and the other in the form of a small blister. The defected fuel rod did not show any gross outward bow, and no abnormalities were seen in any other fuel rods of the entire fuel assembly during visual examination. Visual examinations were not able to confirm the presence of fuel at the location of the main perforation.

Location of Defects in Spent Fuel Assembly 1A10

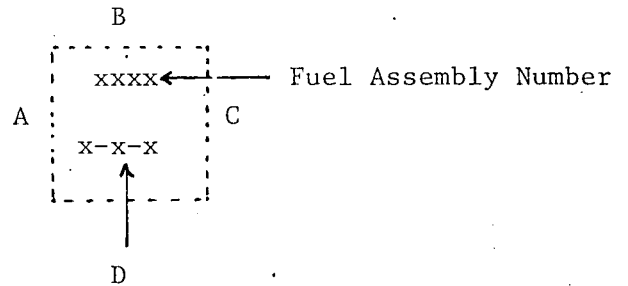
Fuel Assembly 1A10 contained an in-core detector string as well as a control rod of Control Rod Group 1 (safety group), which was fully withdrawn throughout Cycle 1 power operation (see Figure 1). The in-core detector readings indicated that the power density of Fuel Assembly 1A10 was within normal operating limits during Cycle 1 operation and that there was no abnormal power condition that could have affected the integrity of the fuel rods in Fuel Assembly 1A10.

Location of Fuel Assembly 1A10 in Cycle 1 Core
