DUKE POWER COMPANY  
OCONEE UNIT 1

Report No.: AO-269/75-3

Facility: Oconee Unit 1, Seneca, South Carolina

Identification of Occurrence: Defects in a fuel rod of Spent Fuel Assembly  
1A10

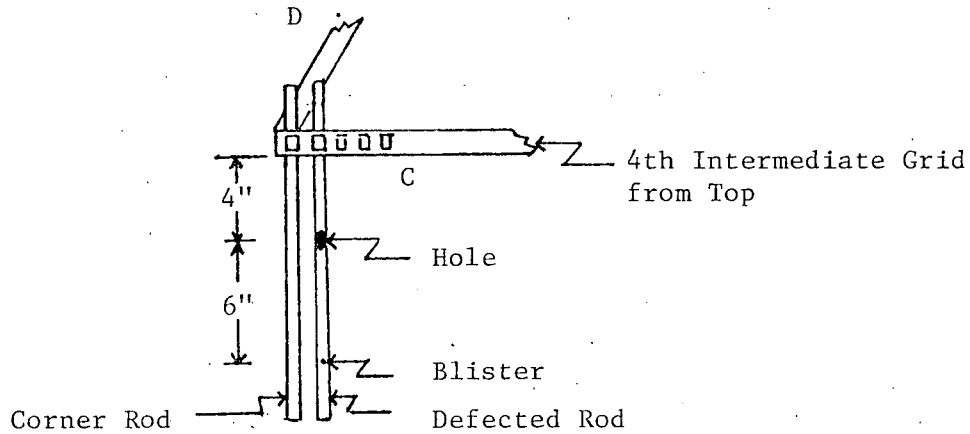
Location of Defects in Spent Fuel Assembly 1A10

The defected fuel rod, a peripheral rod of Fuel Assembly 1A10, has two defects located between the fourth and fifth intermediate spacer grids (see Figure 1). One defect is in the form of a hole in the cladding (approximately  $\frac{1}{2}$ " in diameter), and the other in the form of a small blister. The defected fuel rod did not show any gross outward bow, and no abnormalities were seen in any other fuel rods of the entire fuel assembly during visual examination. Visual examinations were not able to confirm the presence of fuel at the location of the main perforation.

B&W's review of the quality assurance records for the fuel rod components (fuel pellets and cladding) concluded that all recorded parameters were within specification limits and that there were no identifiable factors which could have contributed to the defect.

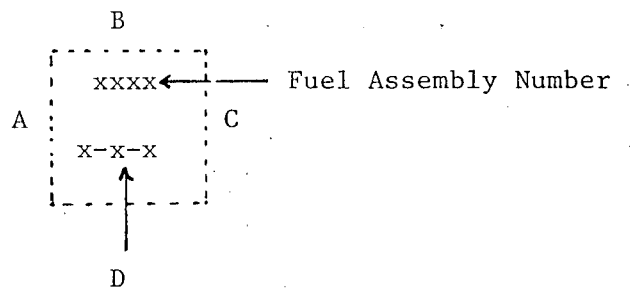
Location of Fuel Assembly 1A10 in Cycle 1 Core

Fuel Assembly 1A10 contained an in-core detector string as well as a control rod of Control Rod Group 1 (safety group), which was fully withdrawn throughout Cycle 1 power operation (see Figure 1). The in-core detector readings indicated that the power density of Fuel Assembly 1A10 was within normal operating limits during Cycle 1 operation and that there was no abnormal power condition that could have affected the integrity of the fuel rods in Fuel Assembly 1A10.
