OCONEE NUCLEAR STATION

UNIT 3

REACTOR BUILDING

END ANCHORAGE SURVEILLANCE

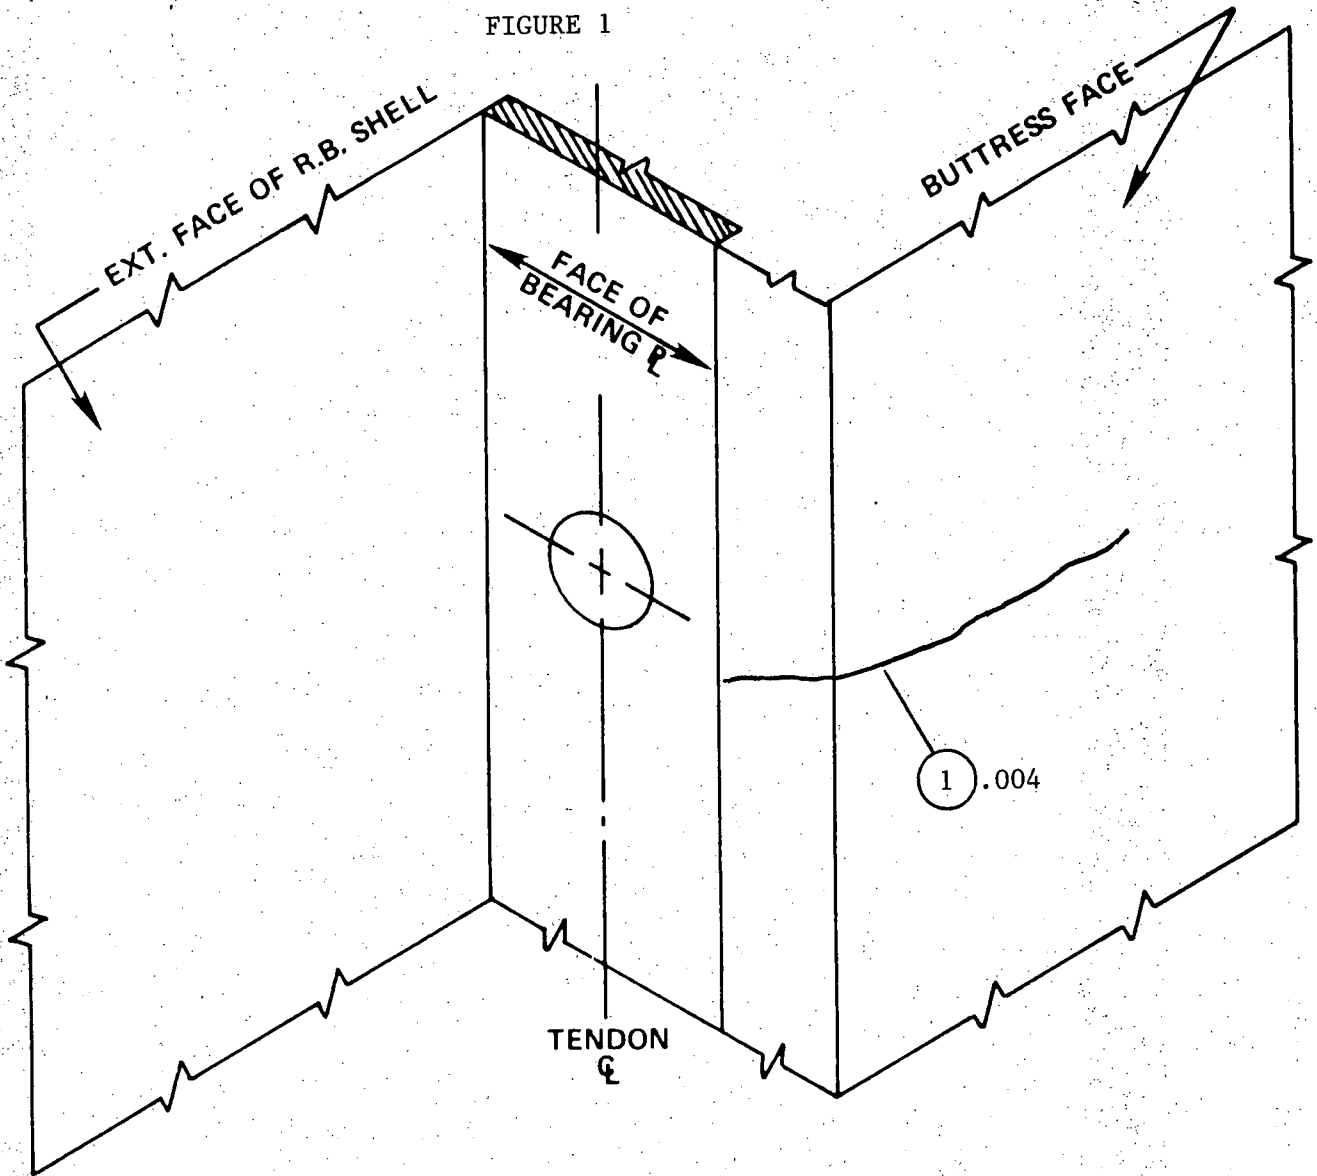
FIGURE 1

TENDON 62 H 26
 ELEVATION 821'

<u>DATA SET</u>	<u>DATE</u>	<u>TEMP INSIDE °F</u>	<u>TEMP OUTSIDE °F</u>	<u>REMARKS</u>
1	5-8-74	78	70	
2	5-2-75	80	86	No new cracks
3	1-30-76	61	42	No new cracks

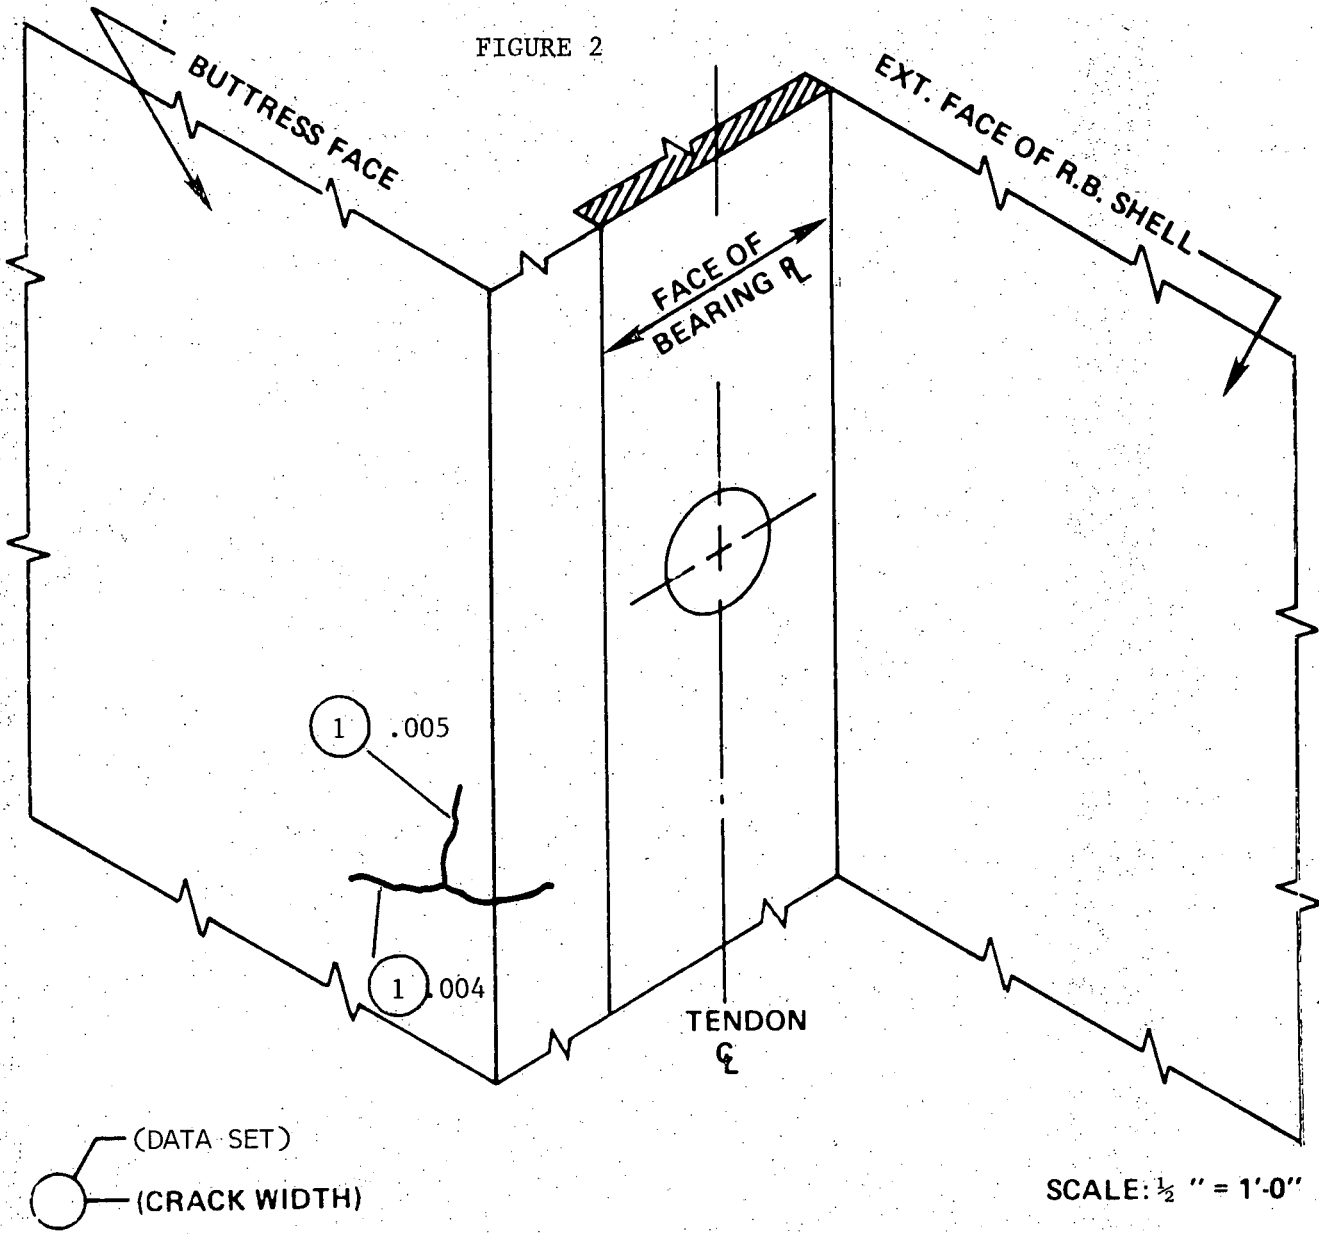
FIGURE 2

TENDON 24 H 29

ELEVATION 827'

<u>DATA SET</u>	<u>DATE</u>	<u>TEMP INSIDE °F</u>	<u>TEMP OUTSIDE °F</u>	<u>REMARKS</u>
1	5-8-74	78	70	
2	5-2-75	80	86	No new cracks
3	1-30-76	61	42	No new cracks

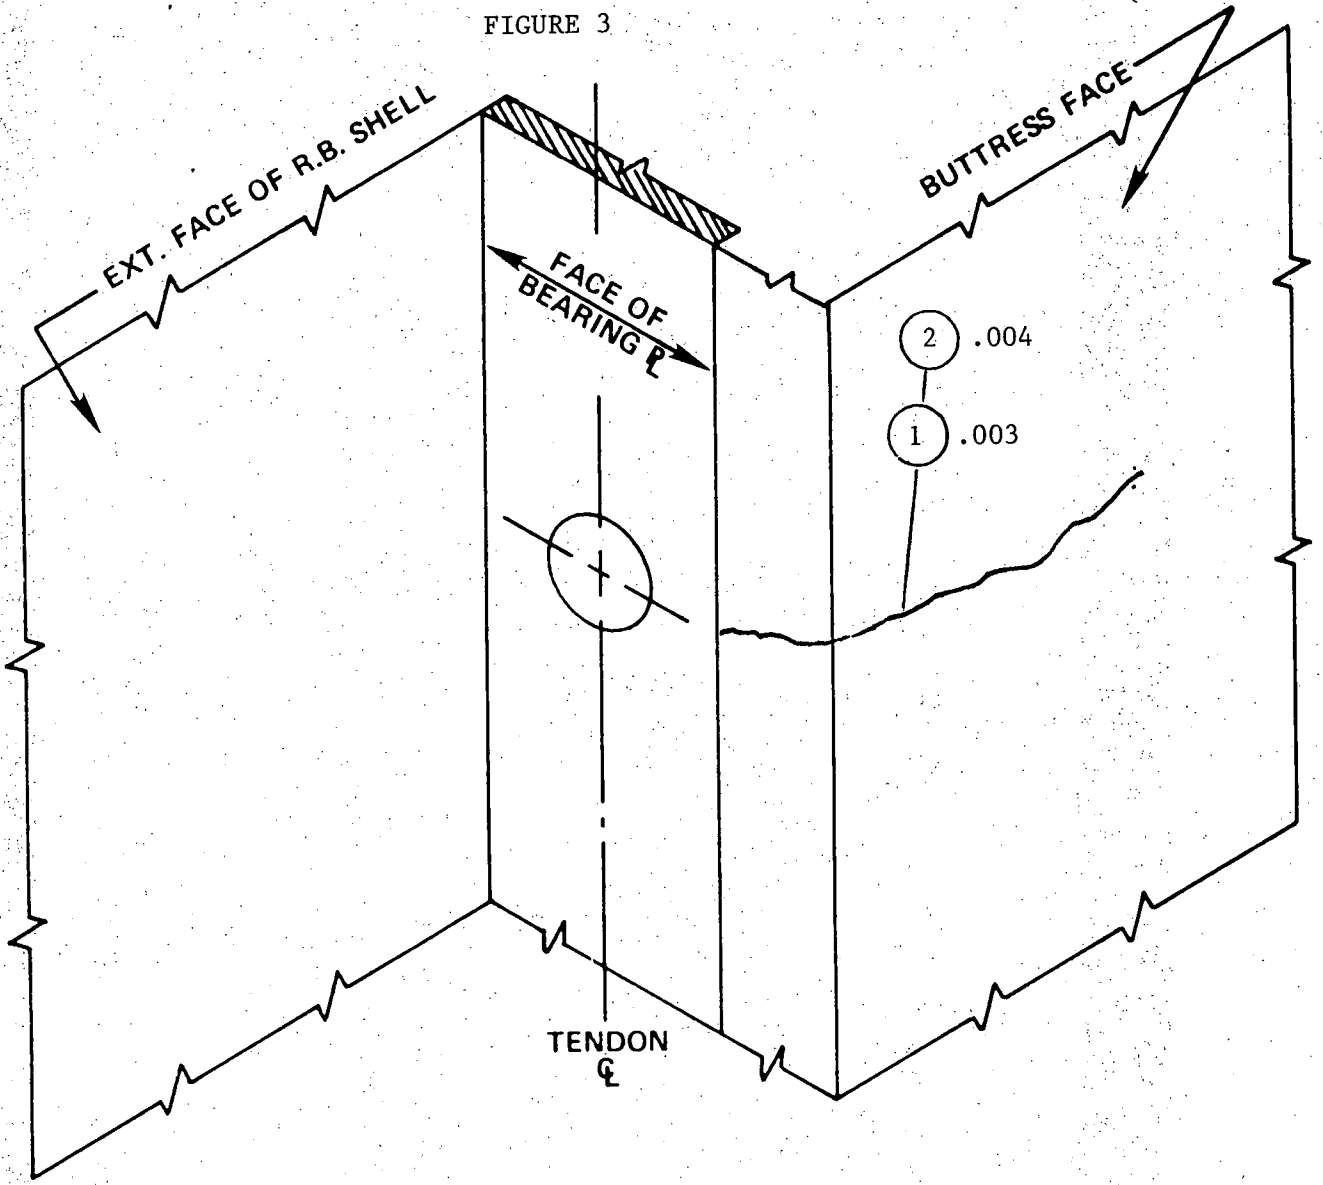
FIGURE 3

TENDON 62 H 78

ELEVATION 908' + 6"

<u>DATA SET</u>	<u>DATE</u>	<u>TEMP INSIDE °F</u>	<u>TEMP OUTSIDE °F</u>	<u>REMARKS</u>
1	5-8-74	78	70	
2	5-2-75	80	86	No new cracks
3	2-28-76	63	52	No new cracks

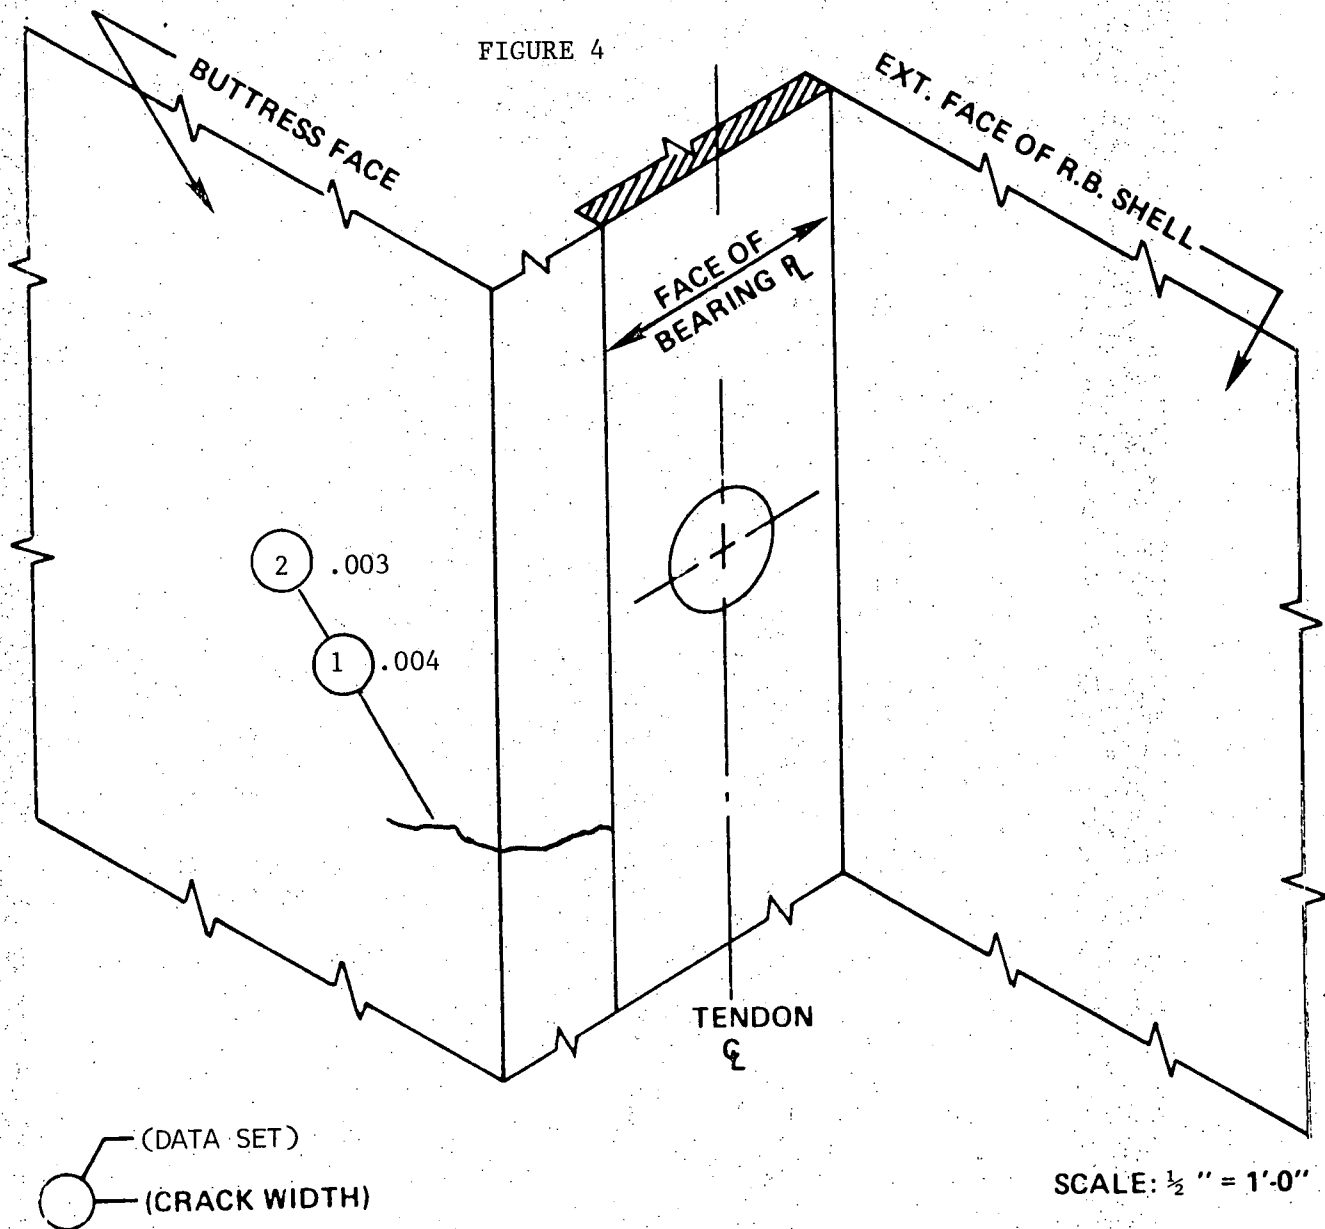
FIGURE 4

TENDON 24 H 96

ELEVATION 939' + 6"

<u>DATA SET</u>	<u>DATE</u>	<u>TEMP INSIDE °F</u>	<u>TEMP OUTSIDE °F</u>	<u>REMARKS</u>
1	5-8-74	78	70	
2	5-2-75	80	86	No new cracks
3	2-27-76	63	52	No new cracks

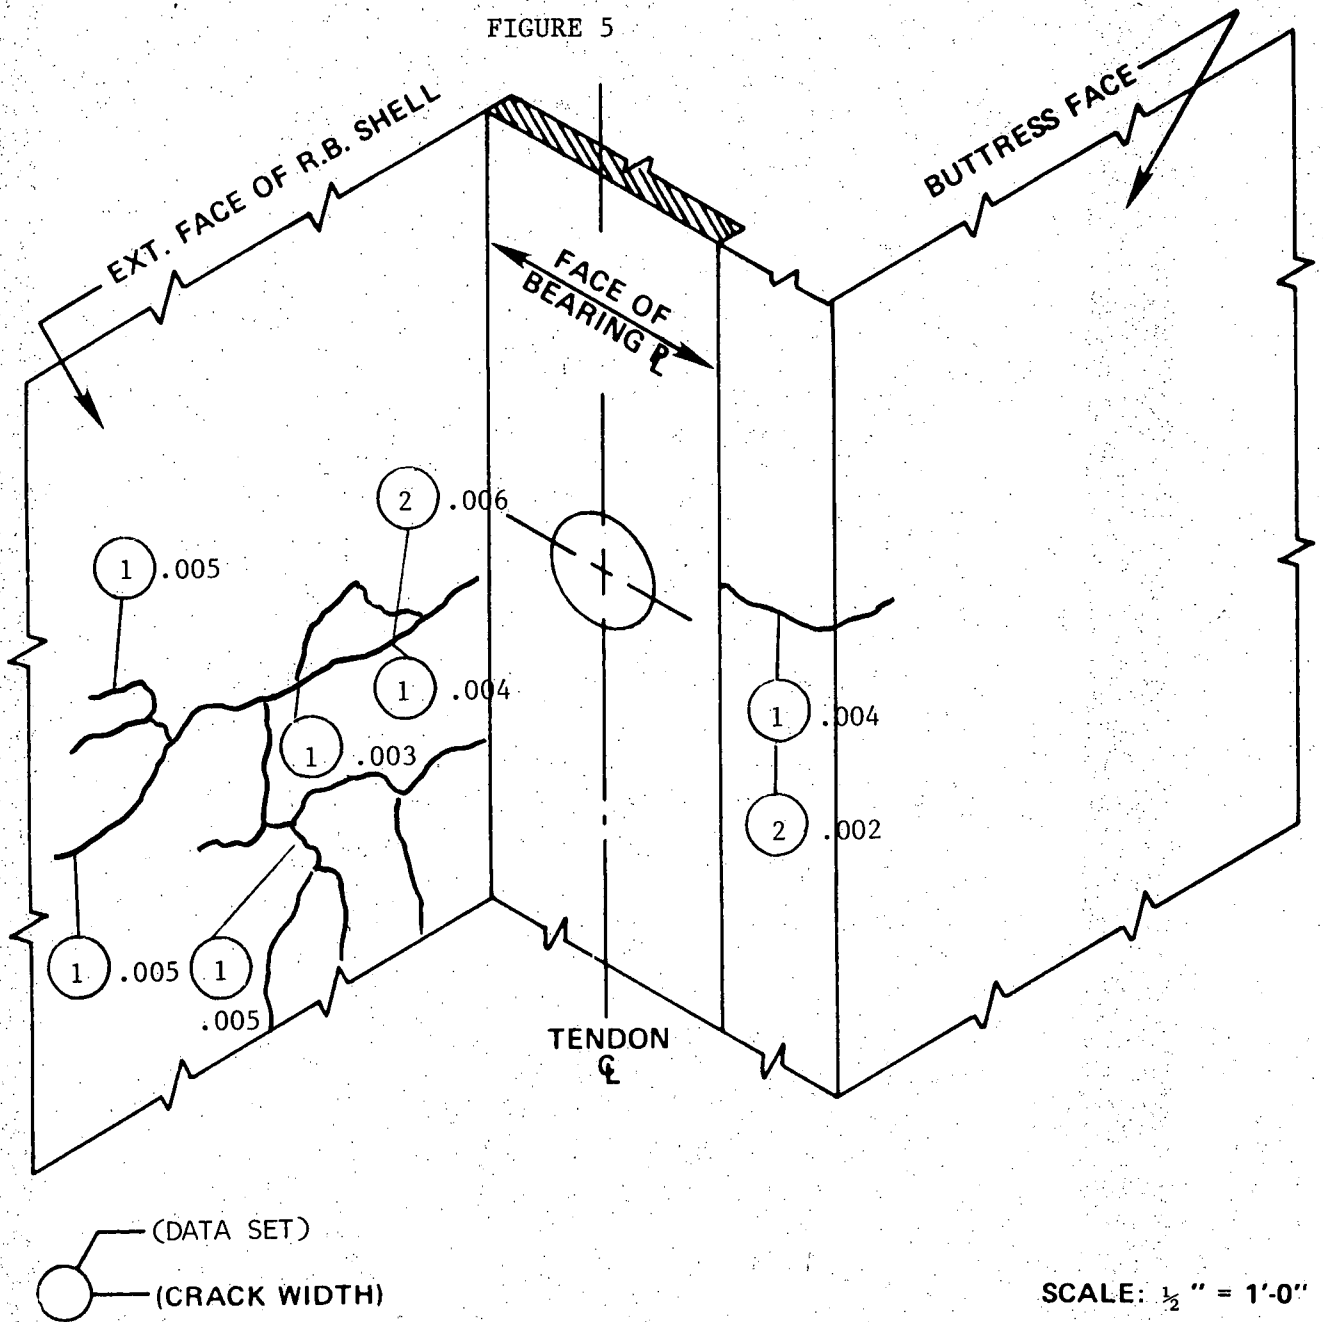
FIGURE 5

TENDON 62 H 100

ELEVATION 944' + 6"

<u>DATA SET</u>	<u>DATE</u>	<u>TEMP INSIDE °F</u>	<u>TEMP OUTSIDE °F</u>	<u>REMARKS</u>
1	5-8-74	78	70	
2	5-2-75	80	86	No new cracks
3	2-27-76	63	52	No new cracks

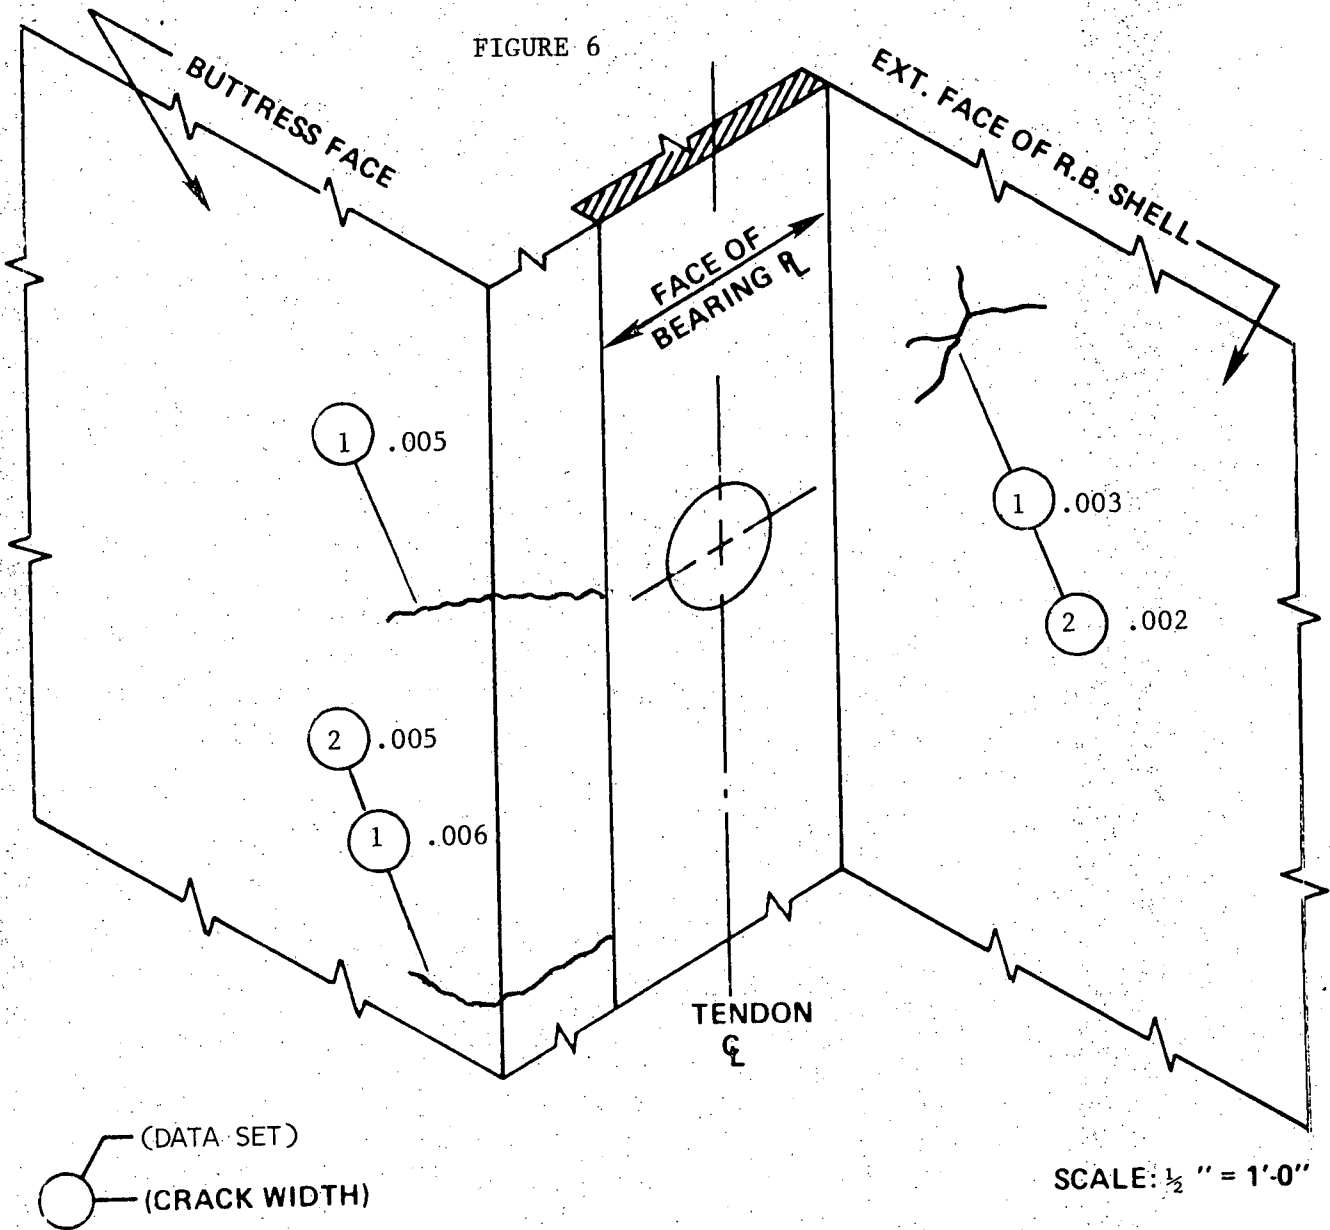
FIGURE 6

TENDON 24 H 102
 ELEVATION 948'

<u>DATA SET</u>	<u>DATE</u>	<u>TEMP INSIDE °F</u>	<u>TEMP OUTSIDE °F</u>	<u>REMARKS</u>
1	5-8-74	78	70	
2	5-2-75	80	86	No new cracks
3	2-27-76	63	53	No new cracks

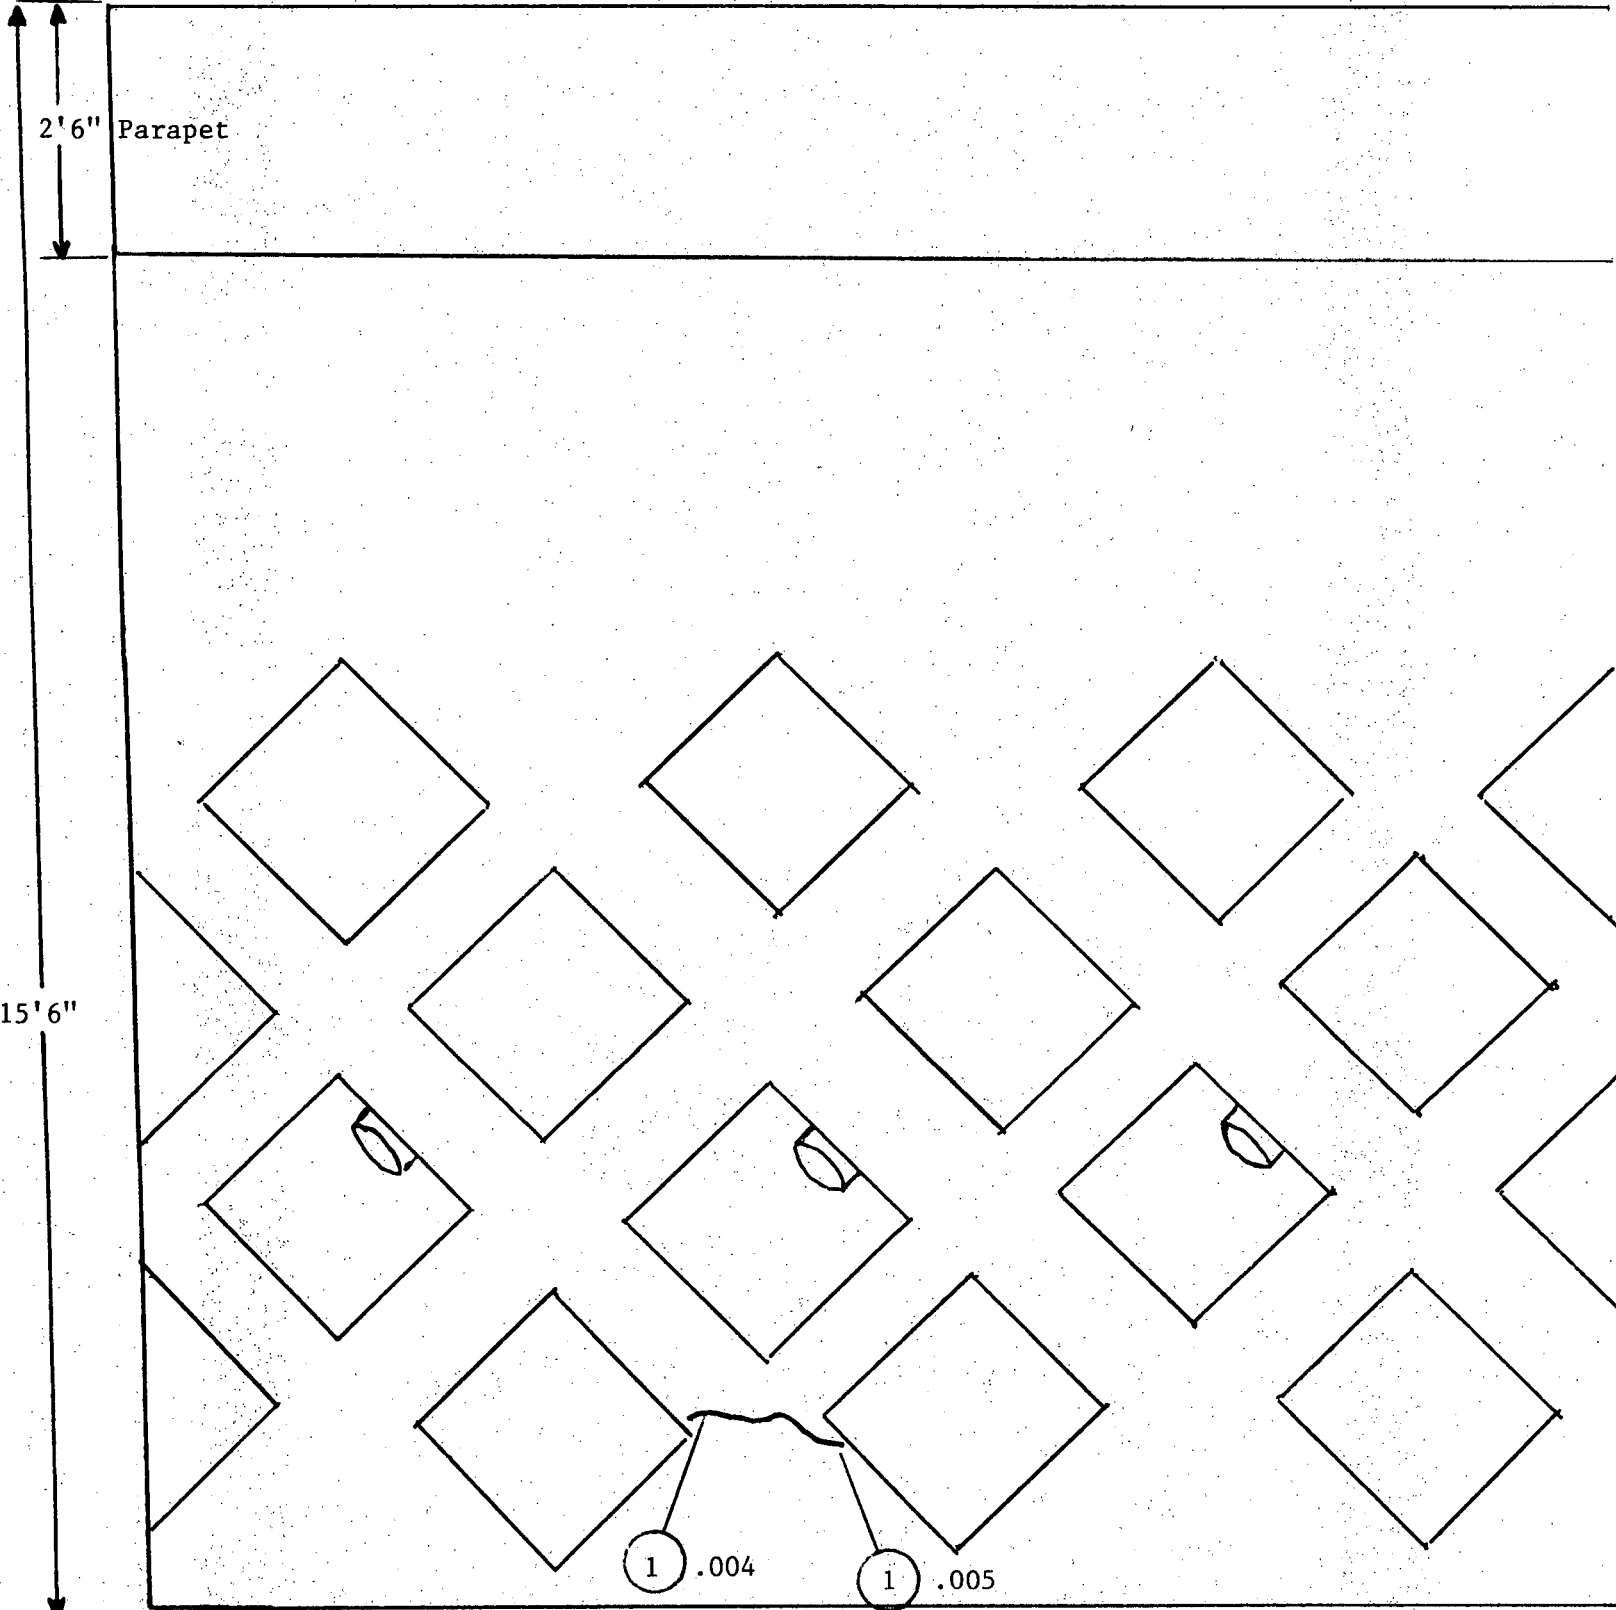
FIGURE 7

CONCRETE CRACK DATA
AT PRESTRESSING TENDON ANCHORS
ON RING GIRDER

<u>DATA SET</u>	<u>DATE</u>	<u>TEMP INSIDE °F</u>	<u>TEMP OUTSIDE °F</u>	<u>REMARKS</u>
1	5-8-74	78	70	Crack as shown
2	5-2-75	80	86	No new cracks
3	2-27-76	63	53	No new cracks
