Re: Oconee Nuclear Station
Docket Nos. 50-269, -270, -287

OCONEE NUCLEAR STATION
STEAM GENERATOR TUBE LEAK
STATUS REPORT

September 24, 1977

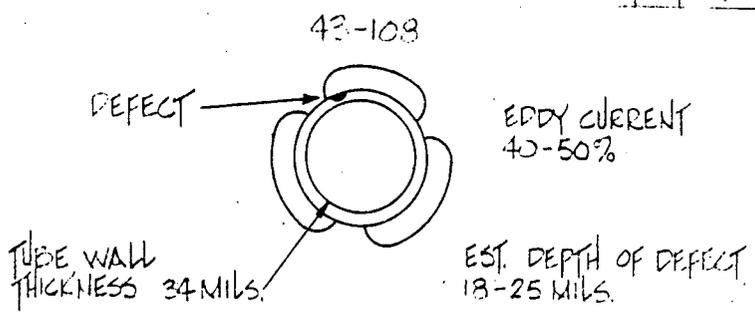
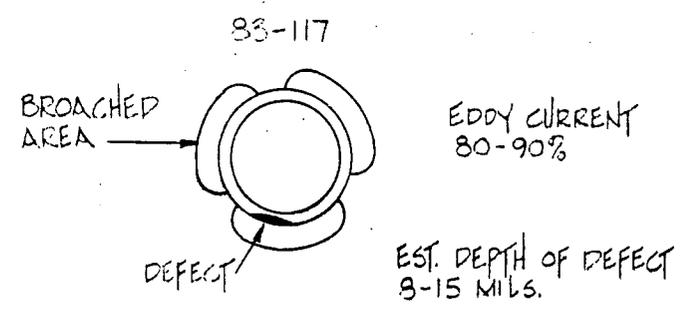
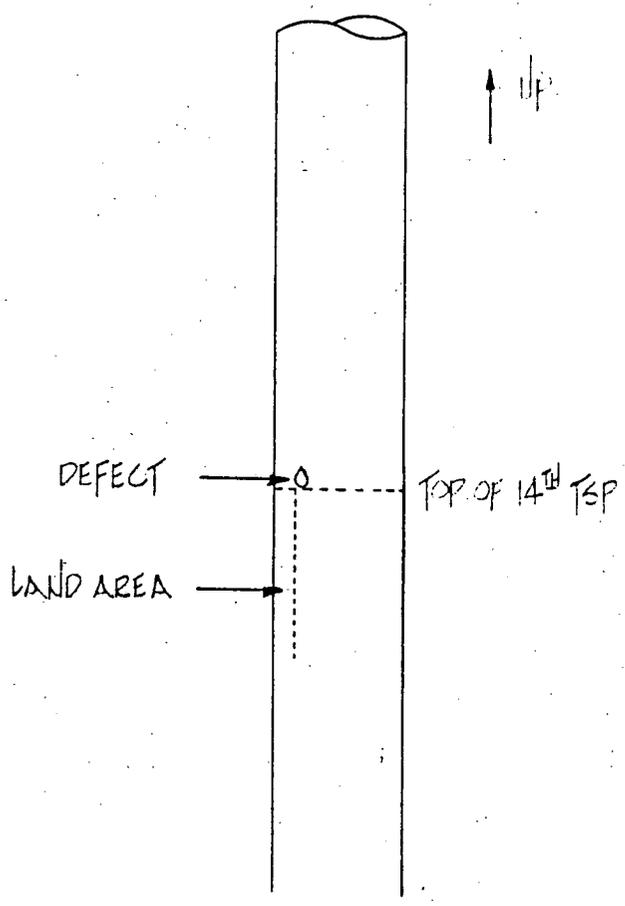
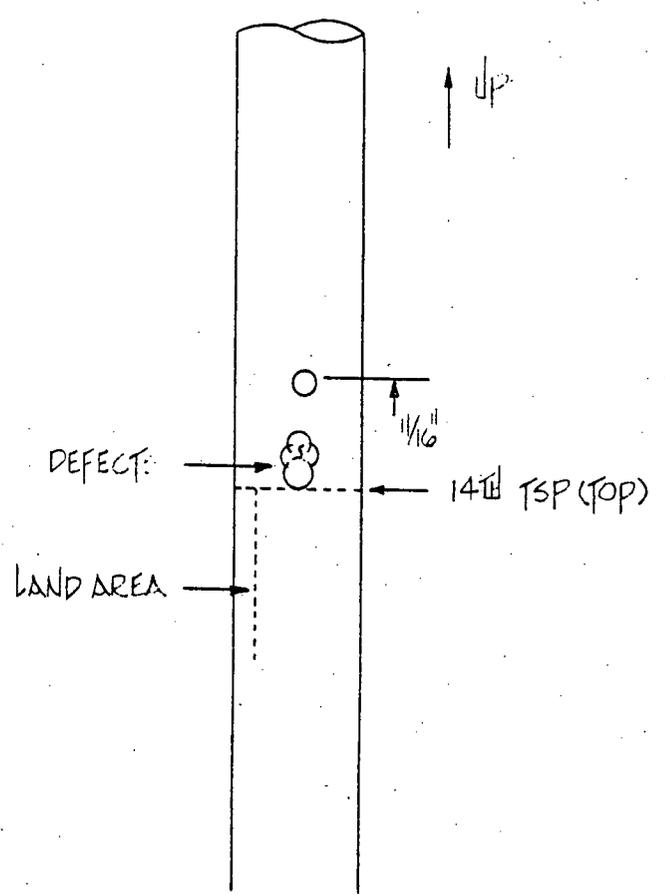
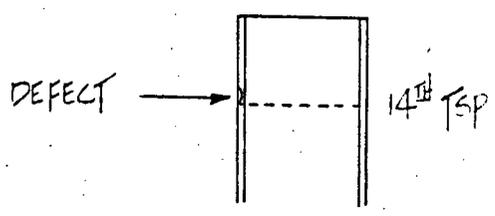
FIGURE 2

Due to the large number of defective eddy current indications, some of which indicated 90%-100% through wall, it was considered essential to obtain tube samples from the periphery for examination. A technique was developed and two tubes were removed and visually inspected on site, with detailed metallurgical analyses to be performed at a later date. The first tube removed was 43/108 which had an eddy current indication of 45-50% through wall at just above the 14th support plate. A visual inspection revealed an eroded area 1/8 inch long and 1/16 inch wide approximately .020 inches deep.

The second tube removed was 83/117 which had an eddy current indication of 80-90% through wall. This tube had erosion wear along a greater area approximately 1 inch long but appeared only to be about 0.010 inches deep. It appeared that the relatively large area of these defects caused the eddy current interpretation to be significantly overestimated. A diagram of these two defects is provided in Figure 2.

1. Information will be provided in a subsequent status report on the metallurgical examination conducted on removed tubes 43/108 and 83/117. This information is expected to be available by December 15, 1977.
