PLANT NAME: Oconee 3

DUKE POWER COMPANY
OCONEE NUCLEAR STATION

UNIT 3
REACTOR BUILDING
POST-TENSIONING SYSTEM
INITIAL SURVEILLANCE

July 23, 1975

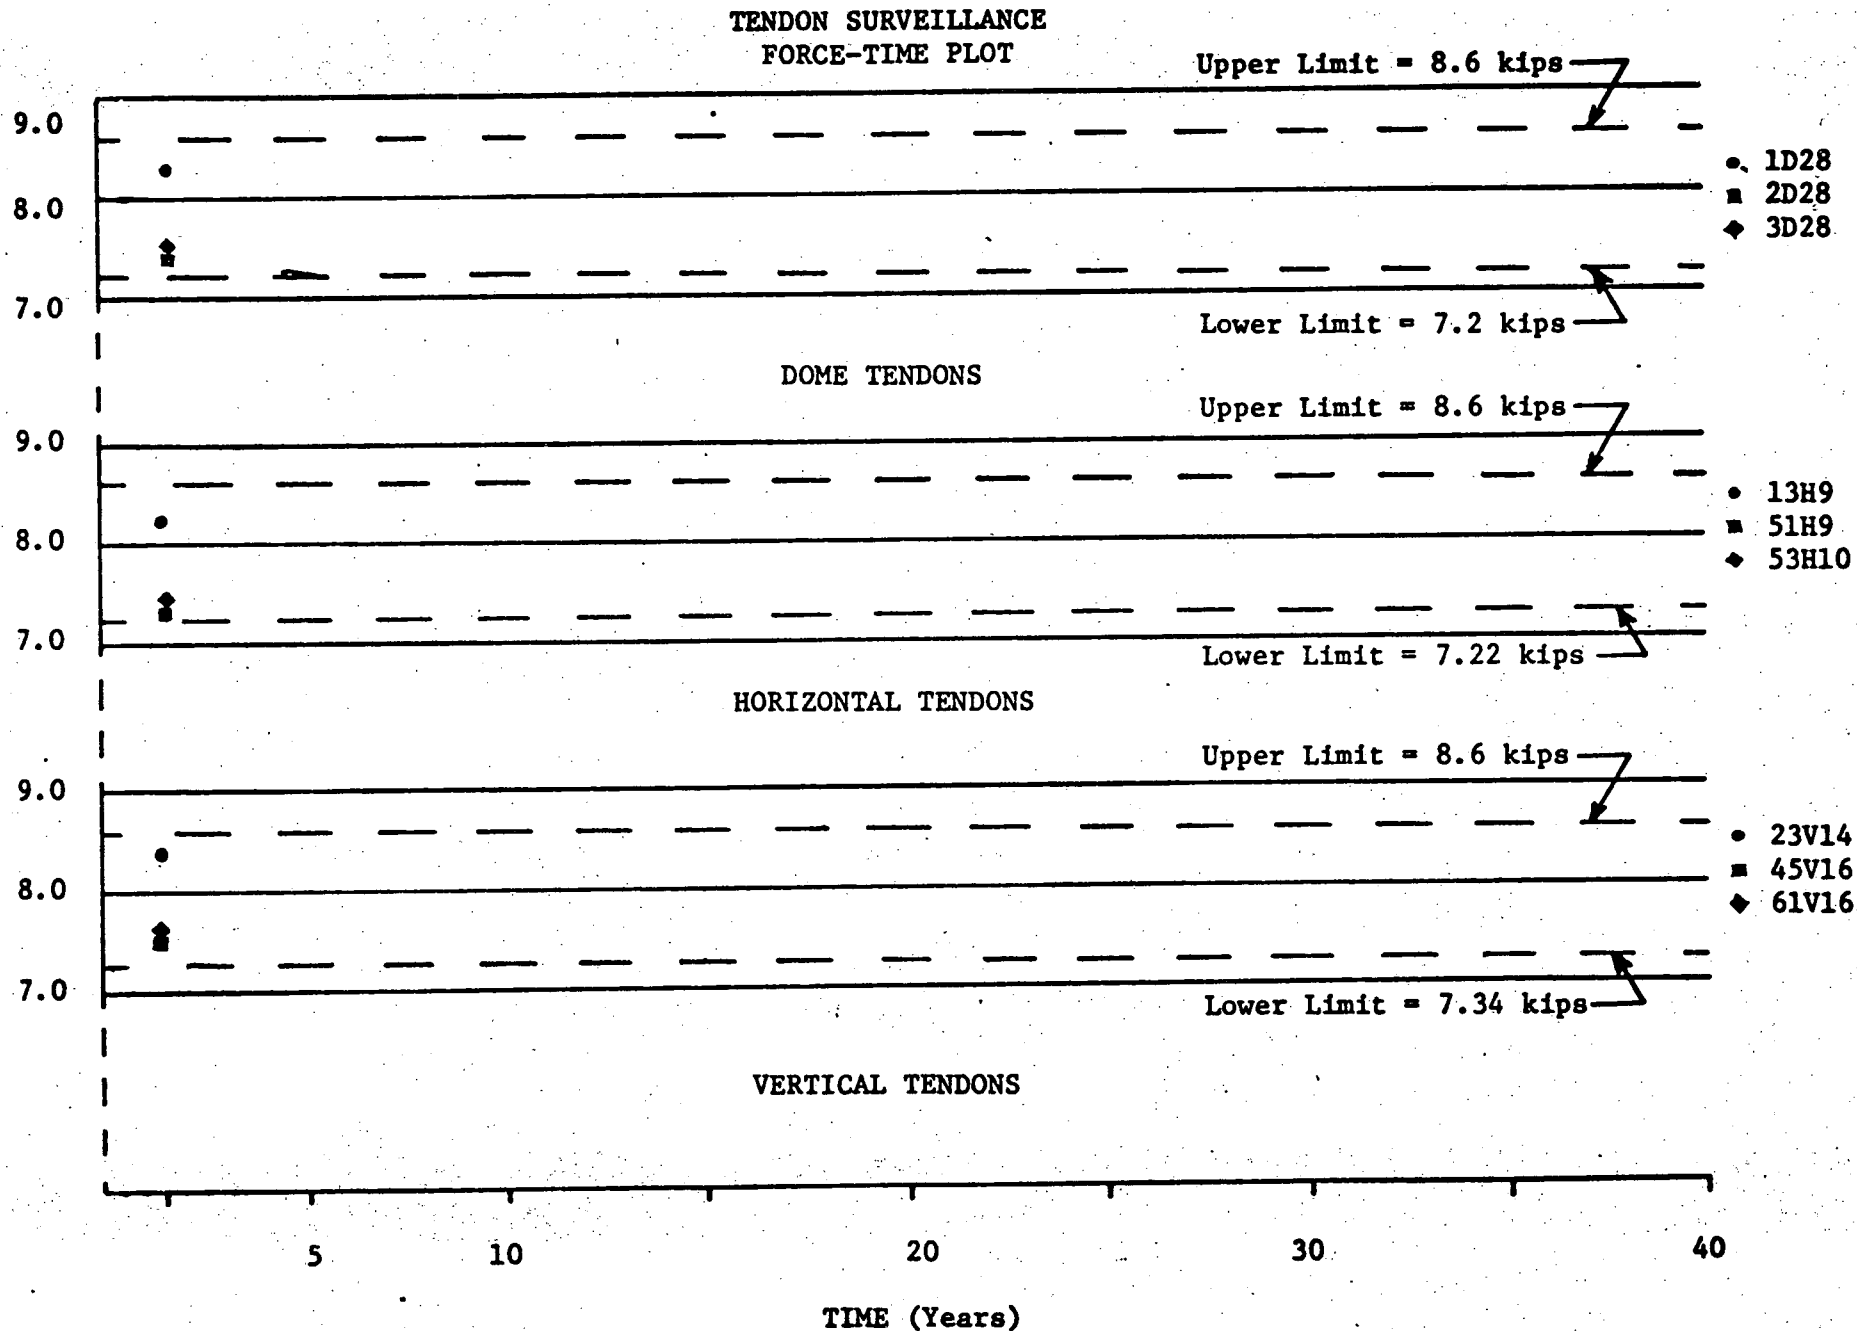
Figure 1

Lift-off forces were obtained for each surveillance tendon - see Table 4. (The field end of tendon 53H10 was not tested due to a physical interference by an emergency feedwater bypass line.) From these readings an average force per wire was determined. The long-term trend of these wire forces is shown graphically in Figure 1. Lift-off forces were within the range of predicted values, considering the effects of concrete creep and shrinkage, steel relaxation and initial structural deformation.
