# Operating Experience Note

No. 011

January 2016

## Operator Response Affected by Inadequate Procedures

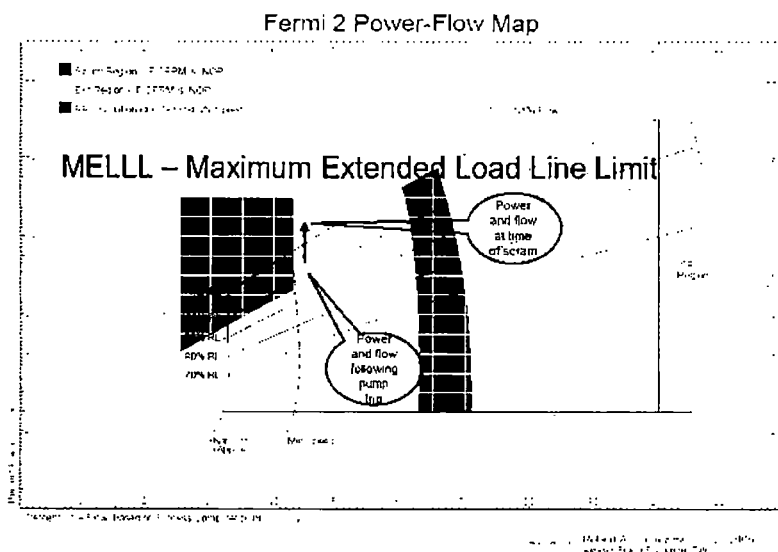
Figure 8: Fermi 2 Power to Flow Map

As the transient progressed, the expected loss of feedwater heating that resulted caused a 10% power increase over about a ten-minute period. This drove the reactor further into the "immediate exit" region of the power-to-flow map and actuated several alarms on the OPRM system. Eventually, two channels of the OPRM system tripped, which inserted an automatic reactor scram.

Post trip review of operator actions during this event showed a lack of timely response to a reactor that was operating in a condition susceptible to THI. The licensee determined that when they installed the OPRM scram feature in 2000, they had also modified the AOPs for loss of feedwater reheating and loss of recirculation pumps to remove the immediate action steps which directed operators to monitor for THI and scram the reactor if it occurred. The thought at the time was that the newly installed protection feature would be more reliable than any operator action. This dependence on automatic protective features impacted operator training and the urgency with which they took actions to get the reactor out of the "immediate exit" region of the power to flow map. In addition, simulator limitations required trainers to manually input power oscillations, and the scenarios operators had encountered in the simulator did not mimic the actual transient.

- Review changes to procedures following plant modifications
  - At Fermi, removing immediate operator actions led to dependence on an automatic protective function to protect core thermal limits.
  - At River Bend, procedure changes were made without a cross-disciplinary review by engineering that might have flagged the discrepancy between the procedure objectives and the design operating characteristics of the startup FRVs.
- Verify that the simulator accurately models expected design plant response to transients following modifications
  - At Fermi, thermal-hydraulic instability had to be manually input into simulator scenarios as an instrument malfunction, and plant alarm response differed from what operators had expected based on simulator training.
  - At River Bend, the simulator did not accurately reflect the post-scram operating characteristics of the startup FRVs.
