Calvert Cliffs Nuclear Power Plant, Unit 1
Facility Operating License No. DPR-53
NRC Docket No. 50-317

Subject: Report Concerning Dissimilar Metal Weld Flaw in Pressurizer Safety Relief
Nozzle-to-Safe-End Weld

Report Concerning Dissimilar Metal Weld Flaw in Pressurizer
Safety Relief Nozzle-to-Safe-End Weld
Page 1 of 6

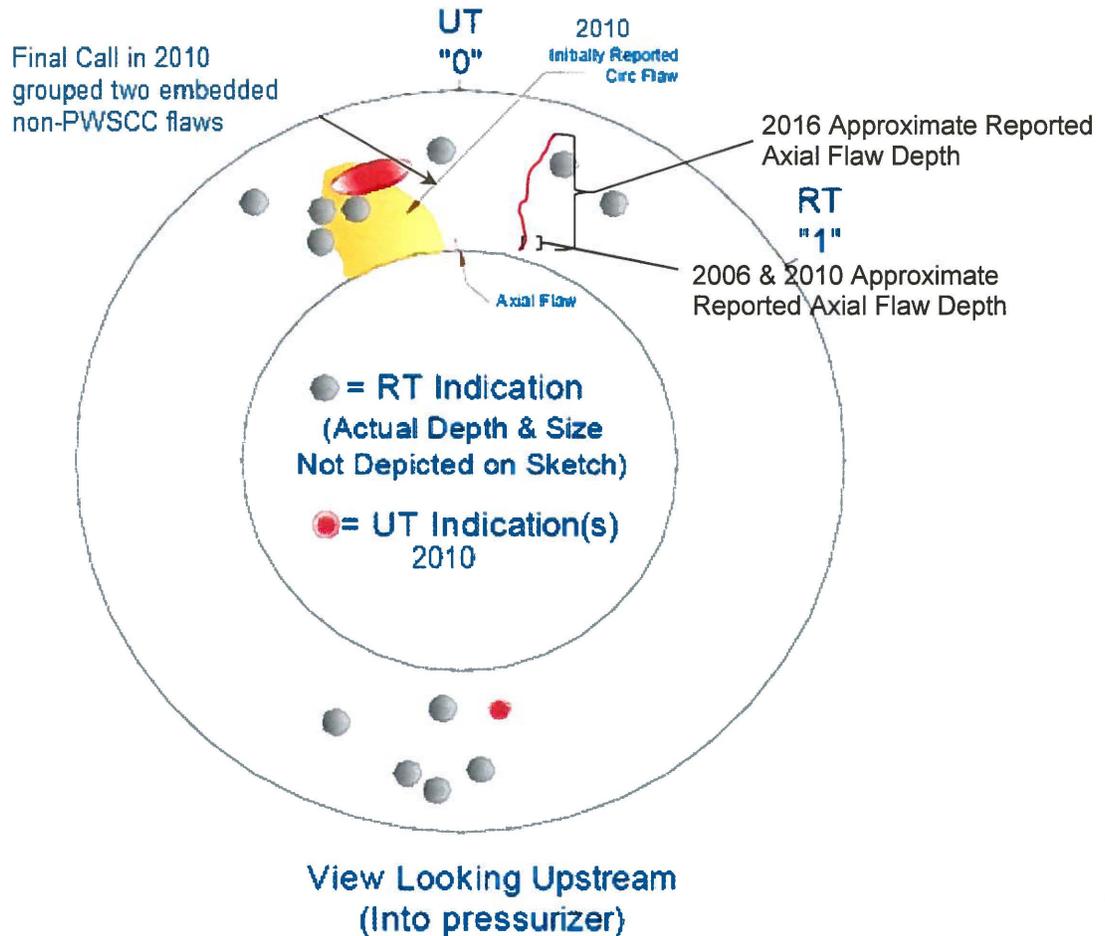
Figure 1
Annotated Figure 6-1 from 2010 EPRI Report Showing 2016 Flaw Approximate Size and Location

The evaluation of the recorded Ultrasonic Testing (UT) data identified one axially oriented flaw, which is contained within the weld material, exhibiting characteristics indicative of PWSCC. The measured depth of the flaw was 81.6% through-wall including clad thickness.

In addition, eight indications characterized as embedded fabrication flaws were detected during the data evaluation. These are similar flaws to those reported during the last examination in 2010.

Figure 1 is a graphic representation of the indications in this weld as reported in 2010 along with an approximation of the reported 2016 axial flaw characteristics. A second ultrasonic examination was performed by another NDE vendor using a manual encoded phased array UT examination system and it confirmed the automated examination results.

The station is examining all twenty-seven (27) dissimilar metal (DM) butt welds within the scope of ASME Code Case N-770-1 during the current refueling outage using examination techniques demonstrated in accordance with ASME Section XI, Appendix VIII, Performance Demonstration for Ultrasonic Examination Systems. The affected weld will be repaired by full structural weld overlay during the current outage.

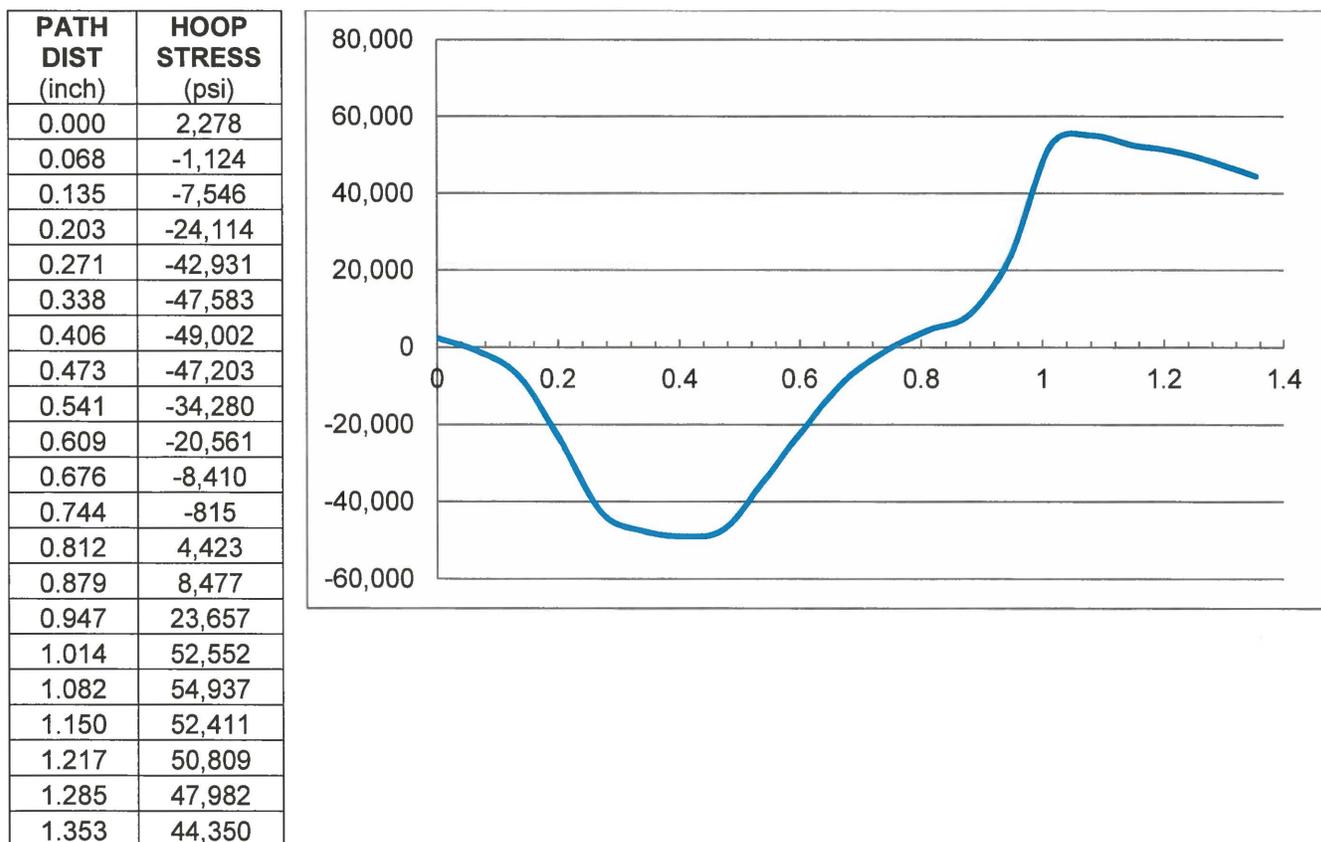
Figure 2
2006 Post MSIP[®]+Operating Stress Calculated Hoop Stress Through Wall at Nominal Flaw Position (Path along butter/weld interface)

Following the examination in 2006 and application of MSIP[®], a flaw evaluation of the axial flaw was performed and submitted to the NRC. A non-linear finite element analysis using the ANSYS Program was performed for the application of MSIP[®]. This analysis confirmed that an axial PWSCC flaw of 8% depth would be contained within the compressive hoop stress zone of the post-MSIP[®] stress profile at operating conditions. The post-MSIP[®] stress profile is compressive from the ID of the pipe wall to an extent of approximately 50% of the through-wall depth. As shown in Figure 2, the hoop stress then becomes tensile out to the OD, reaching tensile stress values of about 55 ksi at 80% through-wall and reducing to about 44 ksi at the OD of the pipe.

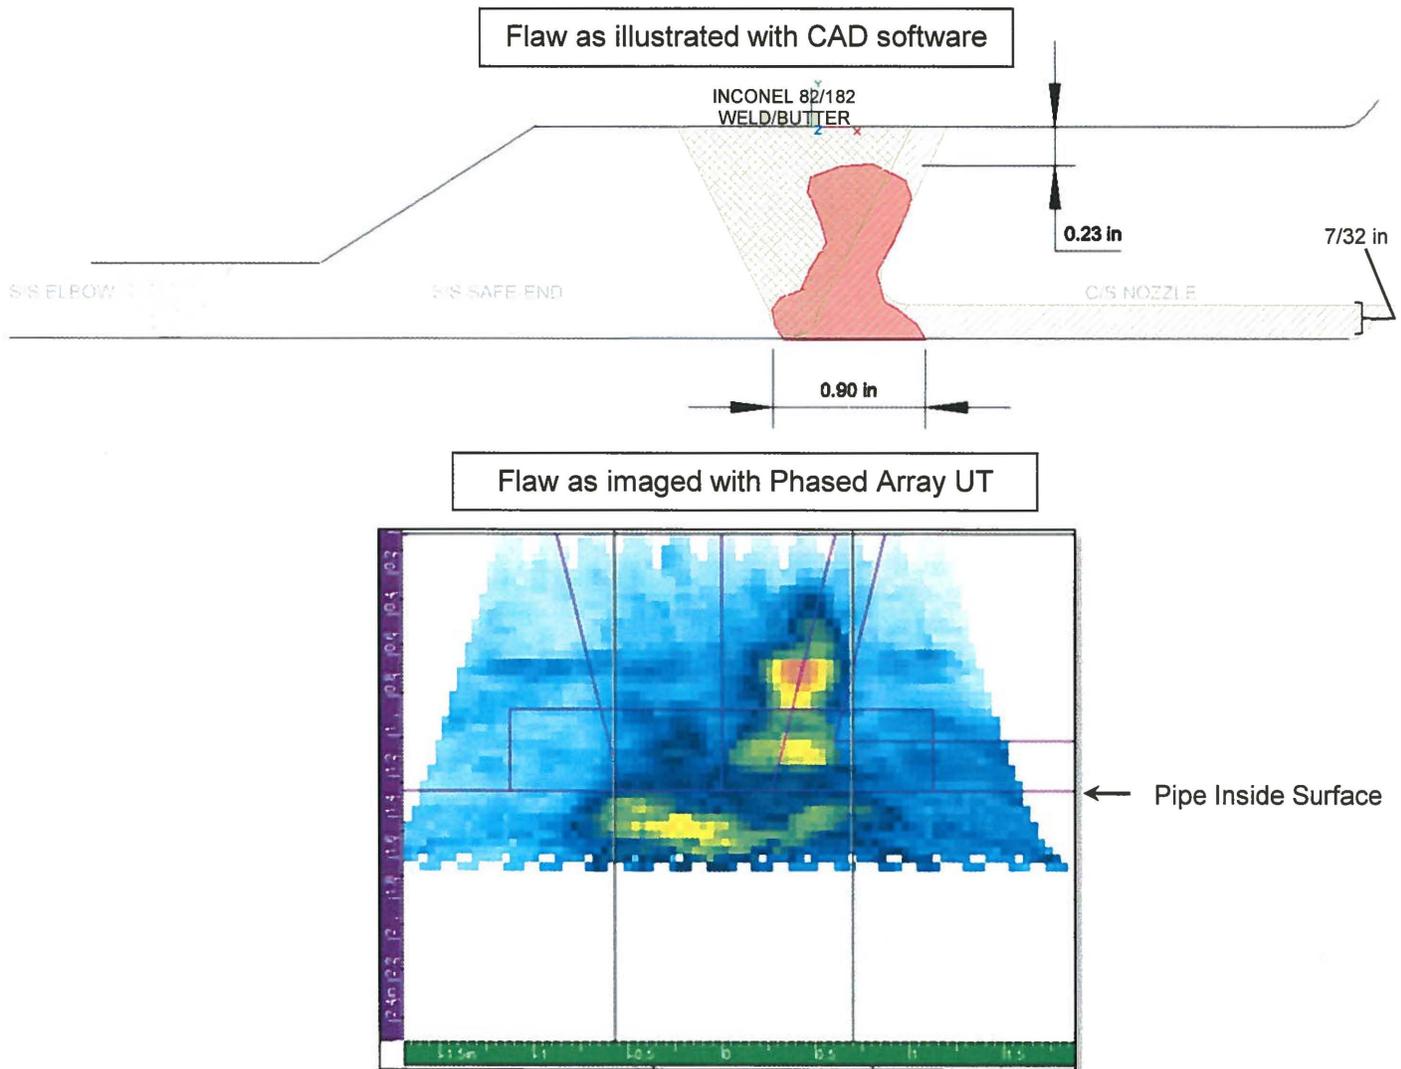
Figure 3
2016 Axial Flaw Characteristics

The results of the phased array encoded NDE examination performed in 2016 show that the axial flaw is widest at the ID (lower $\sim 1/3^{\text{rd}}$ of the flaw), narrower in the center $\sim 1/3^{\text{rd}}$ of the flaw, and becomes wider in the top $\sim 1/3^{\text{rd}}$ of the flaw (see Figure 3 below). The axial flaw is narrower and consequently produces a weaker reflection in the middle through-wall range of the flaw where the compressive stress is the highest.
