U.S. DEPARTMENT OF  
**ENERGY**

Legacy  
Management

**2015 Annual Site Inspection and  
Monitoring Report for Uranium Mill Tailings  
Radiation Control Act Title I Disposal Sites**

March 2016

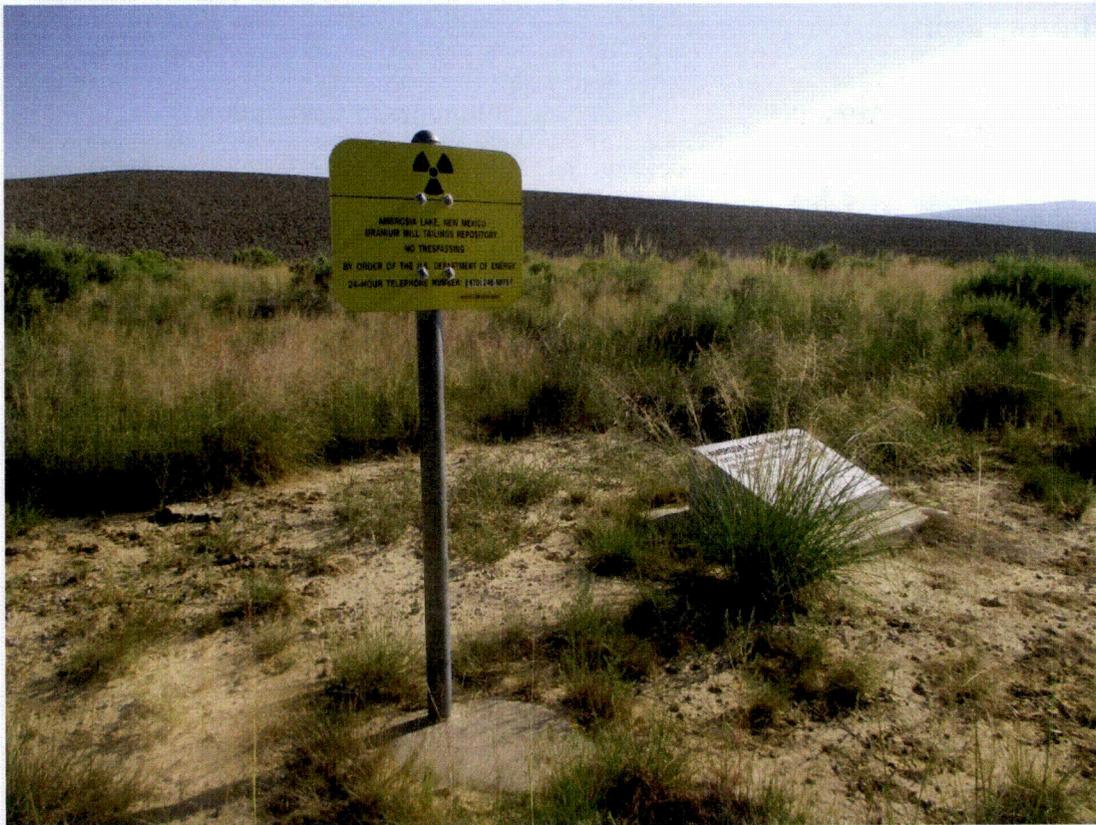
The entrance sign was in good condition (PL-1).

AMB 8/2015. PL-1. Entrance sign and site marker SMK-1.

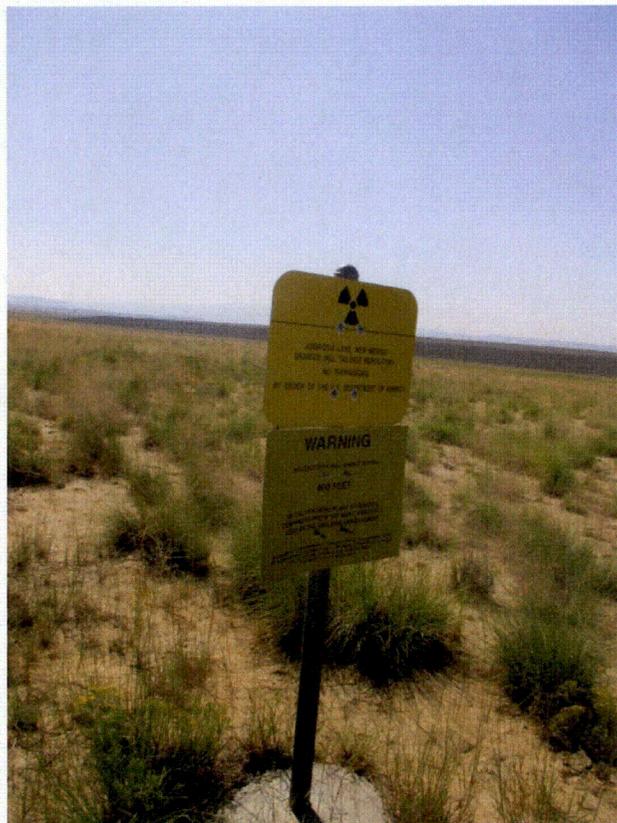
The site is not fenced. Seventy perimeter signs, positioned on the site boundary, were in good condition. Posts for perimeter signs P1 through P15 include mining-restriction-area warning signs. Cattle have rubbed against and bent the mining restriction signs but the signs were otherwise in good condition (PL-2).

AMB 8/2015. PL-2. Perimeter sign P14.

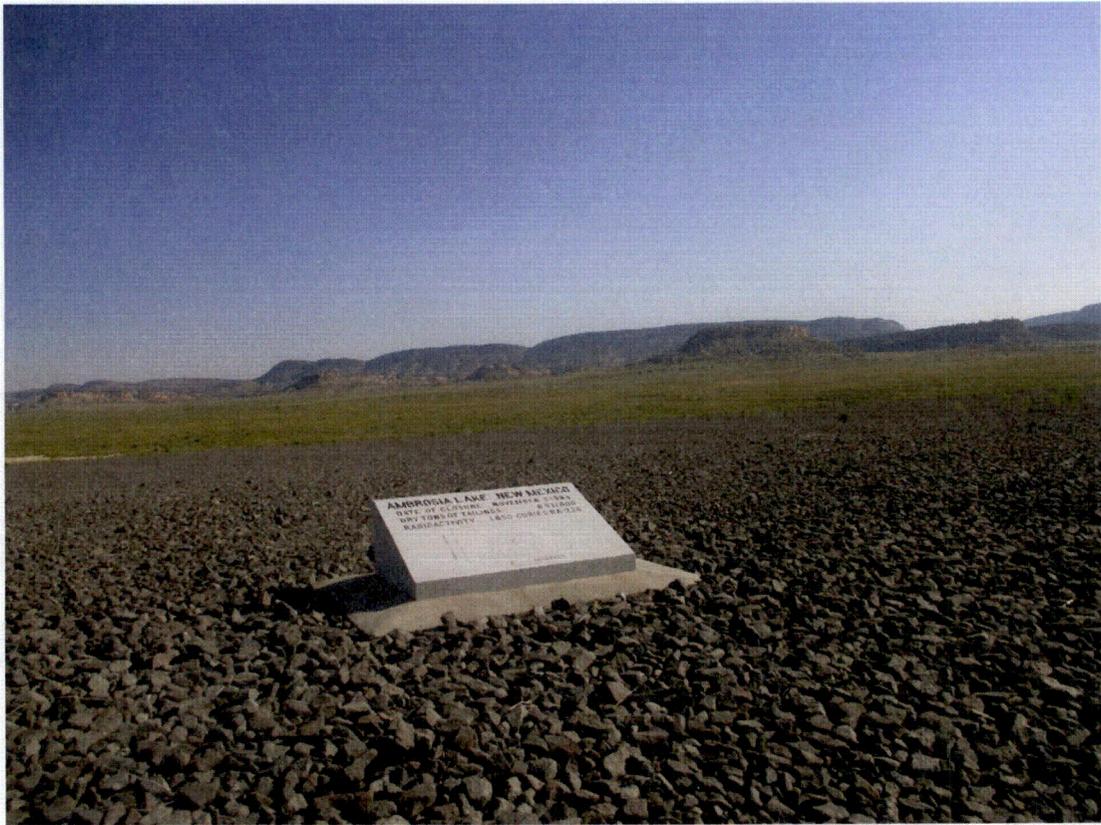
Granite site markers are located near the site entrance and on top of the disposal cell (PL-3). Both site markers were in excellent condition.

AMB 8/2015. PL-3. Site marker SMK-2.

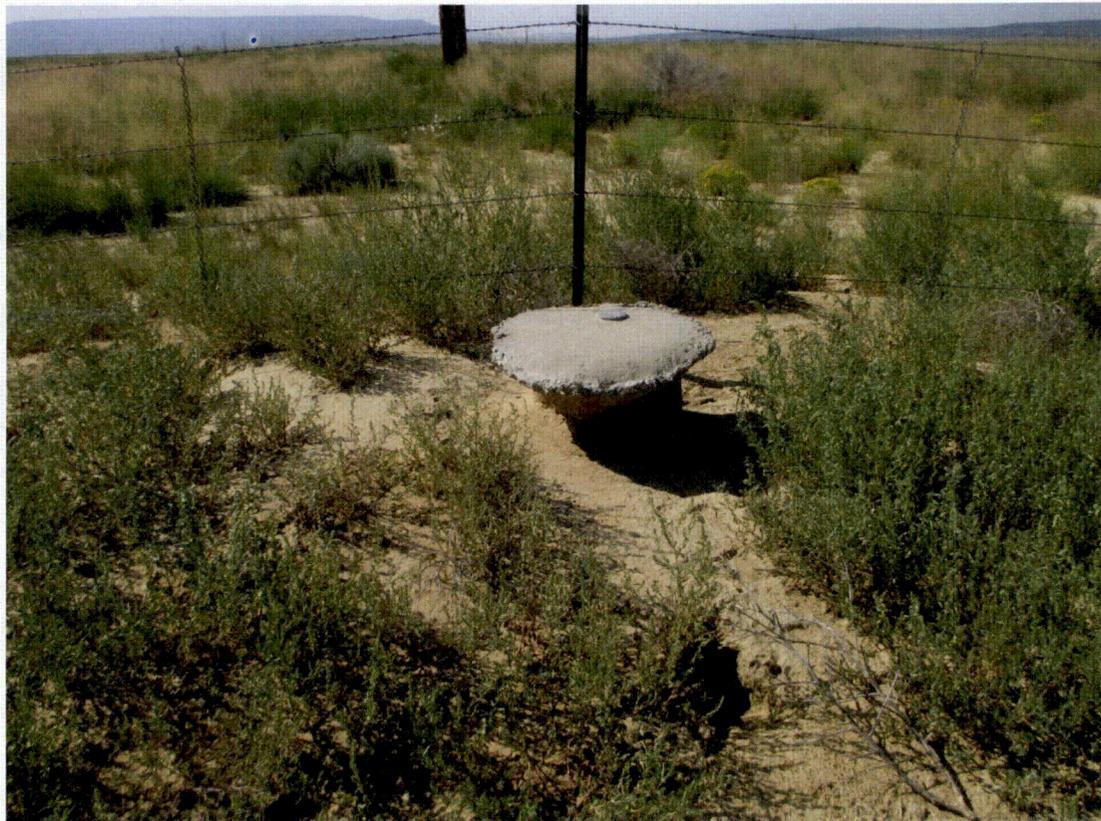
Three combined survey and boundary monuments and five additional boundary monuments identify the property corners and boundary. Boundary monument BM-3 was not found and was apparently covered with soil. All of the other monuments were undisturbed and in good condition. Wind erosion has exposed the concrete base of boundary monument BM-8, but the monument is stable (PL-4).

AMB 8/2015. PL-4. Boundary monument BM-8.

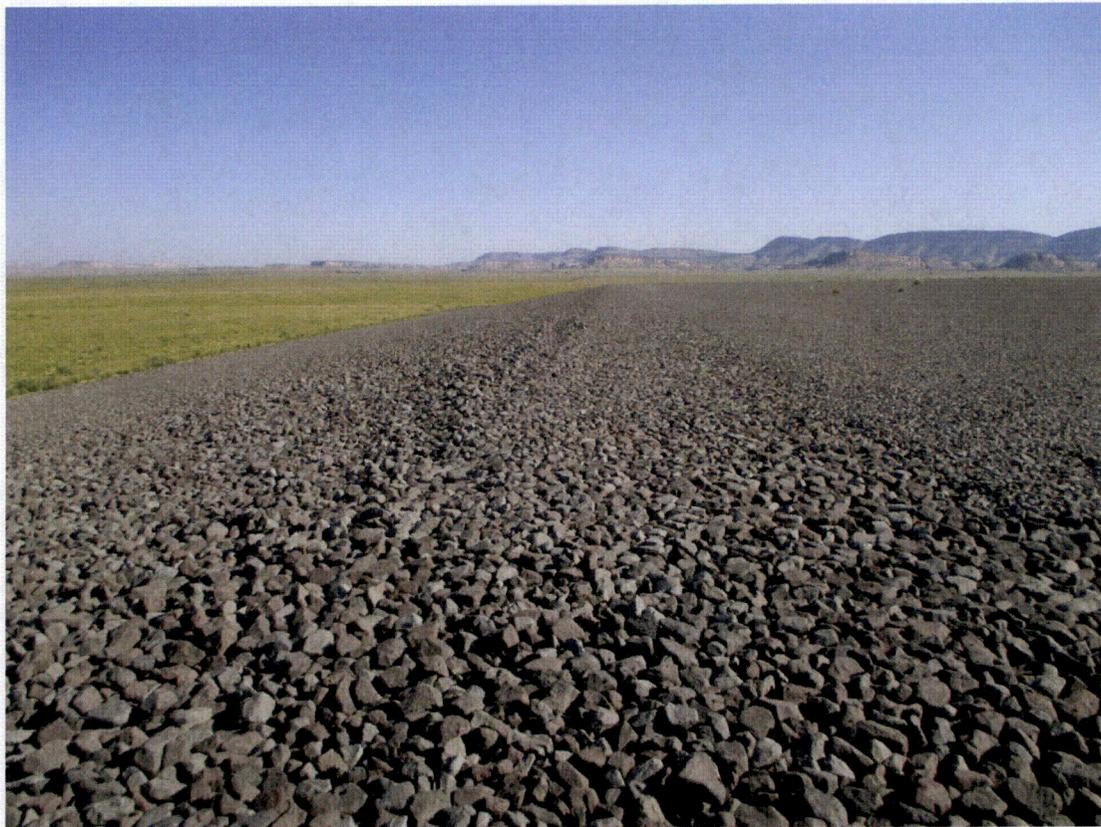
The 91-acre disposal cell was completed in 1994. The basalt riprap-covered top slope of the disposal cell was in excellent condition (PL-6). There was no evidence of cracking, slumping, or erosion, and there was no indication of riprap degradation.

*AMB 8/2015. PL-6. West edge of disposal cell top slope.*

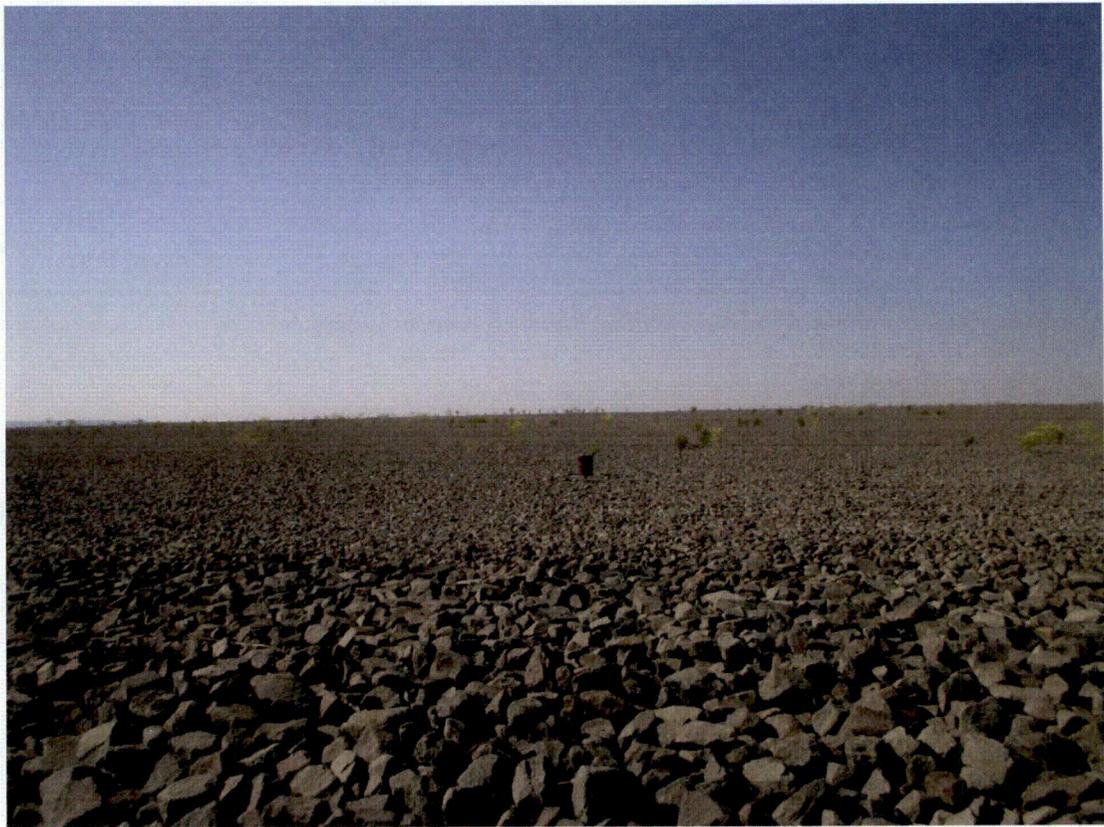
A shallow depression around settlement plate SP-4, near the northeast corner of the disposal cell cover, was first noted during the 1997 inspection and continued to grow in depth and area in subsequent years. The depression was repaired in August 2005. Visual observations during the 2015 inspection indicate that very minor settlement may have occurred since the depression was repaired (PL-7).

*AMB 8/2015. PL-7. Settlement plate SP-4.*

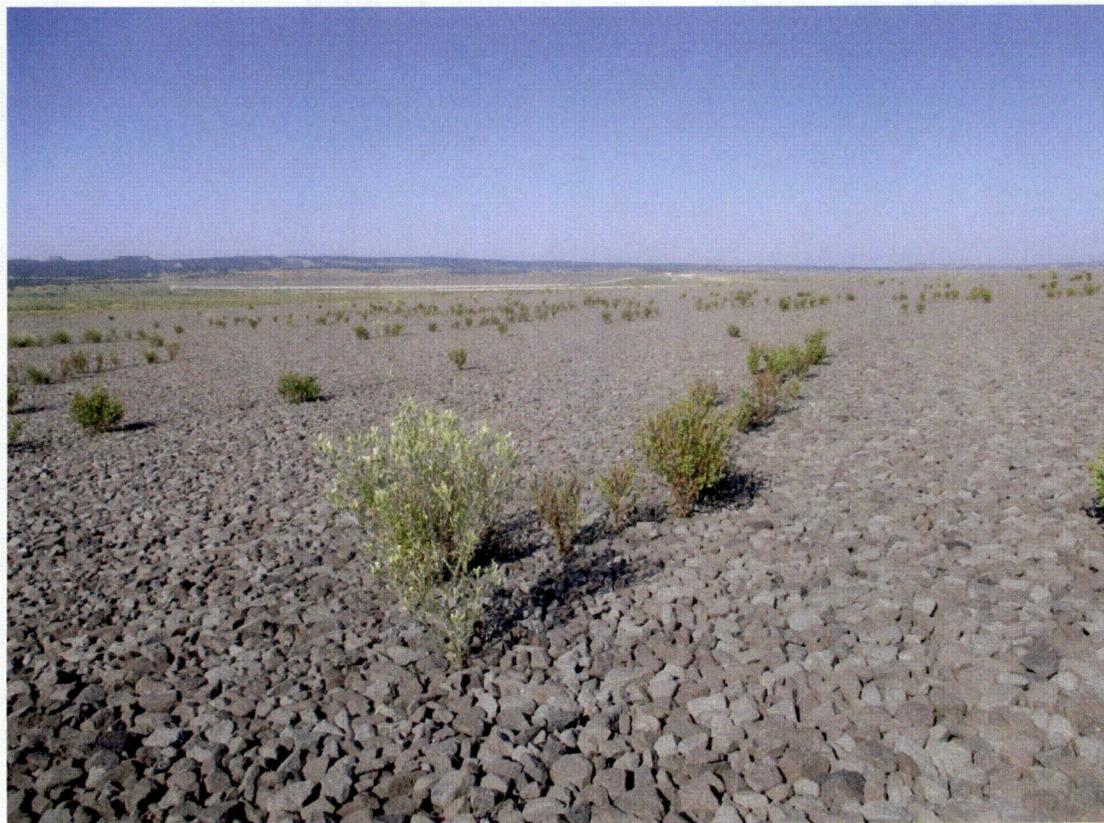
Scattered annual weeds and perennial grasses and forbs are growing on the disposal cell top slope (PL-8). In accordance with the LTSP, deep-rooted shrubs are to be removed from the cell cover. No deep-rooted shrubs were noted during the inspection.

*AMB 8/2015. PL-8. Vegetation on southeast portion of top slope.*

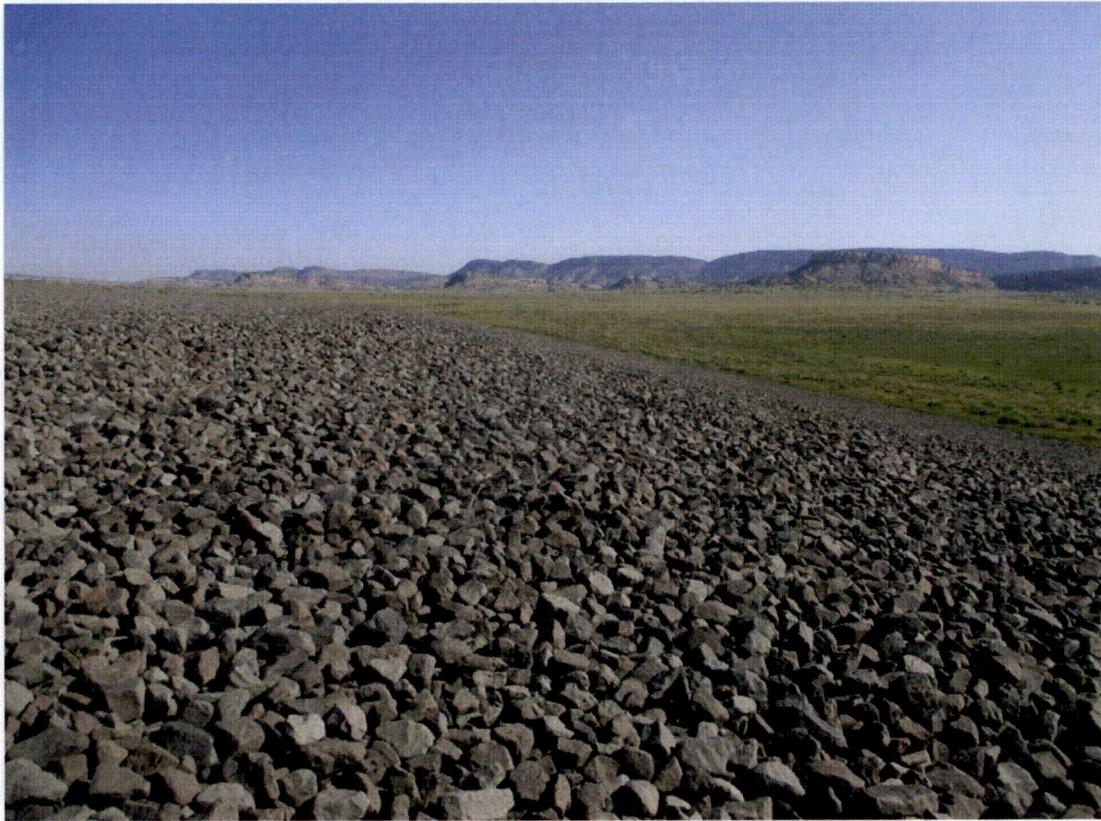
*AMB 8/2015. PL-9. East side slope.*

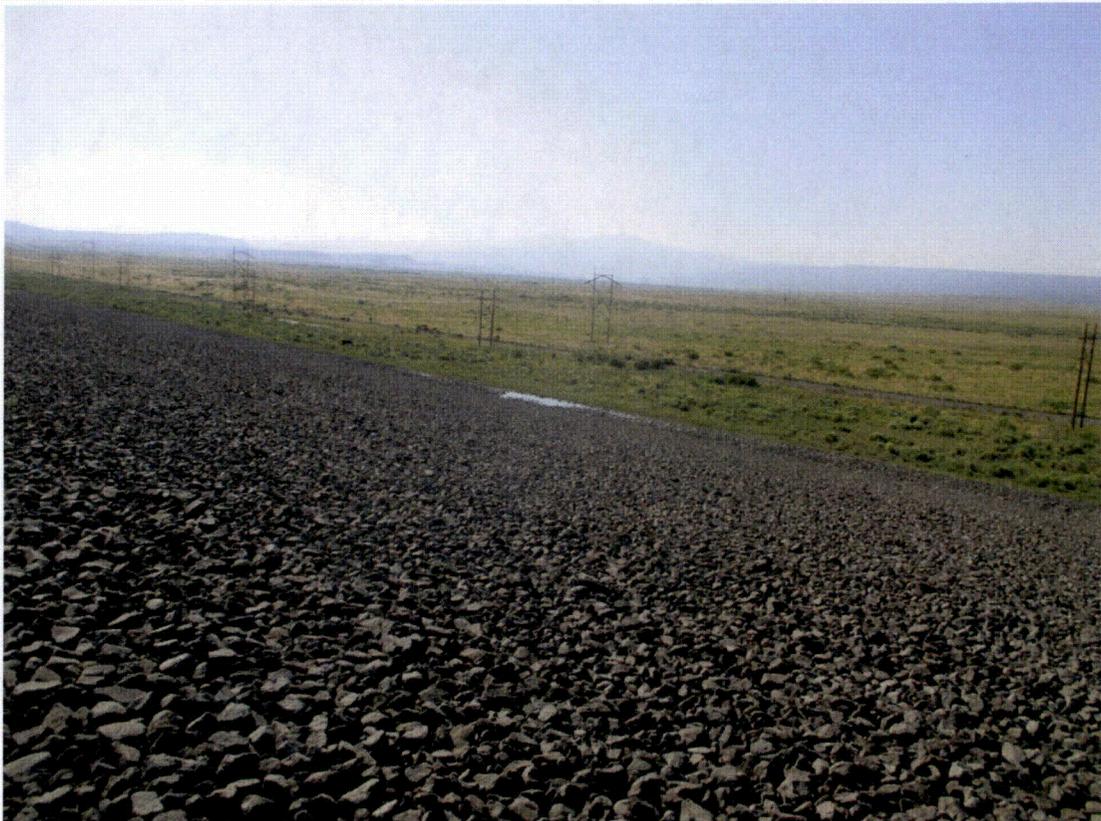
The basalt riprap-covered side slopes and apron were in excellent condition and showed no evidence of cracking, settling, slumping, or erosion (PL-9). Standing water was present in a portion of the south apron (PL-10). This location is the topographic low spot along the base of the disposal cell and rainfall runoff collects in this area.

*AMB 8/2015. PL-10. South side slope and standing water in apron.*

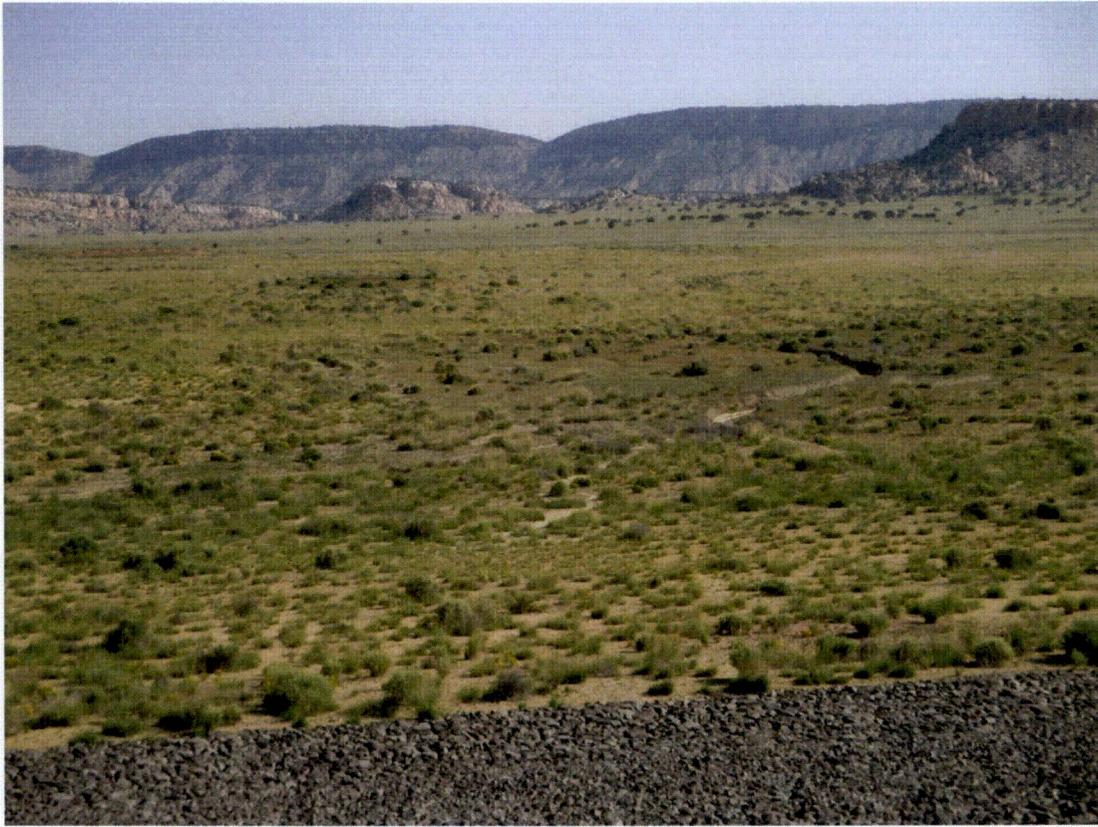
*AMB 8/2015. PL-11. Erosion north of disposal cell.*

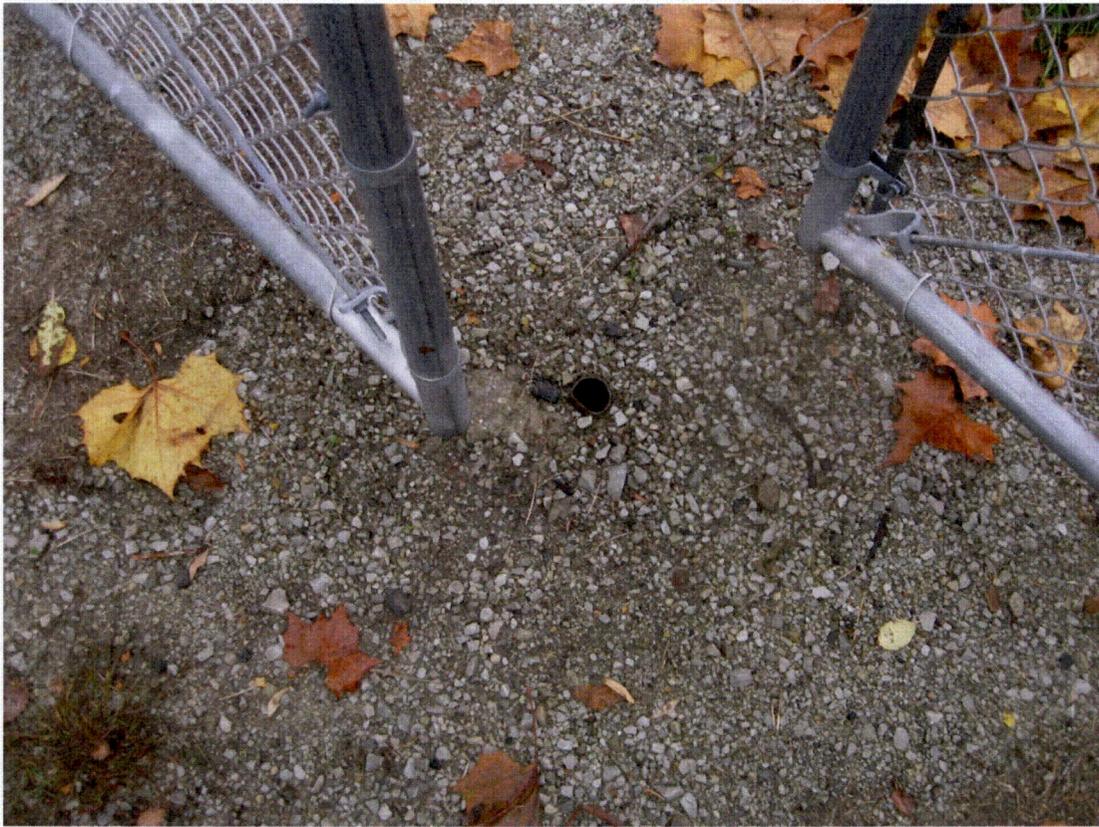
*BUR 10/2015. PL-1. Pipe in ground, vehicle gate, east side of site.*

be made in 2016 to have the existing lock replaced with a new waterproof lock. It was noted during the inspection that the main entrance gate could be further secured by installing a lockable J-post. A pipe is already installed in the ground beneath the gates that could easily receive the J-post (PL-1). The site entrance sign was missing from the main site entrance gate. A J-post will be installed and the site entrance sign will be replaced.

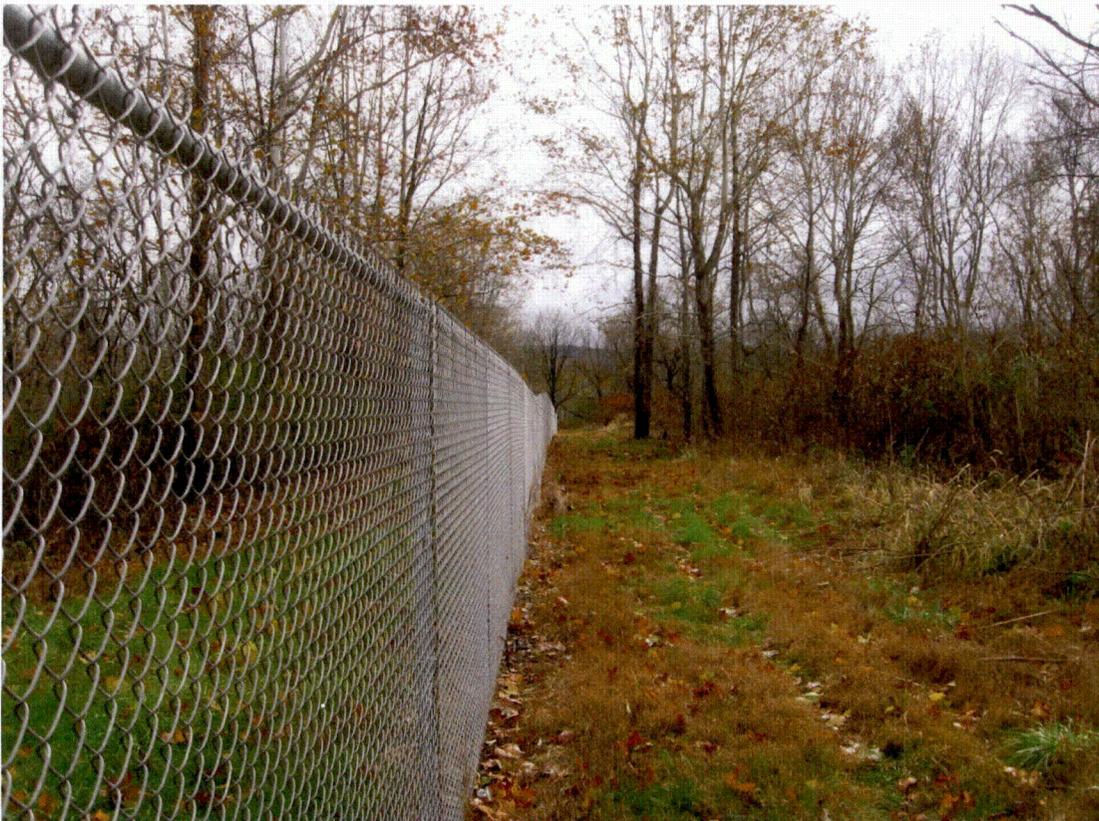
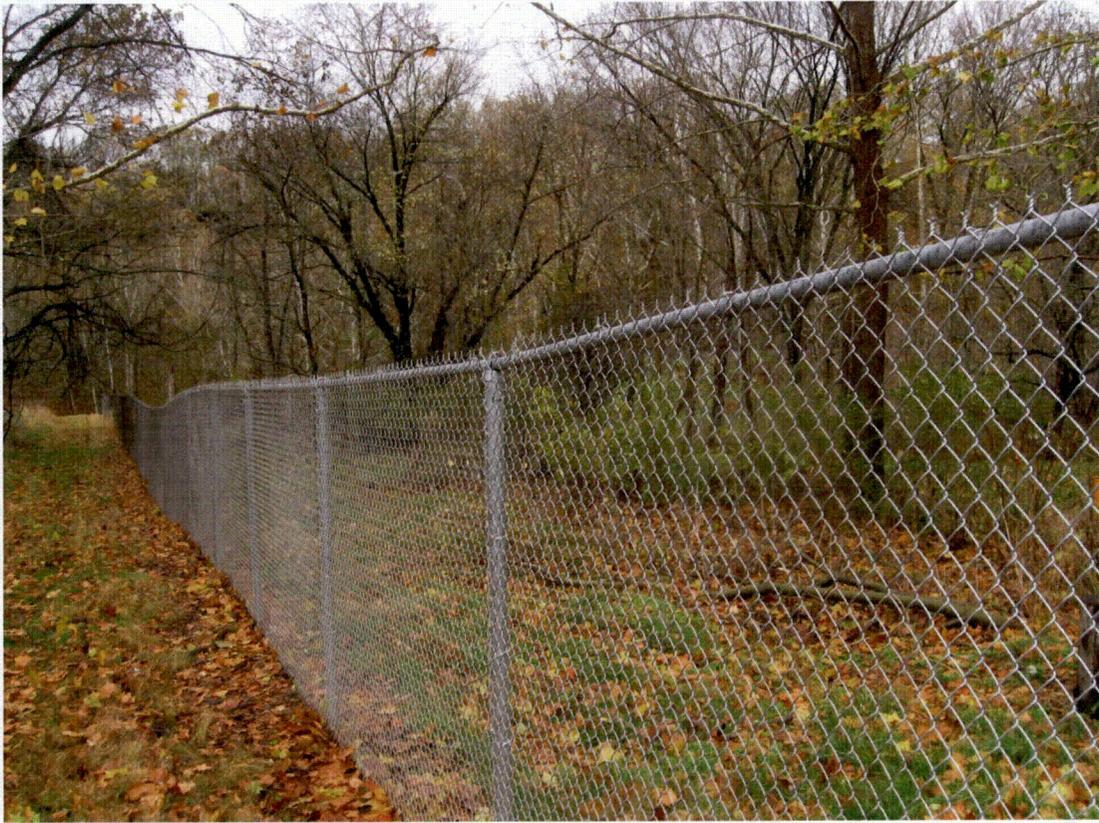
The chainlink perimeter fence that encircles the site was replaced in 2007, and it remains in good condition. The site herbicide subcontractor is doing an excellent job keeping the fence line clear of vegetation, which should prolong the life of the fence (PL-2 and PL-3).

*BUR 10/2015. PL-2. South perimeter fence line.*

*BUR 10/2015. PL-3. South perimeter fence line.*

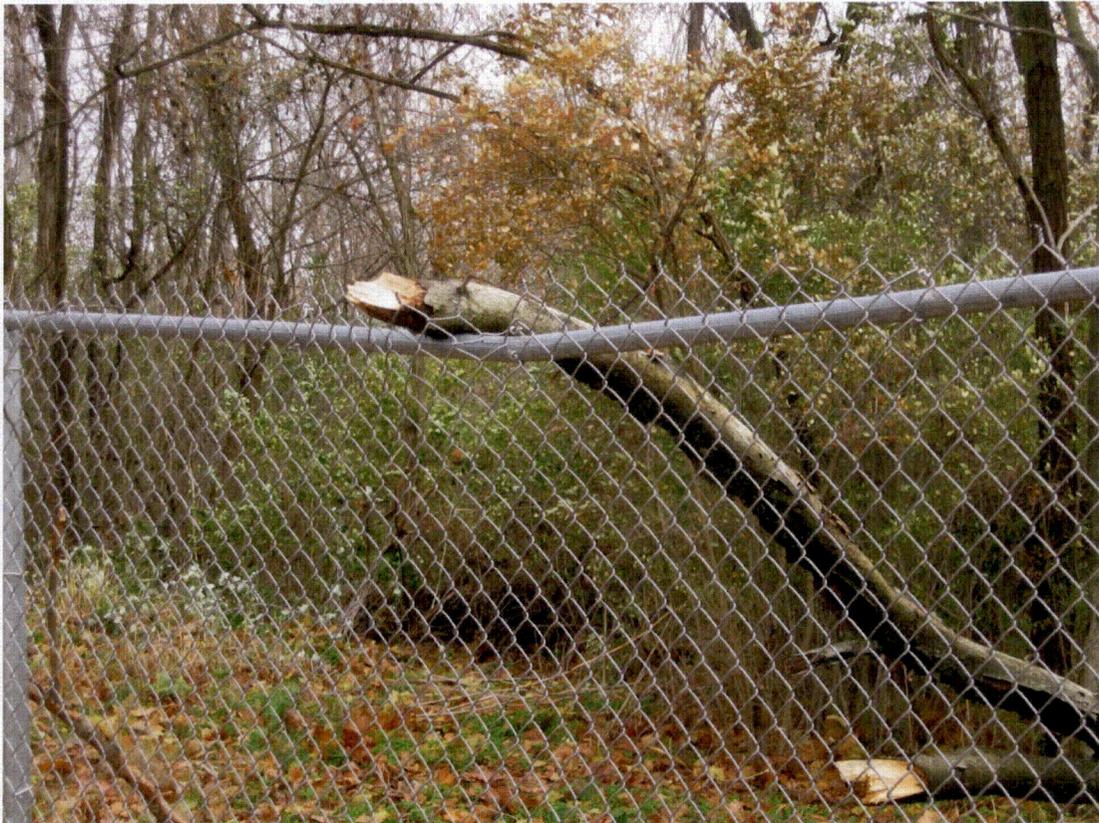
The south fence received minor damage at several locations in 2014 due to fallen trees. All of the damage areas identified in the 2014 inspection report were repaired in 2015. A new area of minor damage was noted in 2015 due to another tree limb falling across the top rail of the south fence (PL-4). The limb was too large for inspectors to safely remove. The site maintenance subcontractor will remove the limb from the fence. Additional repairs to the fence are not needed.

*BUR 10/2015. PL-4. Tree limb on top of fence.*

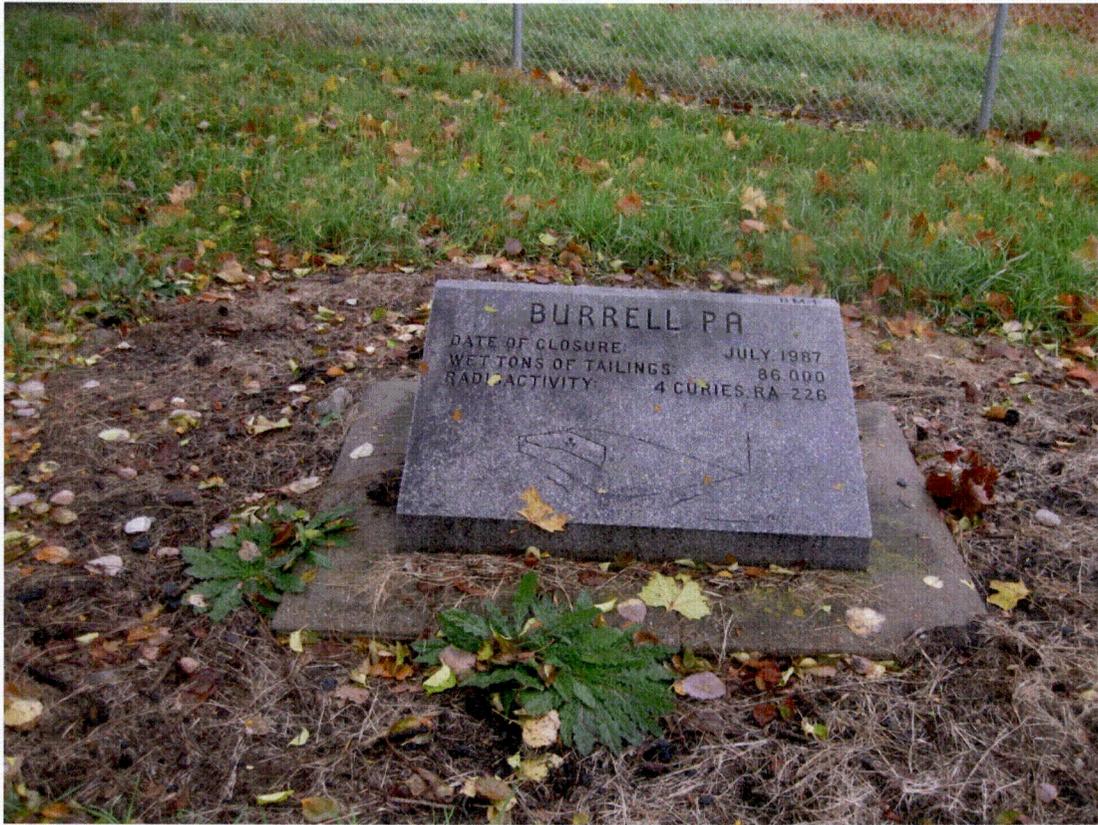
The Burrell site has one site marker. It is just inside the main entrance gate and was in excellent condition (PL-5).

*BUR 10/2015. PL-5. Site marker.*

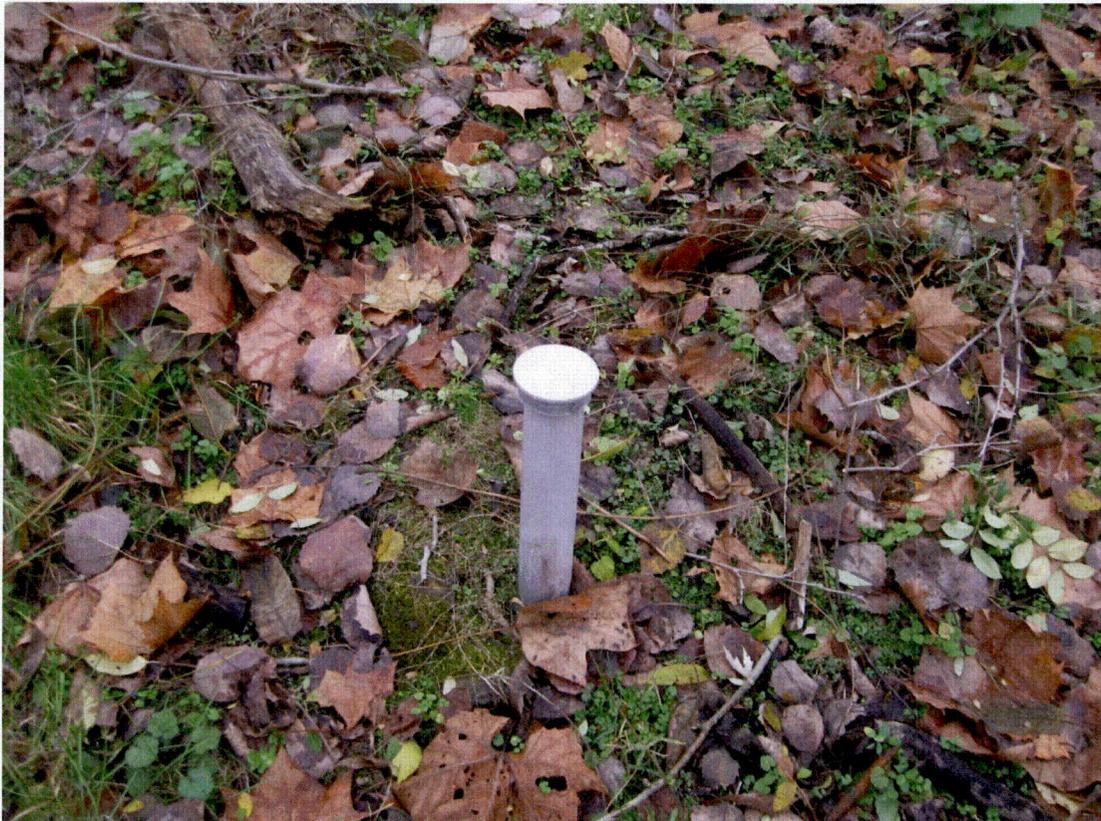
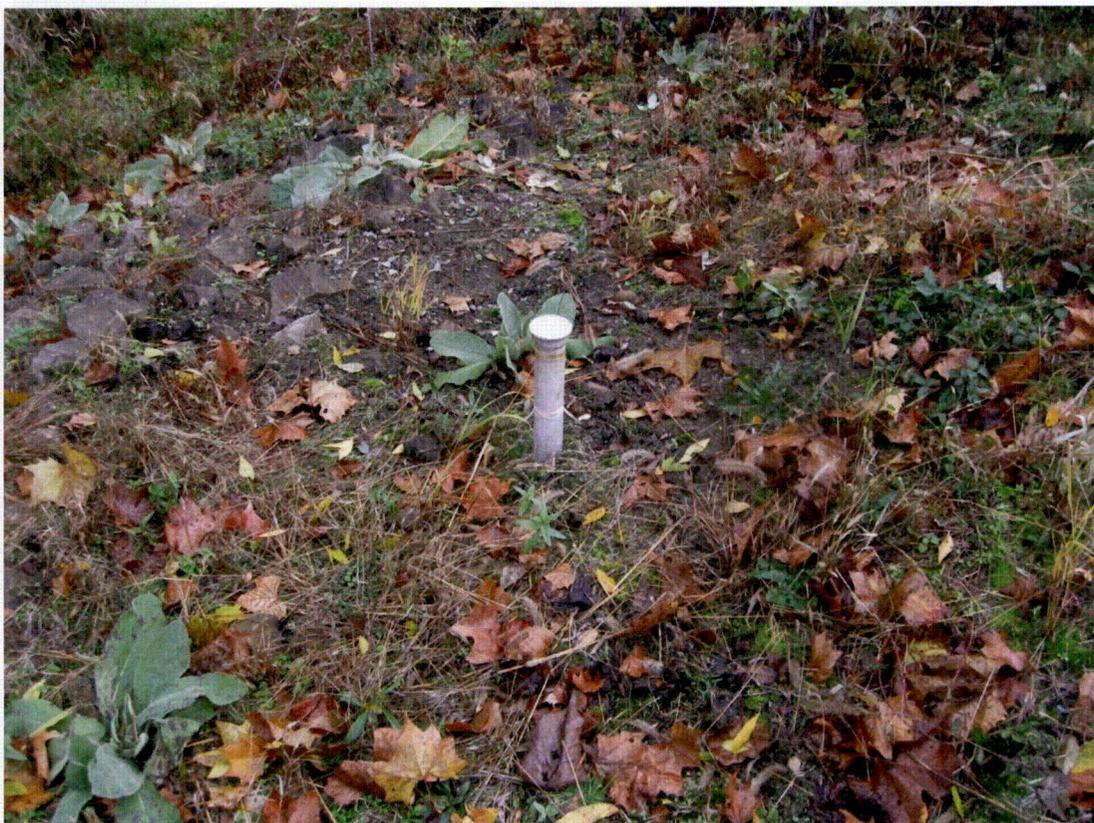
There are eight erosion control markers at Burrell. All eight erosion control markers were located and were in good condition (PL-6 and PL-7).

*BUR 10/2015. PL-6. Erosion control marker ECM-8.*

*BUR 10/2015. PL-7. Erosion control marker ECM-2A.*

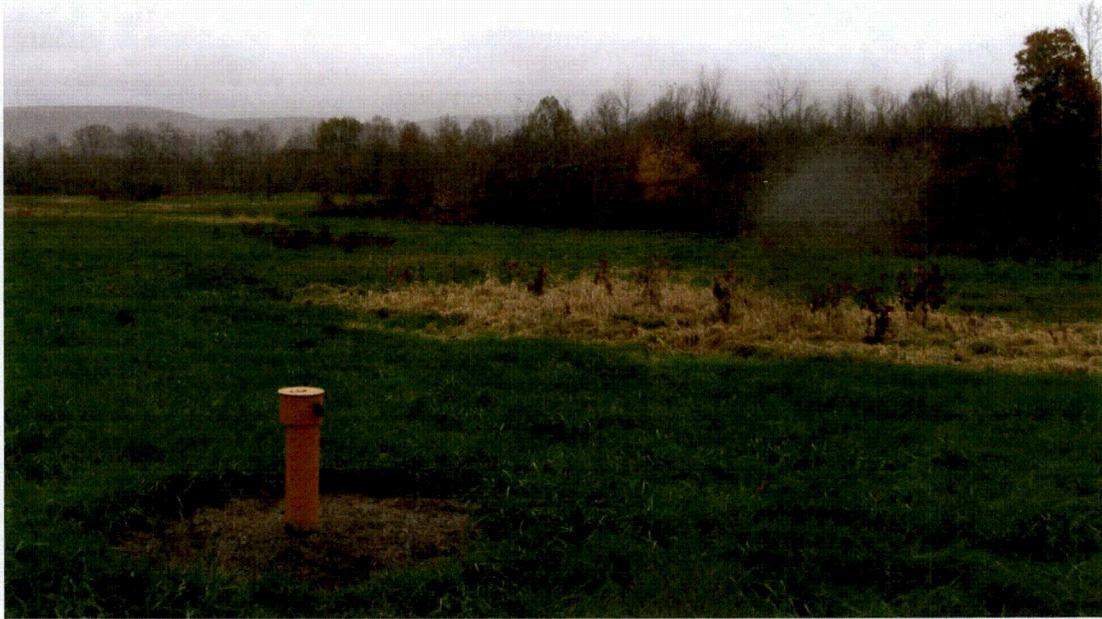
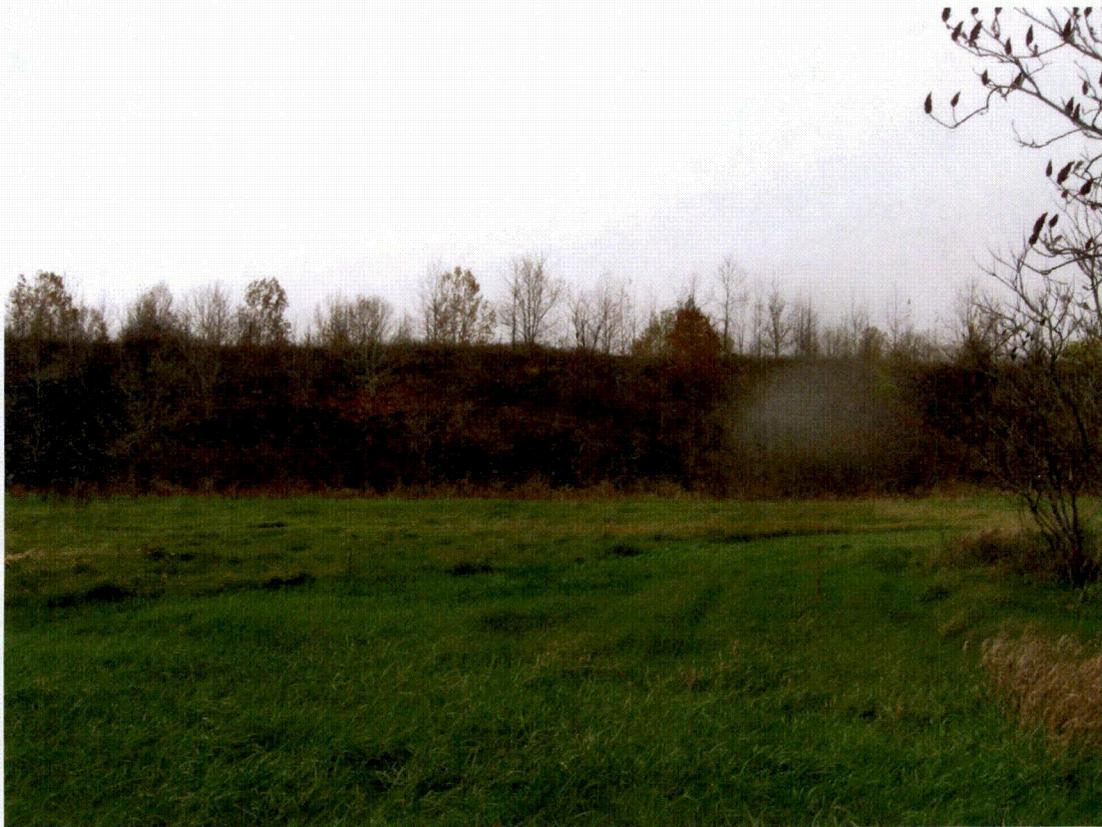
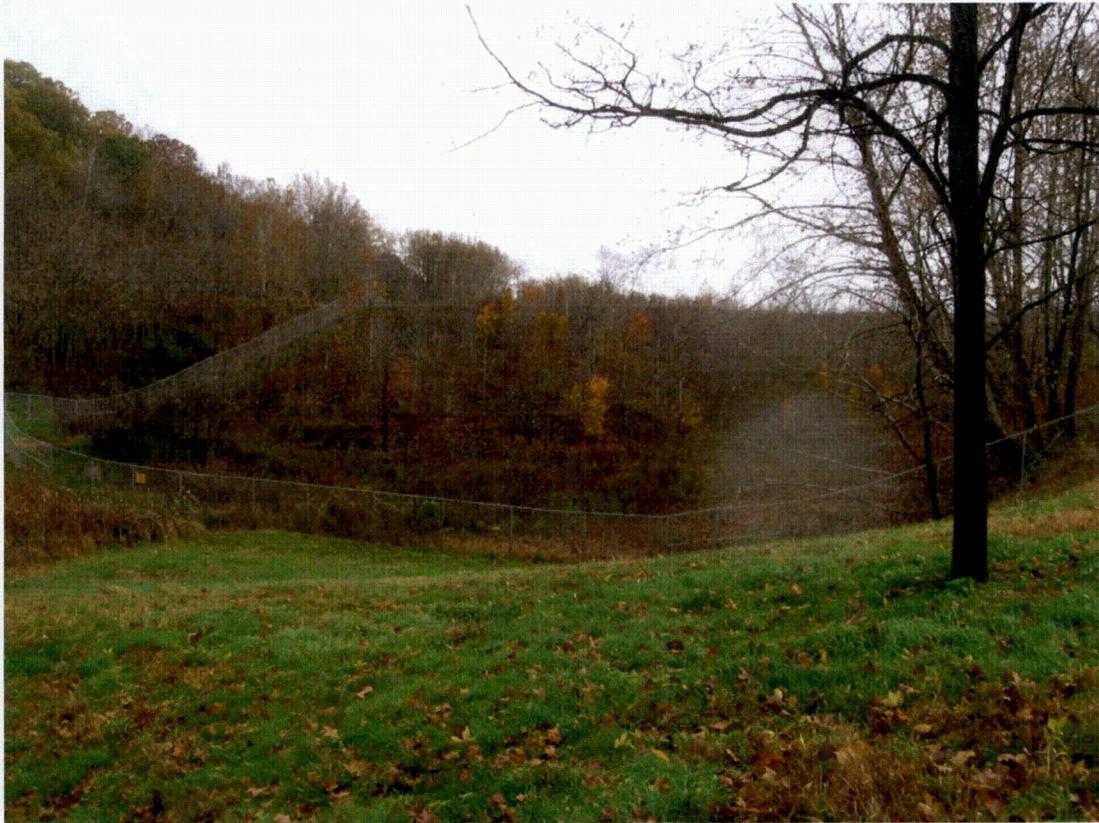
No indications of cell instability (e.g., slumping, bulging, or differential settlement) were noted by the inspectors (PL-9, PL-10, and PL-11). Rock quality remains good; degradation of the riprap was not evident. Due to the rain and slippery conditions, inspectors did not walk across the riprap cover to inspect seep 0611 (located on the south side slope of the disposal cell).

*BUR 10/2015. PL-9. Northeast end of the disposal cell.*

*BUR 10/2015. PL-10. North side of the disposal cell.*

*BUR 10/2015. PL-11. West side of the disposal cell*

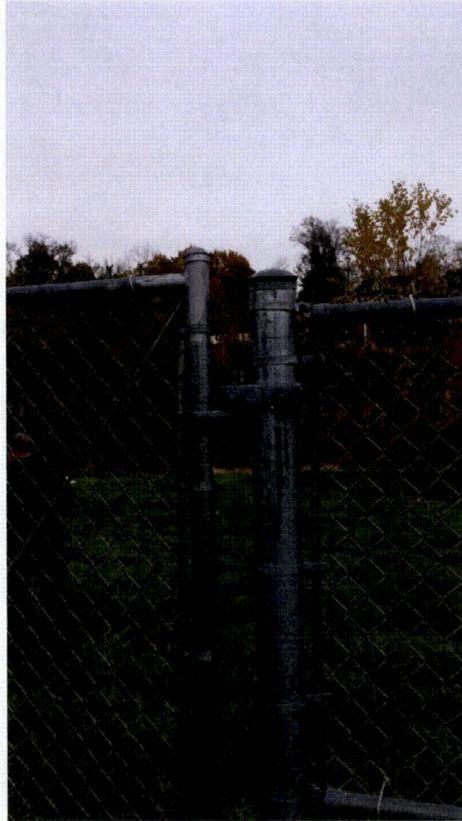
3A The security fence was replaced in 2007 and is in excellent condition. The north vehicle gate hinge was repaired in 2015 and is in good condition (PL-5). A vegetation-free buffer zone is being maintained around the entire site security fence.

*CAN 10/2015. PL-5. Repaired hinge on northeast vehicle gate.*

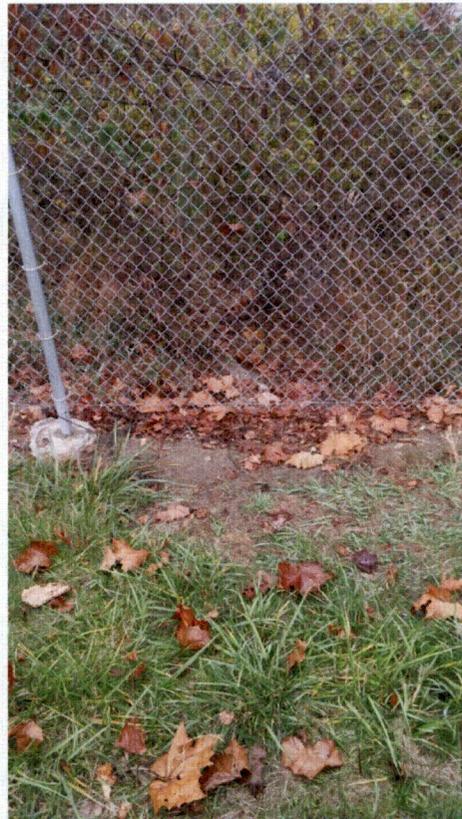
An area of erosion under the west perimeter fence remains (see Figure 3-1). The area appears to be stable and has not grown in size in several years (PL-6). For added security, the gap that is present between the bottom of the fence and the ground surface will be better secured with a few stakes and some wires or additional fence fabric.

*CAN 10/2015. PL-6. Gap beneath fence fabric and ground in area of erosion.*

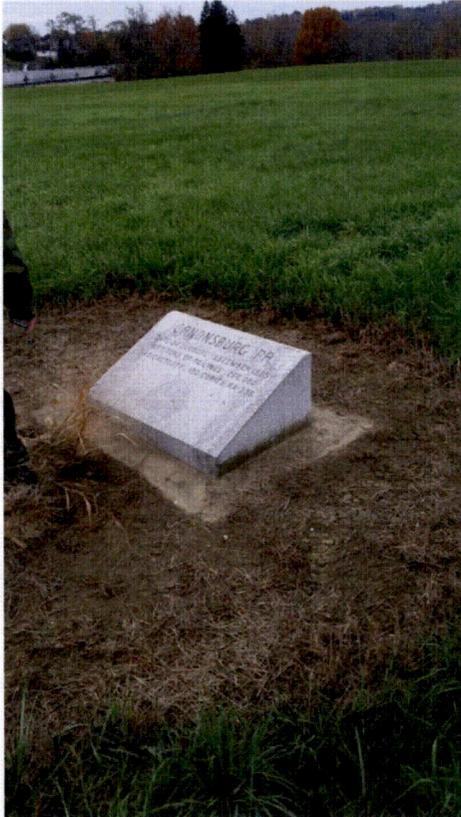
The site has two markers. Both site markers were in good condition (PL-7).

*CAN 10/2015. PL-7. Site marker SMK-1 on top of the disposal cell.*

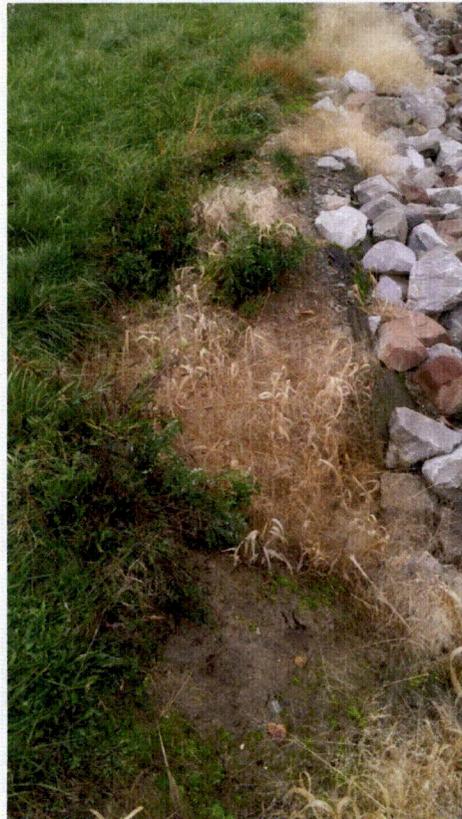
*CAN 10/2015. PL-14. Small area of erosion along the bank of Chartiers Creek, above armored riprap.*

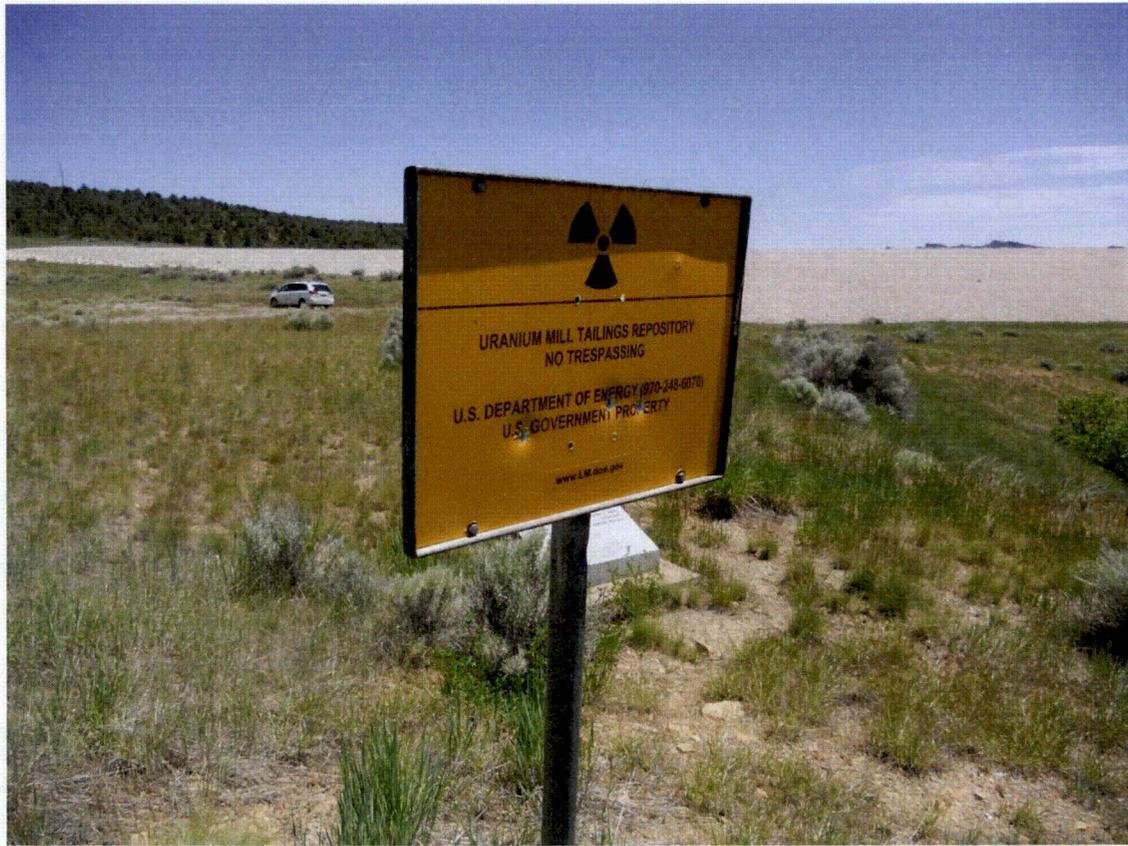
*DUD 6/2015. PL-1. Entrance sign, damaged by bullets.*

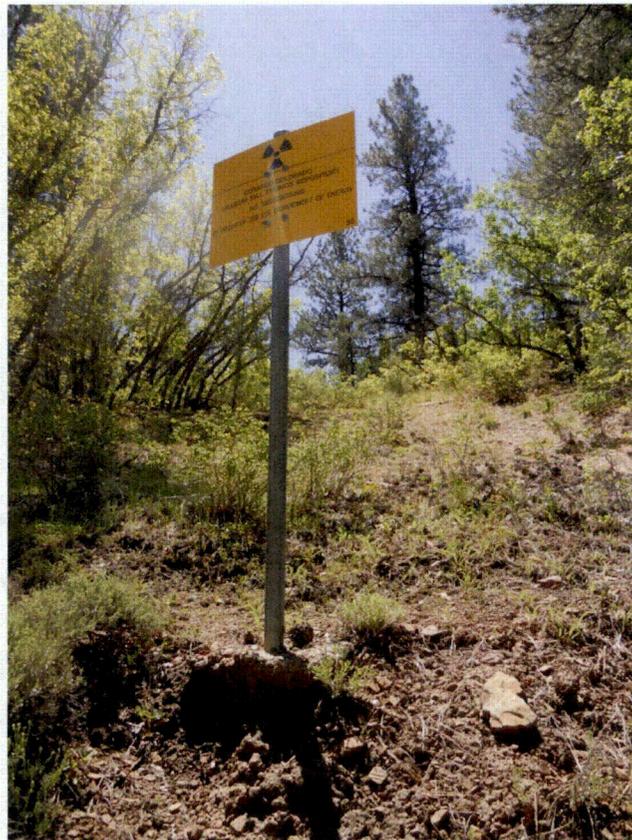
*DUD 6/2015. PL-2. Perimeter Sign P56, slightly undercut.*

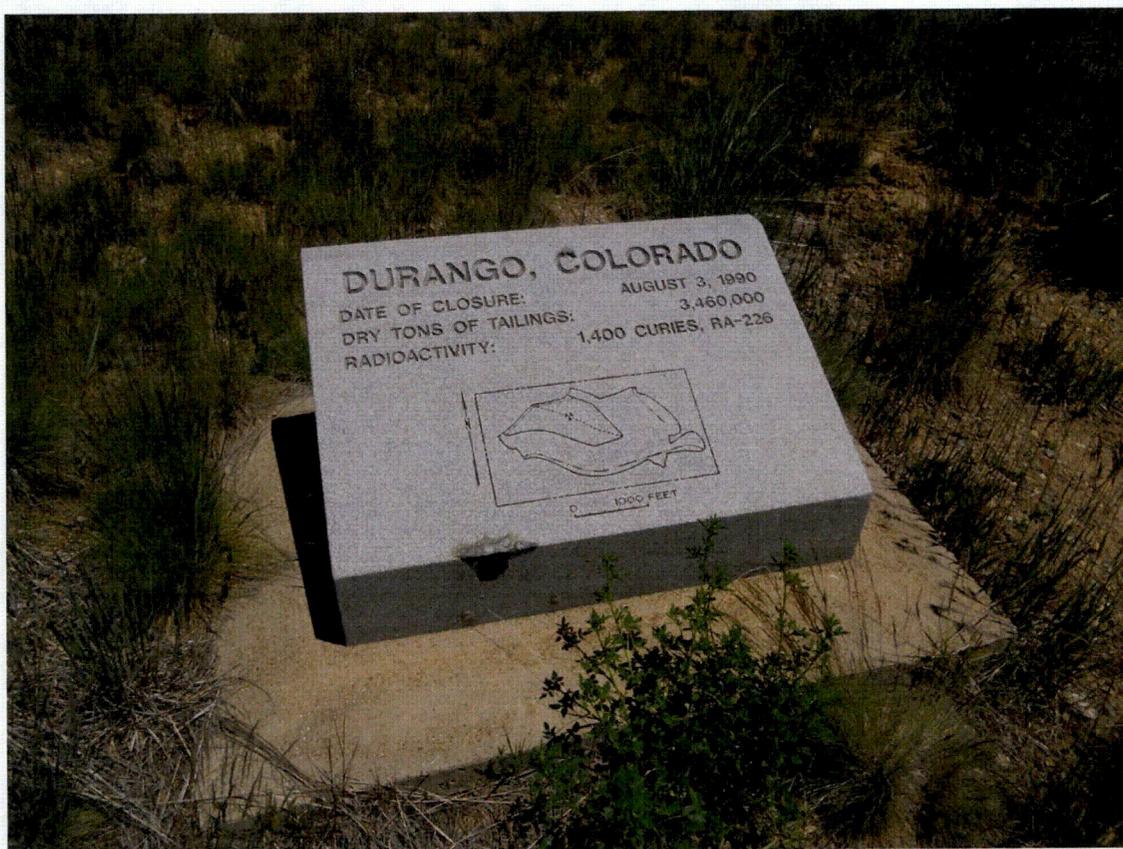
*DUD 6/2015. PL-3. Site marker SMK-1, repaired in 2015.*
