U.S. DEPARTMENT OF  
**ENERGY**

Legacy  
Management

**2015 Annual Site Inspection and  
Monitoring Report for Uranium Mill Tailings  
Radiation Control Act Title I Disposal Sites**

March 2016

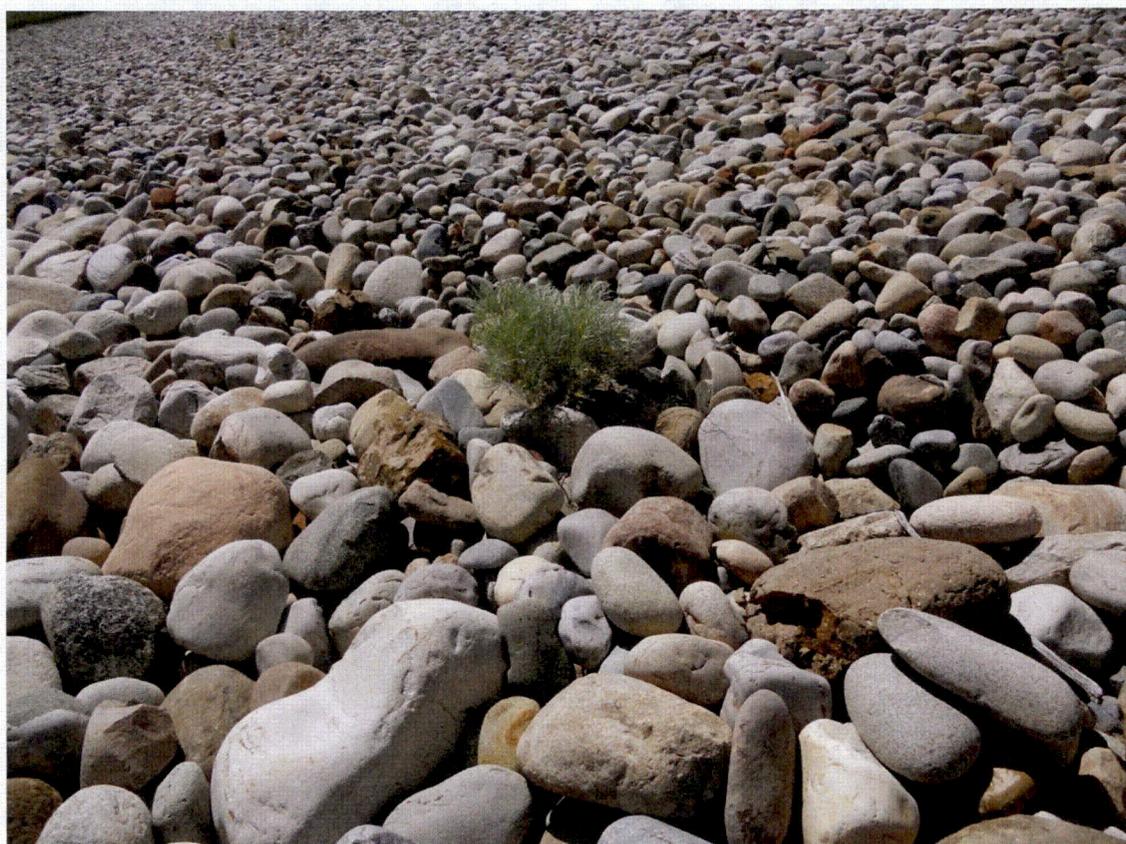
*DUD 6/2015. PL-6. Rock displacement on cell.*
